UNITED STATES
NUCLEAR REGULATORY COMMISSION
OFFICE OF INSPECTION AND ENFORCEMENT
WASHINGTON, DC 20555

IE INFORMATION NOTICE NO. 85-28: PARTIAL LOSS OF AC POWER AND DIESEL
GENERATOR DEGRADATION

WNP-2*

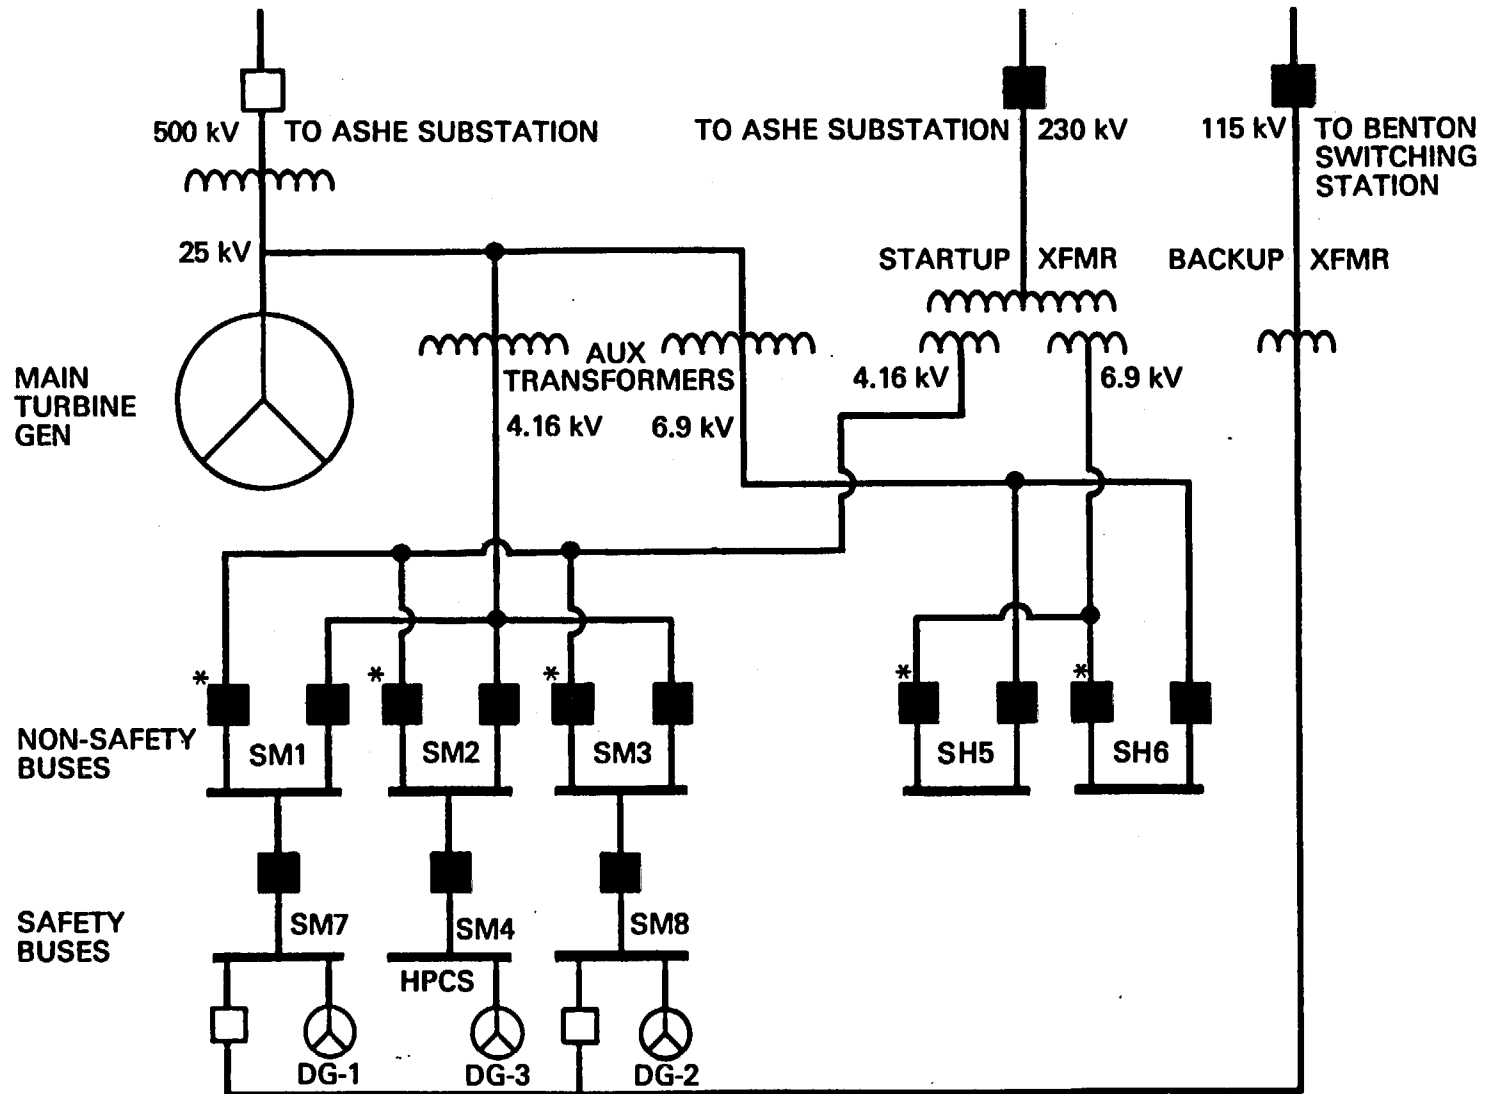
(SIMPLIFIED ONE LINE DIAGRAM)

As a result of this abnormal condition, the generator remained connected to the 230 kV grid via the auxiliary and startup transformers. (See attached simplified diagram illustrating abnormal breaker alignment during the first seconds of this transient.) After 4 seconds, a breaker in the 230 kV line to the startup transformer opened, leaving the plant without non-safety-related power. Two of the buses without power, SM-1 and SM-3, ordinarily feed safety-related buses SM-7 and SM-8. As a result of losing power to two safety-related buses, the backup transformer, which is powered by a 115 kV line, was automatically connected to the safety-related buses and the diesel generators for these buses started, but were not required to assume load.

* Abnormal breaker alignment caused by partial spurious actuation of the Offsite Power Supply Fast Transfer Logic
