UNITED STATES
NUCLEAR REGULATORY COMMISSION
OFFICE OF INSPECTION AND ENFORCEMENT
WASHINGTON, DC 20555

IE INFORMATION NOTICE NO. 85-28: PARTIAL LOSS OF AC POWER AND DIESEL
GENERATOR DEGRADATION

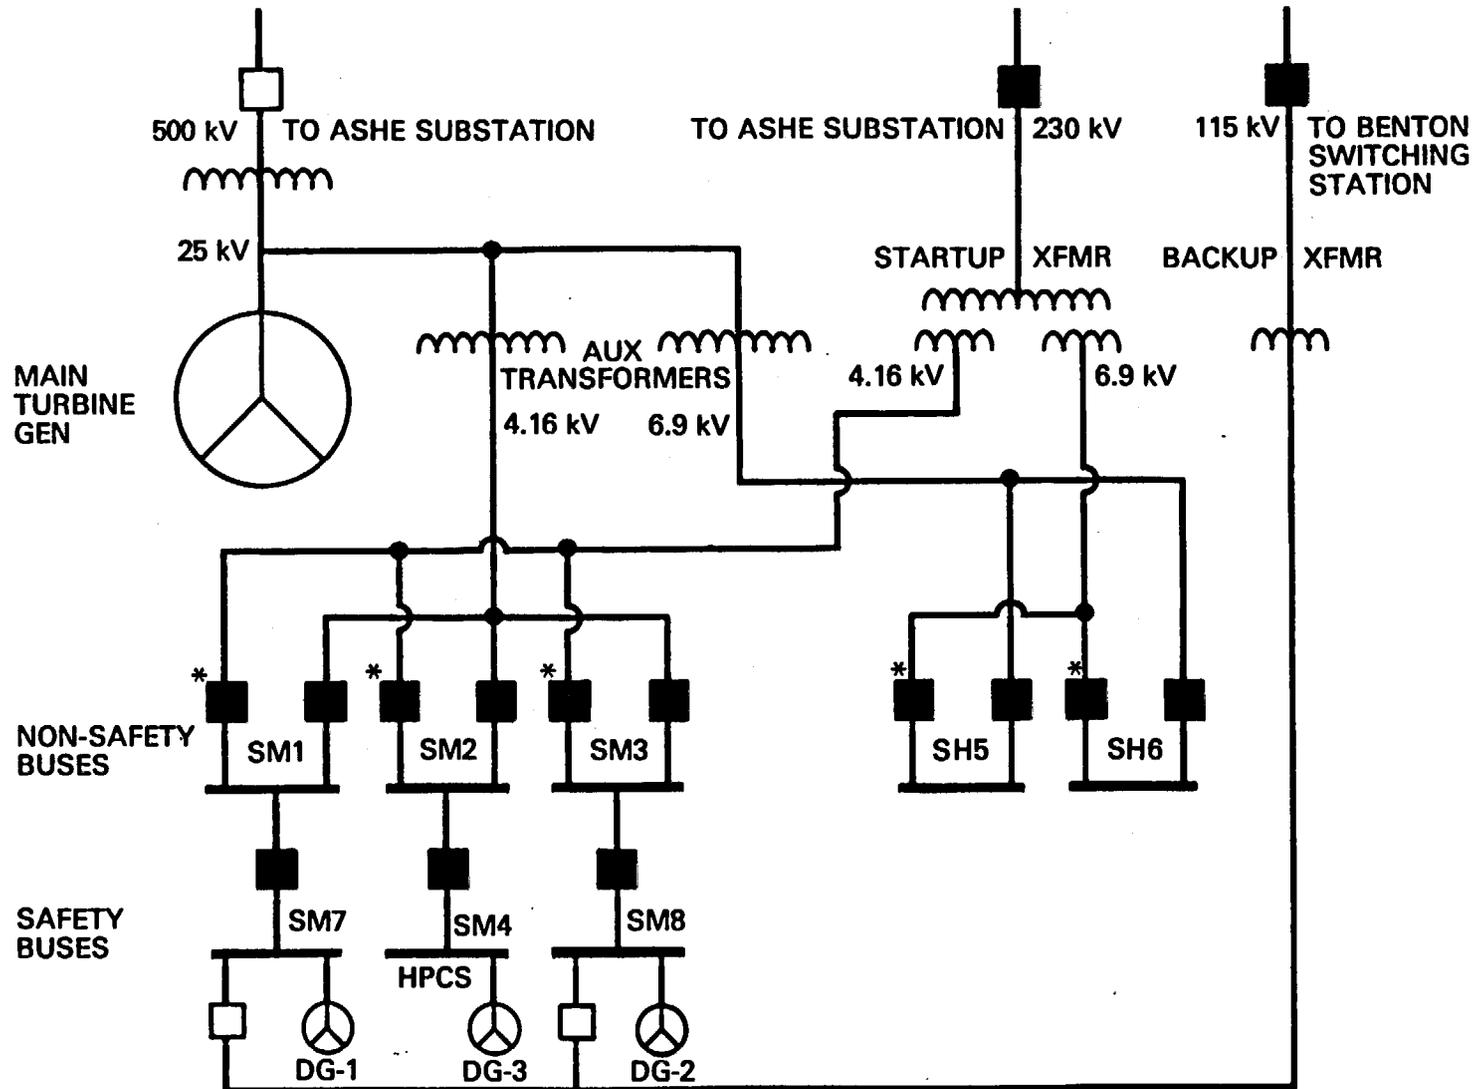
(SIMPLIFIED ONE LINE DIAGRAM)

As a result of this abnormal condition, the generator remained connected to the 230 kV grid via the auxiliary and startup transformers. (See attached simplified diagram illustrating abnormal breaker alignment during the first seconds of this transient.) After 4 seconds, a breaker in the 230 kV line to the startup transformer opened, leaving the plant without non-safety-related power. Two of the buses without power, SM-1 and SM-3, ordinarily feed safety-related buses SM-7 and SM-8. As a result of losing power to two safety-related buses, the backup transformer, which is powered by a 115 kV line, was automatically connected to the safety-related buses and the diesel generators for these buses started, but were not required to assume load.

* Abnormal breaker alignment caused by partial spurious actuation of the Offsite Power Supply Fast Transfer Logic
