UNITED STATES  
NUCLEAR REGULATORY COMMISSION  
OFFICE OF INSPECTION AND ENFORCEMENT  
WASHINGTON, D.C. 20555

August 30, 1985

IE INFORMATION NOTICE NO. 85-75: IMPROPERLY INSTALLED INSTRUMENTATION,  
INADEQUATE QUALITY CONTROL AND INADEQUATE  
POSTMODIFICATION TESTING

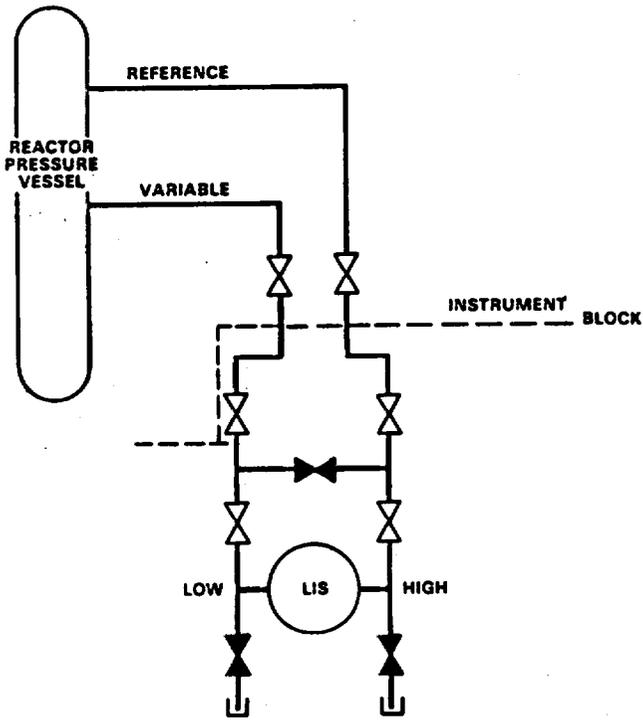
reactor vessel level actuation switches for ECCS Division I had been accidentally reversed since June 3, 1985; thus leaving the plant with no ECCS automatic actuation and no secondary containment.

The cause of the piping reversal was initially the result of incorrect design drawings which were released to the contractor on April 1, 1985. The licensee's site personnel recognized the error on April 4, 1985, and issued a Field Change Request to correct it. However, the isometric drawings being used at the location of the modification activities were not corrected. Therefore, the contractor proceeded to connect piping in the reverse order from the correct configuration. Figure 1 shows the correct configuration and Figure 2 shows the reversal. This error was not identified by the Quality Control (QC) Program because the contractor's QC did not assign inspection hold points for either the electrical or mechanical piping connections for any of the 22 instruments replaced by the modification. Consequently, the installation adequacy was not verified against the design drawings, which did include the field change and, therefore, which could reasonably be expected to have revealed the error in the two instruments that were piped backwards.

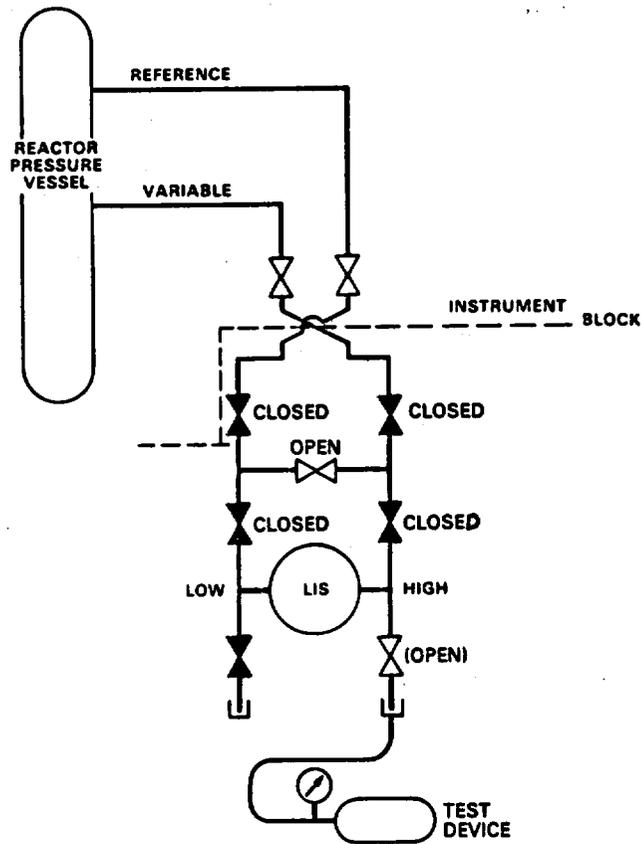
Figure 3

Subsequent postmodification testing failed to detect the error because (as shown in Figure 3) the test shut the instrument block isolation valves and injected a test pressure source through the installed test connections downstream from the instrument. This test method isolated the portion of the piping where the reversal occurred from the test because it was upstream of the shut valves.
