SSINS No.: 6835
Accession No.:
8008220180
IN-80-38

UNITED STATES
NUCLEAR REGULATORY COMMISSION
OFFICE OF INSPECTION AND ENFORCEMENT
WASHINGTON, D.C. 20555

October 30, 1980

IE Information Notice No. 80-38: CRACKING IN CHARGING PUMP CASING CLADDING

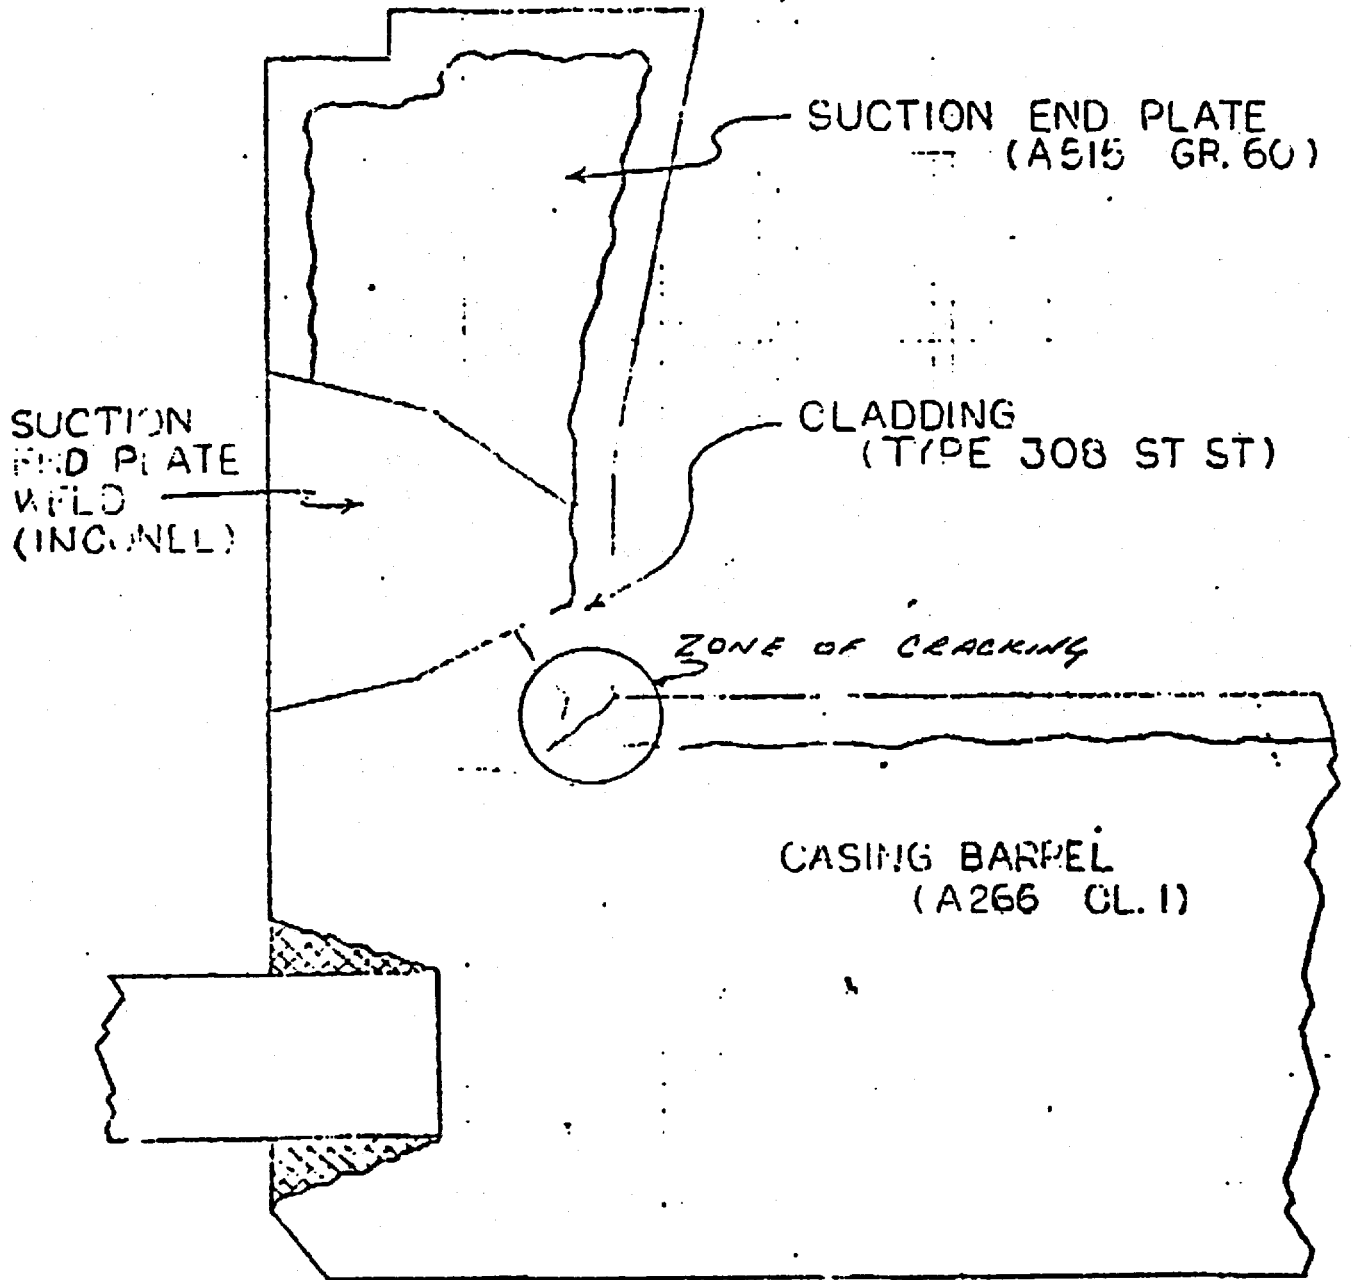
FIGURE 1

The pumps are 2-1/2 inch, 11 stage, Type IJ manufactured by the Pacific Pumps Division of Dresser Industries. The pump casing end assembly in the area of interest, Figure 1, consists of a suction end plate of A515 grade 60 carbon steel plate welded to the casing barrel forging of A266 class 1 carbon steel using an Inconel weldment. The entire inner surface is clad with type 308 stainless steel applied by submerged arc welding.

An in-situ ultrasonic examination conducted in late April confirmed clad cracking indications at the barrel case to end plate inner radius for approximately 330 degrees around the circumference and that the cracking possibly extended into the pump base material in the bottom 130 degrees of the assembly. A review of the original radiographs revealed crack like indications in the clad overlay, however, not to the extent observed during this examination.

Subsequently, the entire suction end of the pump was removed and cross sections metallographically examined to further evaluate the nature and extent of the cracking. It was determined that initiation and propagation of the clad cracks probably resulted from stress concentration and dilution effects in the initial corner bead pass due to the difficult access and bead sequencing required by the fairly sharp corner geometry. Extension of the cracks at the base metal-clad interface ranged to a depth of 1/16 inch maximum in the 1-1/2 inch thick base material. These crack tip areas were well blunted and slightly cavitated from corrosion effects due lengthy exposure to the localized boric acid attack. Examination of the crack morphology revealed that the clad cracking essentially arrested at the base metal-clad interface and that base metal corrosion progressed at a relatively slow rate.

The 1A charging pump was replaced with a new pump provided with a casing constructed entirely of stainless steel. The licensee is currently developing improved NDE procedures for examination of the three remaining pumps at the next refueling outage. Further, the licensee and pump manufacturer are developing repair procedures in the event cracks are discovered in the remaining pumps.

Based on the available information no immediate safety concern is indicated. However, the observed conditions reveal a potential source of pump degradation over long term operations. Therefore, to assure maximum availability, it appears prudent to perform a nondestructive examination of this pump type at the earliest practical time during the first code required in-service inspection interval and if cracking is confirmed, take appropriate corrective actions per the rules of ASME Section XI BP&V Code.
