UNITED STATES
NUCLEAR REGULATORY COMMISSION
OFFICE OF INSPECTION AND ENFORCEMENT
WASHINGTON, D.C. 20555

March 7, 1985

IE INFORMATION NOTICE NO. 85-18: FAILURES OF UNDERVOLTAGE OUTPUT CIRCUIT
BOARDS IN THE WESTINGHOUSE-DESIGNED SOLID
STATE PROTECTION SYSTEM

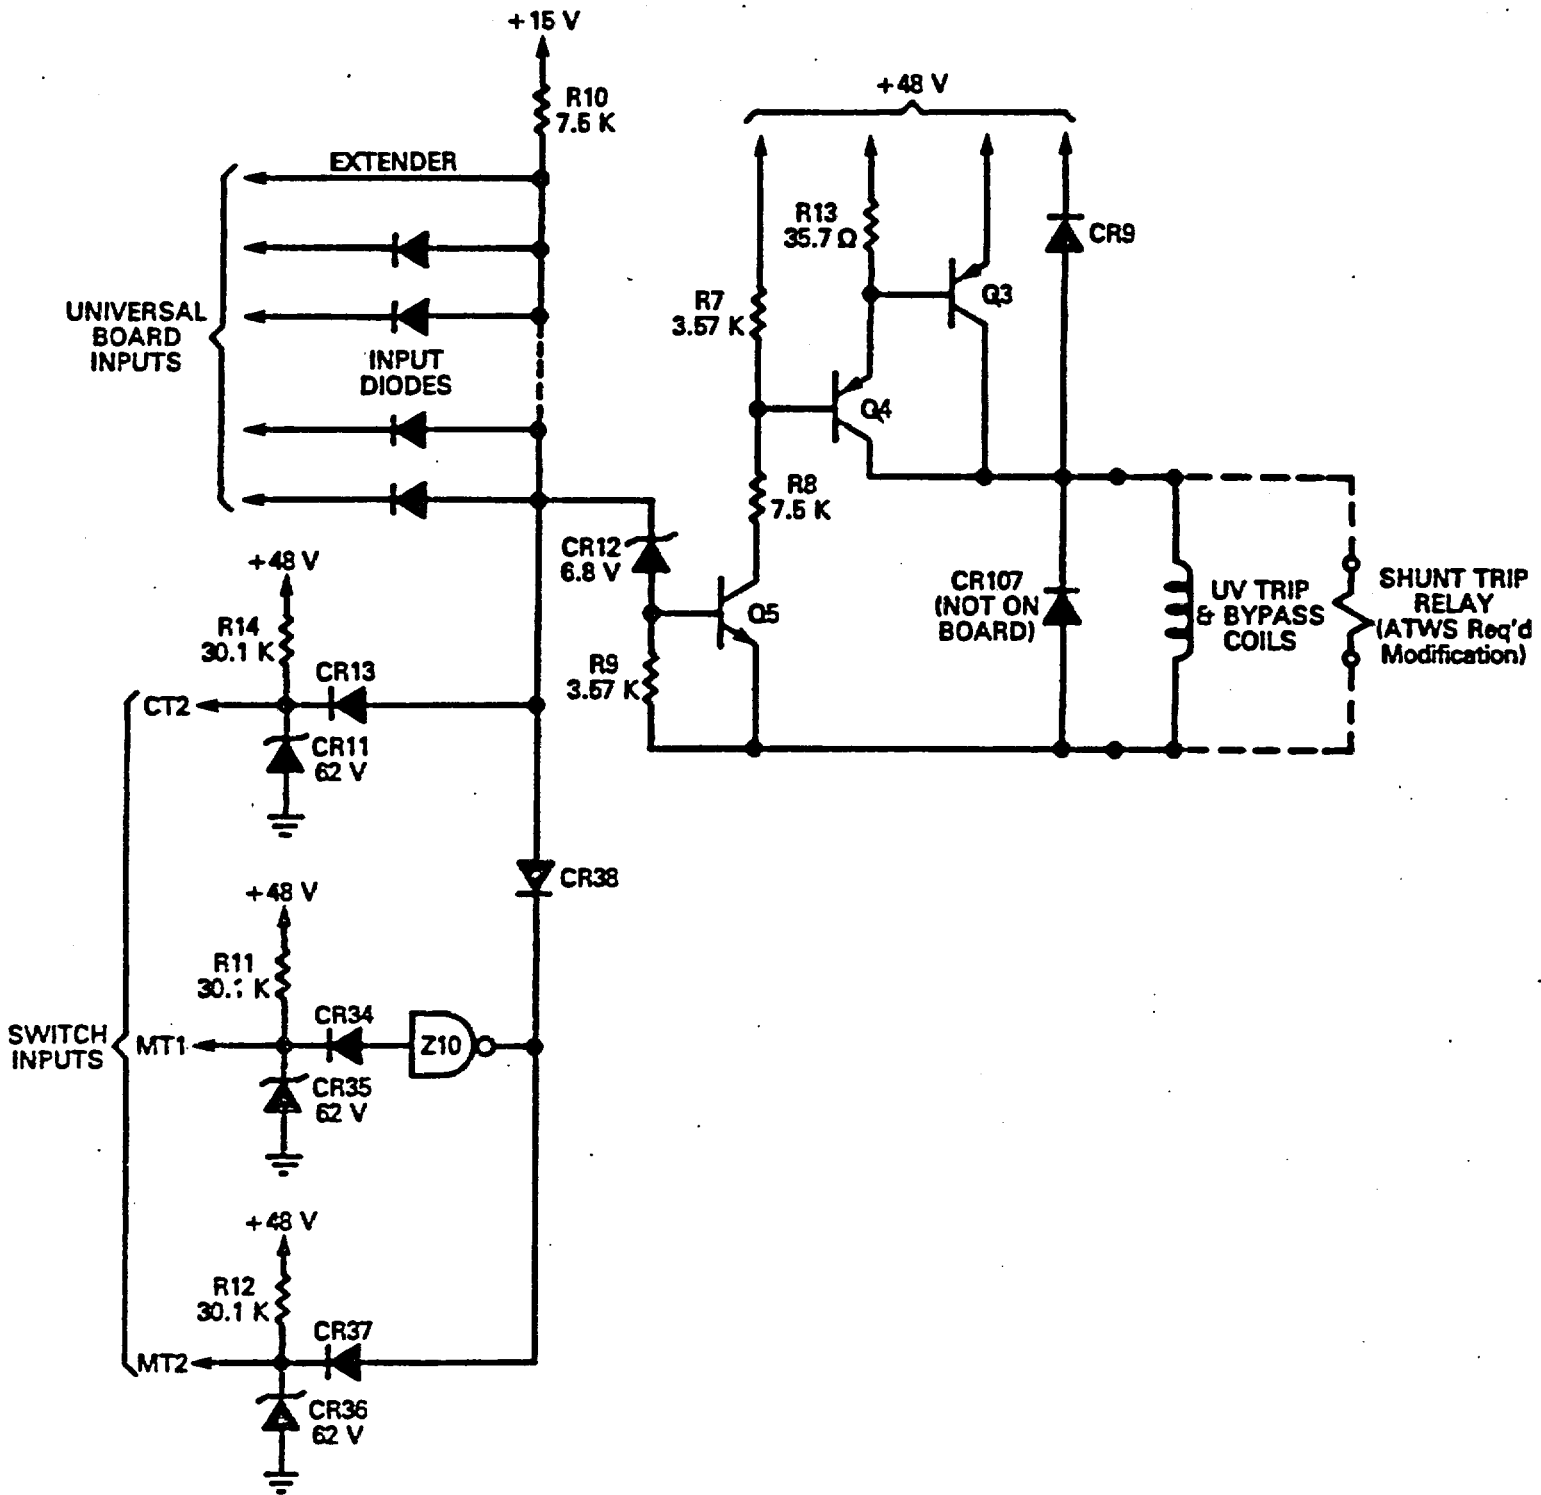
UV OUTPUT CIRCUIT

The UV output circuit (see Attachment 1, UV Output Circuit) is designed so that in the absence of a reactor trip signal from the universal logic boards or switched inputs, the Darlington pair transistors Q3 and Q4 in the UV output circuit will conduct current and energize the UV trip coil of the associated RTB. A reactor trip input will result in the turning off of the Darlington pair transistors Q3 and Q4, thereby interrupting current flow to the UV trip coil of the associated RTB and causing the RTB to open. Similarly, if the automatic shunt trip feature has been implemented, the turning off of transistors Q3 and Q4 would also deenergize the associated shunt trip relay, thereby tripping the same RTB by a diverse mechanism.

Failures of the type experienced at North Anna and Sequoyah have resulted in the shorting of transistors Q3 or Q4. Such short-circuit failures are not only

not fail-safe (i.e., they do not cause a reactor trip) but they also would prevent the functioning of any subsequent automatic reactor trip signal because the failure would continuously maintain power to the UV trip coil of the associated RTB. Since the Darlington pair transistors Q3 and Q4 are also being used to control the automatic shunt trip feature of the RTBs, failures of the type experienced at North Anna and Sequoyah would also incapacitate the automatic shunt trip feature of the associated RTB. Thus, the coincident failures of both the A and B train UV output circuits would disable both automatic trip functions (UV trip and shunt trip) of both RTBs, thereby exposing the plant to a potential ATWS event.

The described failures appear to be associated with maintenance activities external to the SSPS, including the implementing of the automatic shunt trip features of the RTBs. To preclude potential failures of the UV output circuit boards while implementing the shunt trip feature, Westinghouse informed North Anna that it is imperative that the SSPS UV output circuit card be removed before performing such work. Prudent actions also would include testing the UV output circuit by using the SSPS semiautomatic testor after any maintenance work is performed on the associated RTB cubicle.
