UNITED STATES
NUCLEAR REGULATORY COMMISSION
OFFICE OF INSPECTION AND ENFORCEMENT
WASHINGTON, D.C. 20555

February 22, 1985

IE INFORMATION NOTICE NO. 85-14: FAILURE OF A HEAVY CONTROL ROD (B4C) DRIVE ASSEMBLY TO INSERT ON A TRIP SIGNAL

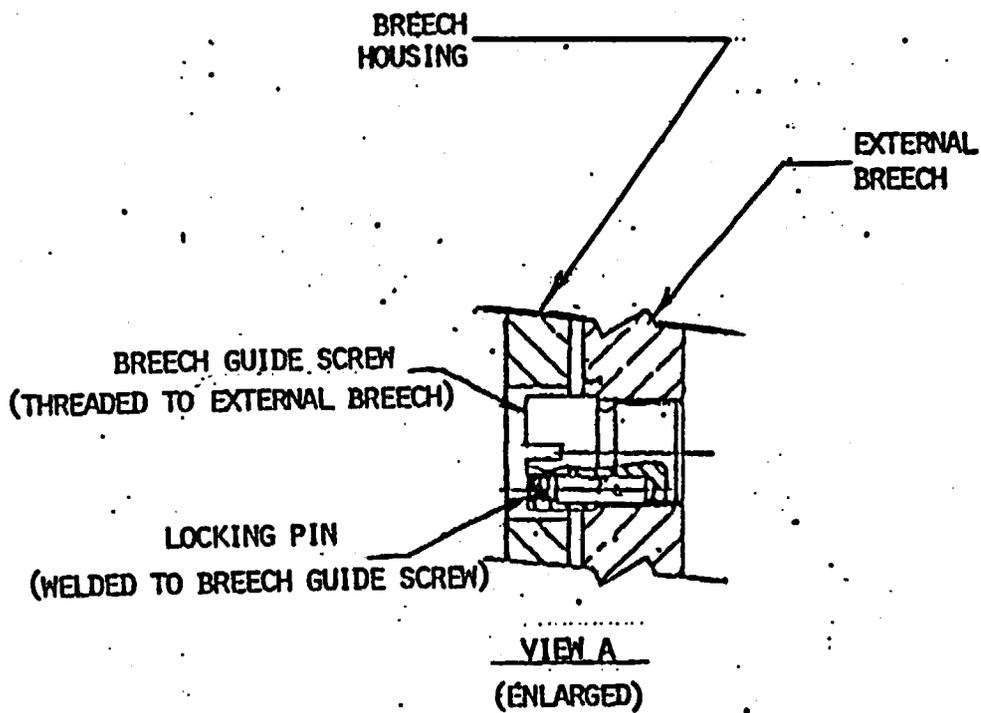
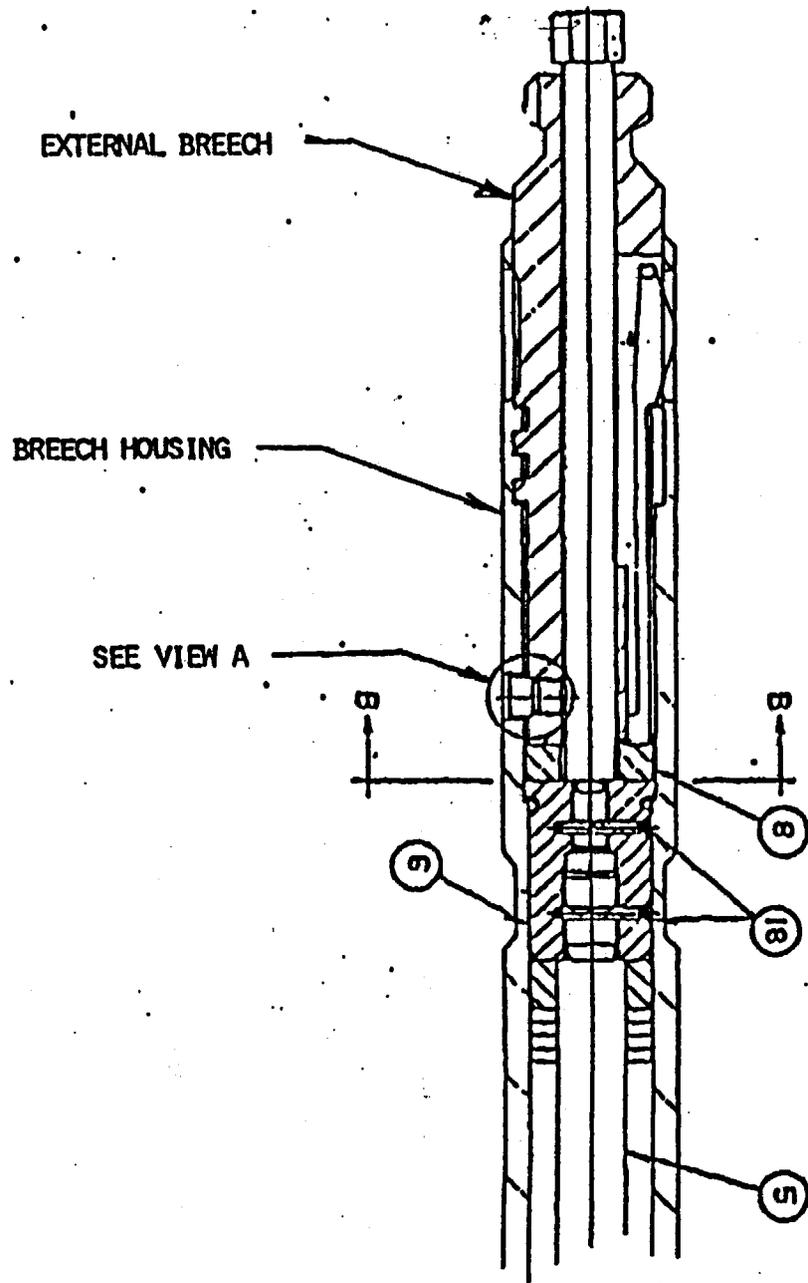
ROD DRIVE ASSEMBLY

operating plant (McGuire 2) and for six construction plants (Catawba 1 and 2, Seabrook 1 and 2, Watts Bar 1 and 2). (Note: At that time, Catawba 1 had been issued a low power testing license but had not yet attained initial criticality.) The drive rod became stuck at a foreign reactor during downward stepping while performing hot rod drop tests as part of preoperational testing prior to achieving initial criticality. Subsequent on-site investigations revealed that a breech guide screw from a CRDM heavy drive rod assembly had rotated out of position and fell on top of the CRDM latch assembly where it became lodged and prevented driveline motion.

The function of the breech guide screw is to provide alignment and guidance during coupling and uncoupling of the drive rod from the rod cluster control assembly during refueling. The breech guide screw is 0.52 inch long and has a 0.433 inch diameter. If a breech guide screw were to rotate out of the drive rod assembly, it would fall into the annulus between the external breech and the rod travel housing. Although this annulus is nominally 3/8 inch wide, it is sufficiently flexible to allow a loose breech guide screw to travel downward during rod stepping. The loose breech guide screw would then lodge on top of the CRDM latch assembly, potentially causing misstepping, intermittent sticking of the driveline or a totally stuck driveline. Such a loose breech guide screw would not be able to pass below the above position because the clearance between the guide tube and the drive rod assembly is only 0.055 inch. Thus, if a breech guide screw should become loose, it would not be able to migrate into the reactor upperhead region during plant operation; therefore, it would not subsequently be expected to become a loose part in the reactor coolant system.

The breech guide screw of a heavy drive rod assembly is designed to be held in position by a locking pin. The locking pin is inserted in a drilled hole that intersects the mating threads of the breech guide screw and those of a threaded hole in the external breech of the drive rod assembly. The locking pin, in turn, is welded to the head of the breech guide screw to ensure that it stays in place. (See Attachment 1, Drive Rod Assembly.) However, in the foreign plant, the breech guide screw was drilled at an angle such that the locking pin did not intersect the threads. Thus, the locking pin was ineffectual in that the breech guide screw was not actually locked in place but was free to unscrew from the external breech.

Westinghouse is inspecting the CRDMs of all affected plants under construction and will repair those assemblies with loose breech guide screws. Westinghouse has developed a repair procedure for any breech guide screw that fails the inspection. The procedure consists of drilling another hole in the breech guide screw at least 90 degrees from the existing hole, inserting a locking pin in the new hole and welding the locking pin in place.
