UNITED STATES  
NUCLEAR REGULATORY COMMISSION  
OFFICE OF NUCLEAR REACTOR REGULATION  
WASHINGTON, D.C. 20555

NRC INFORMATION NOTICE NO. 89-29: POTENTIAL FAILURE OF ASEA BROWN BOVERI  
CIRCUIT BREAKERS DURING SEISMIC EVENT

Subject: Slow Close Lever Rebound Spring for  
ABB Power Distribution K-Line  
Electrically Operated K-225 through  
K-2000 Circuit Breakers  
(Part 21 Report)

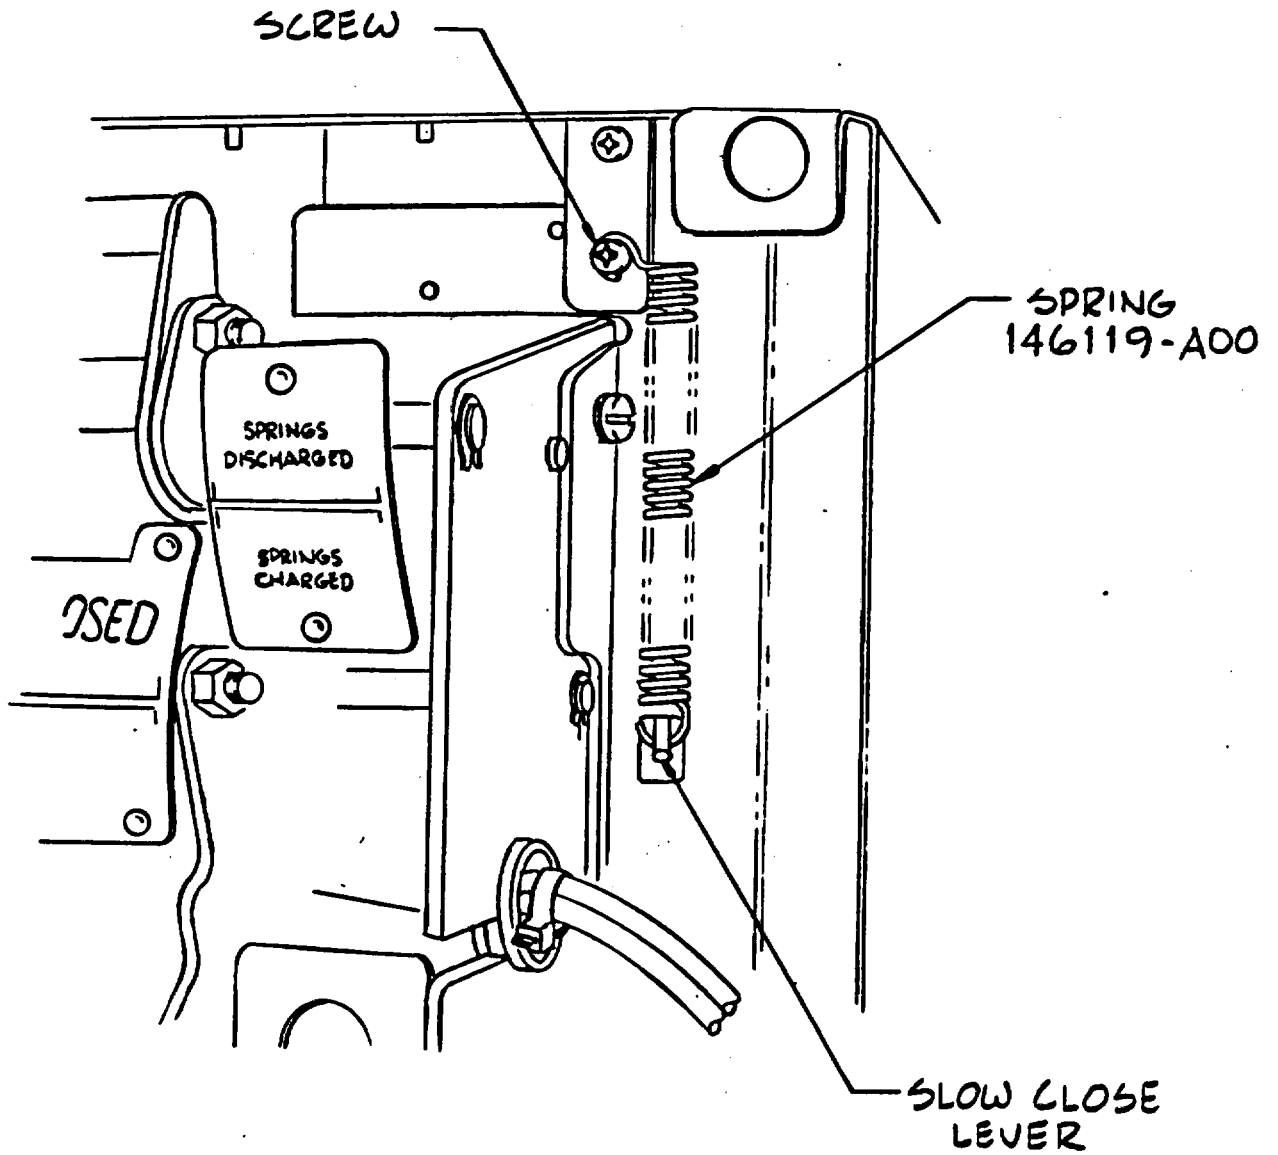
FIGURE 1

4. Locate the slow close lever by looking to the right inside the black box. It will be protruding through a small rectangular opening in the silver-grey painted front frame of the breaker.

5. Locate also the upper right Phillips pan head screw which attaches the black housing to the silver-grey front frame. Loosen this screw approximately two turns. See Figure 1.

6. Hook on end of spring 146119A00 over the loosened screw. Stretch the spring so that the hook can be slid down on the slow close lever.
7. Retighten the screw to secure the spring at its top. This completes the spring installation.
