UNITED STATES
NUCLEAR REGULATORY COMMISSION
OFFICE OF NUCLEAR REACTOR REGULATION
WASHINGTON, D.C. 20555

NRC INFORMATION NOTICE NO. 89-29: POTENTIAL FAILURE OF ASEA BROWN BOVERI
CIRCUIT BREAKERS DURING SEISMIC EVENT

Subject: Slow Close Lever Rebound Spring for
ABB Power Distribution K-Line
Electrically Operated K-225 through
K-2000 Circuit Breakers
(Part 21 Report)

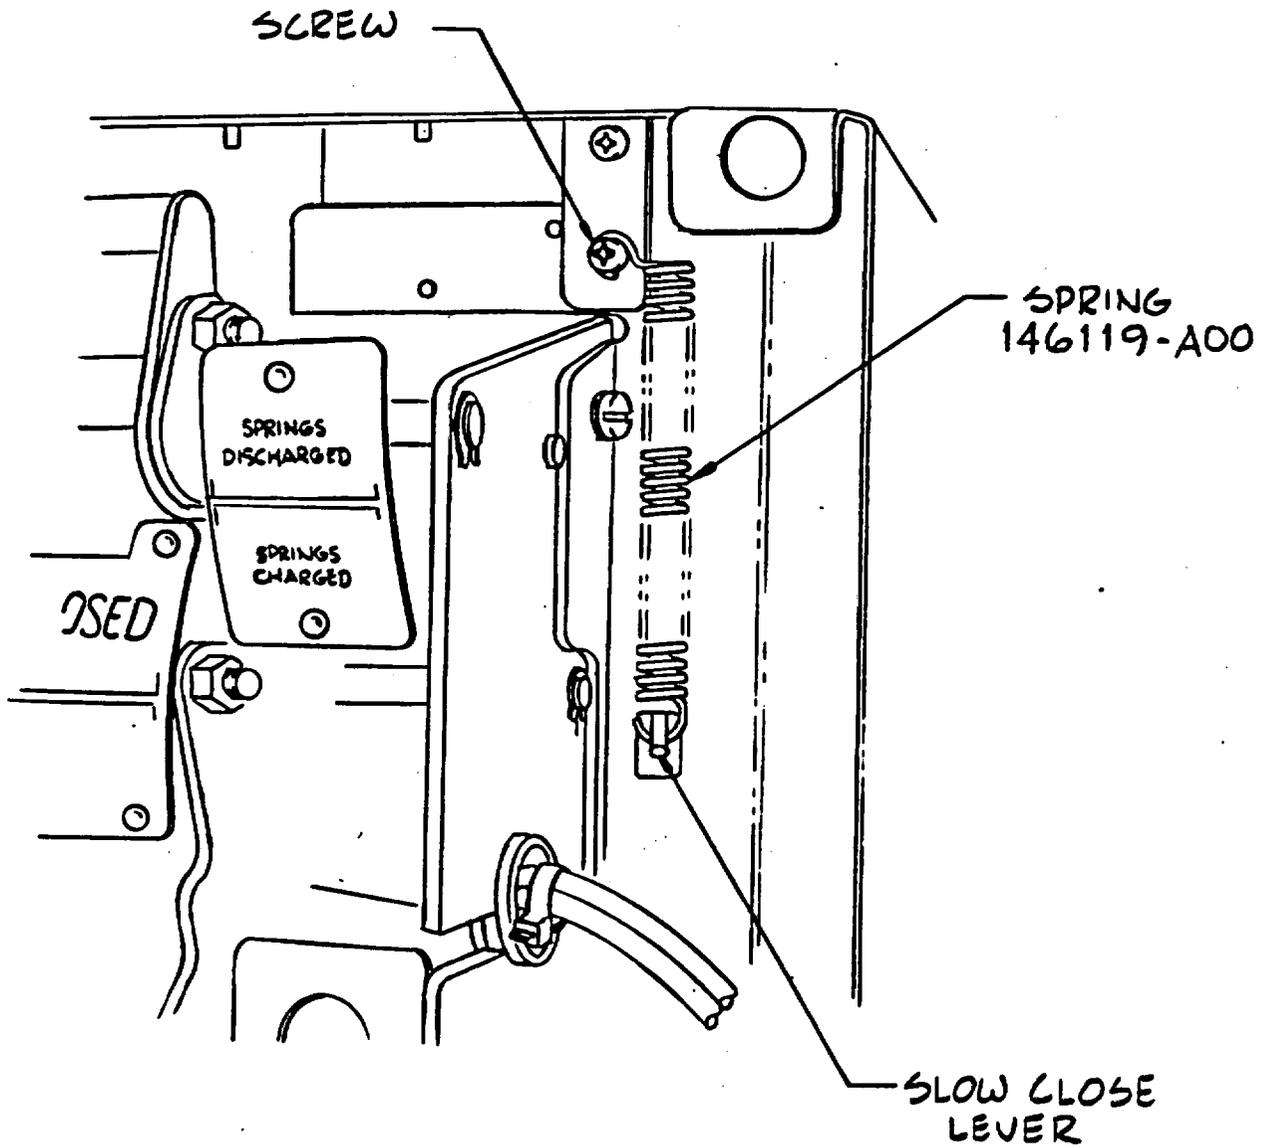
FIGURE 1

4. Locate the slow close lever by looking to the right inside the black box. It will be protruding through a small rectangular opening in the silver-grey painted front frame of the breaker.

5. Locate also the upper right Phillips pan head screw which attaches the black housing to the silver-grey front frame. Loosen this screw approximately two turns. See Figure 1.

6. Hook on end of spring 146119A00 over the loosened screw. Stretch the spring so that the hook can be slid down on the slow close lever.
7. Retighten the screw to secure the spring at its top. This completes the spring installation.
