UNITED STATES  
NUCLEAR REGULATORY COMMISSION  
OFFICE OF NUCLEAR REACTOR REGULATION  
WASHINGTON, D.C. 20555

NRC INFORMATION NOTICE NO. 89-57: UNQUALIFIED ELECTRICAL SPLICES IN  
VENDOR-SUPPLIED ENVIRONMENTALLY  
QUALIFIED EQUIPMENT

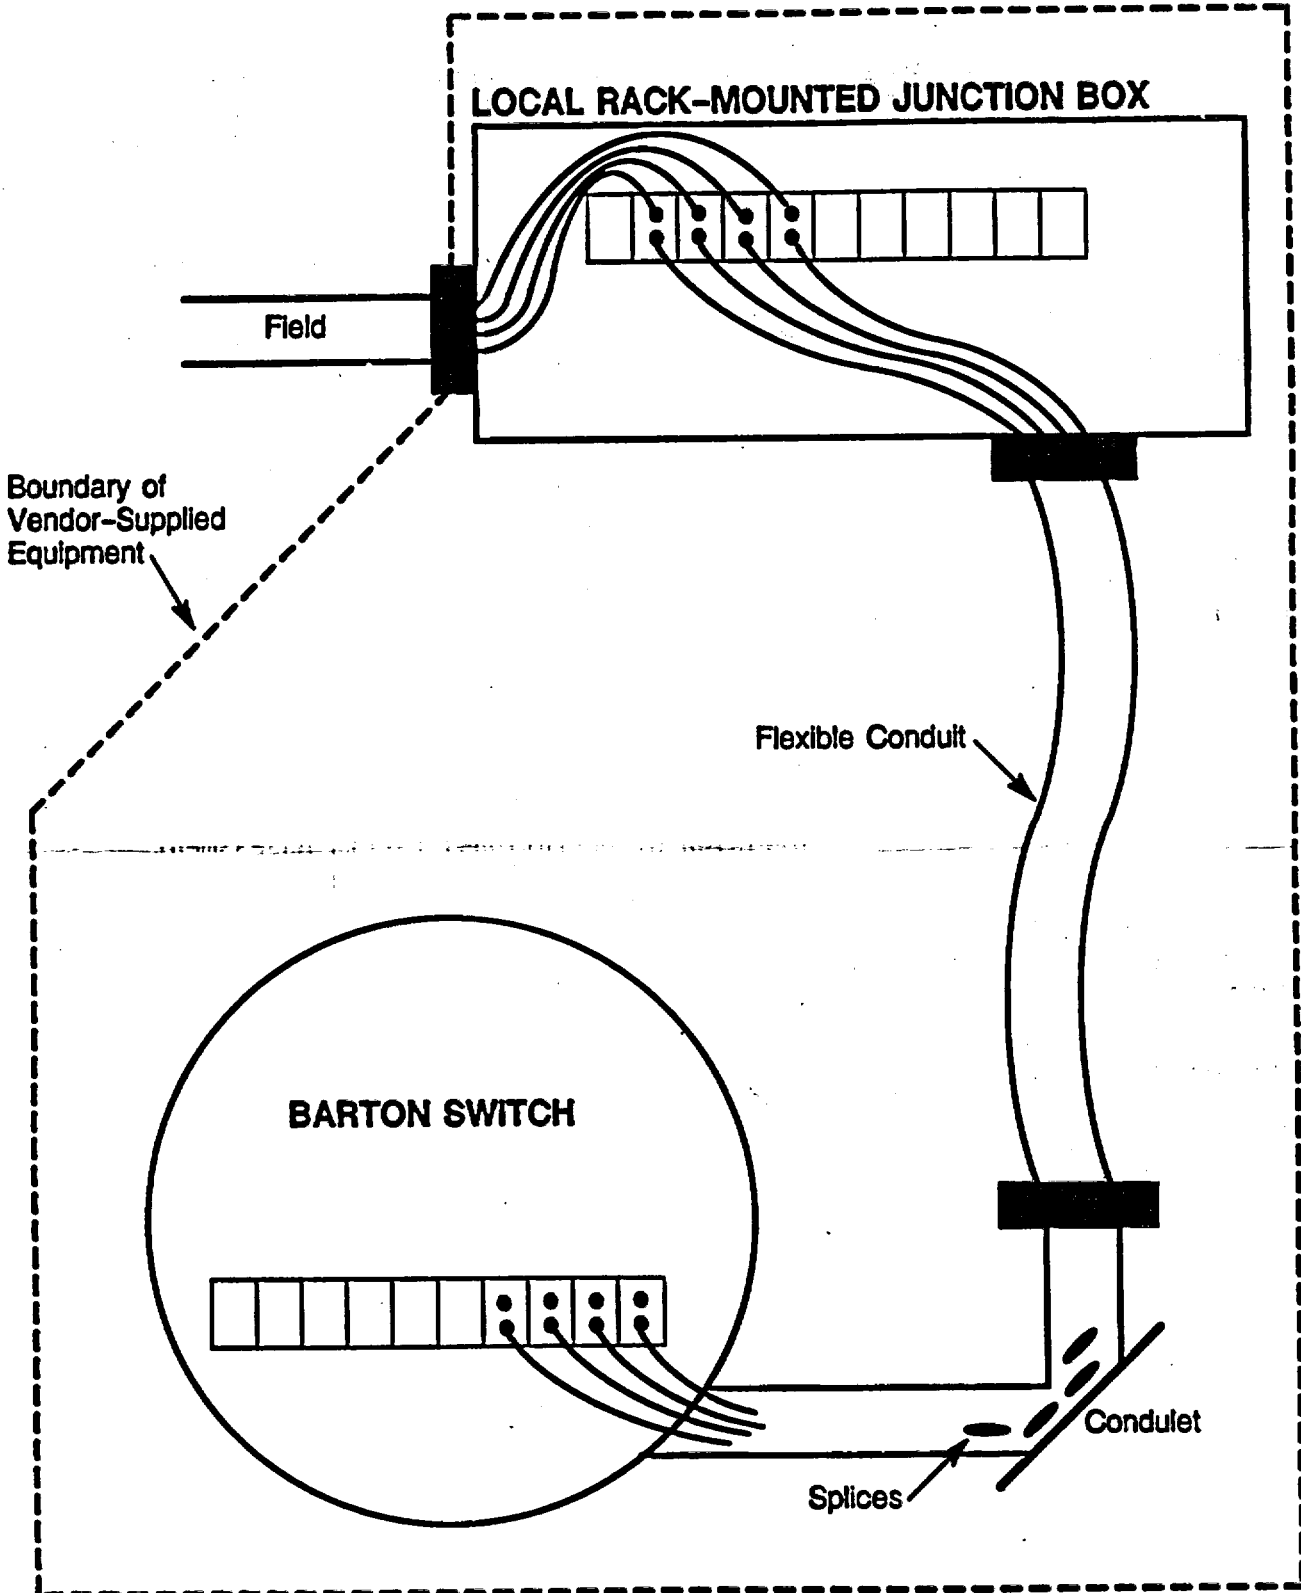
Figure 1 Typical Junction Box and Barton Switch Arrangement

On June 5, 1989, the licensee for the Cooper Nuclear Station (CNS) reported to the NRC the finding of unqualified splices within conduits on vendor-supplied instrument racks. The racks contain wire junction boxes and Barton differential pressure indicating switches (DPISs). A piece of flexible conduit runs between the junction box and a condulet mounted on the DPIS (See Attachment 1). The flexible conduits vary in length from 2 to 10 feet. The unqualified splices consisted of wirenuts, insulated butt crimps, or Scotch tape splices. This problem was discovered during an unrelated walkdown inspection that was being performed as part of an instrument upgrading process for Regulatory Guide 1.97, "Instrumentation for Light-Water-Cooled Nuclear Power Plants to Assess Plant and Environs Conditions During and Following an Accident." The racks were manufactured by HUICO Incorporated of Pasco, Washington, and supplied as a unit by the General Electric Company during initial plant construction.

have affected the EQ integrity of the DPISs and because only a short run of wire was involved. It was assumed that the qualified wire in the junction boxes continued to the DPIS terminal strips, but unqualified splices were found instead. These splices were not indicated on any plant drawings.

The licensee performed a 100-percent walkdown inspection of all instrument racks and believes that the problem is confined to approximately seven racks. A review of maintenance records indicated that about four of the DPIS instruments were replaced. As this replacement only involved disconnection of leads at the terminal strip located inside the instrument, the unqualified splices remained undetected. The results of the licensee's investigation indicate that the unqualified splices are restricted to the specific instrument racks manufactured by HUICO. The investigation also indicates that the unqualified splices existed in the conduits when the racks were delivered to CNS.
