UNITED STATES
NUCLEAR REGULATORY COMMISSION
OFFICE OF NUCLEAR REACTOR REGULATION
WASHINGTON, D.C. 20555

August 31, 1989

NRC INFORMATION NOTICE NO. 89-62: MALFUNCTION OF BORG-WARNER PRESSURE SEAL
BONNET CHECK VALVES CAUSED BY VERTICAL
MISALIGNMENT OF DISK

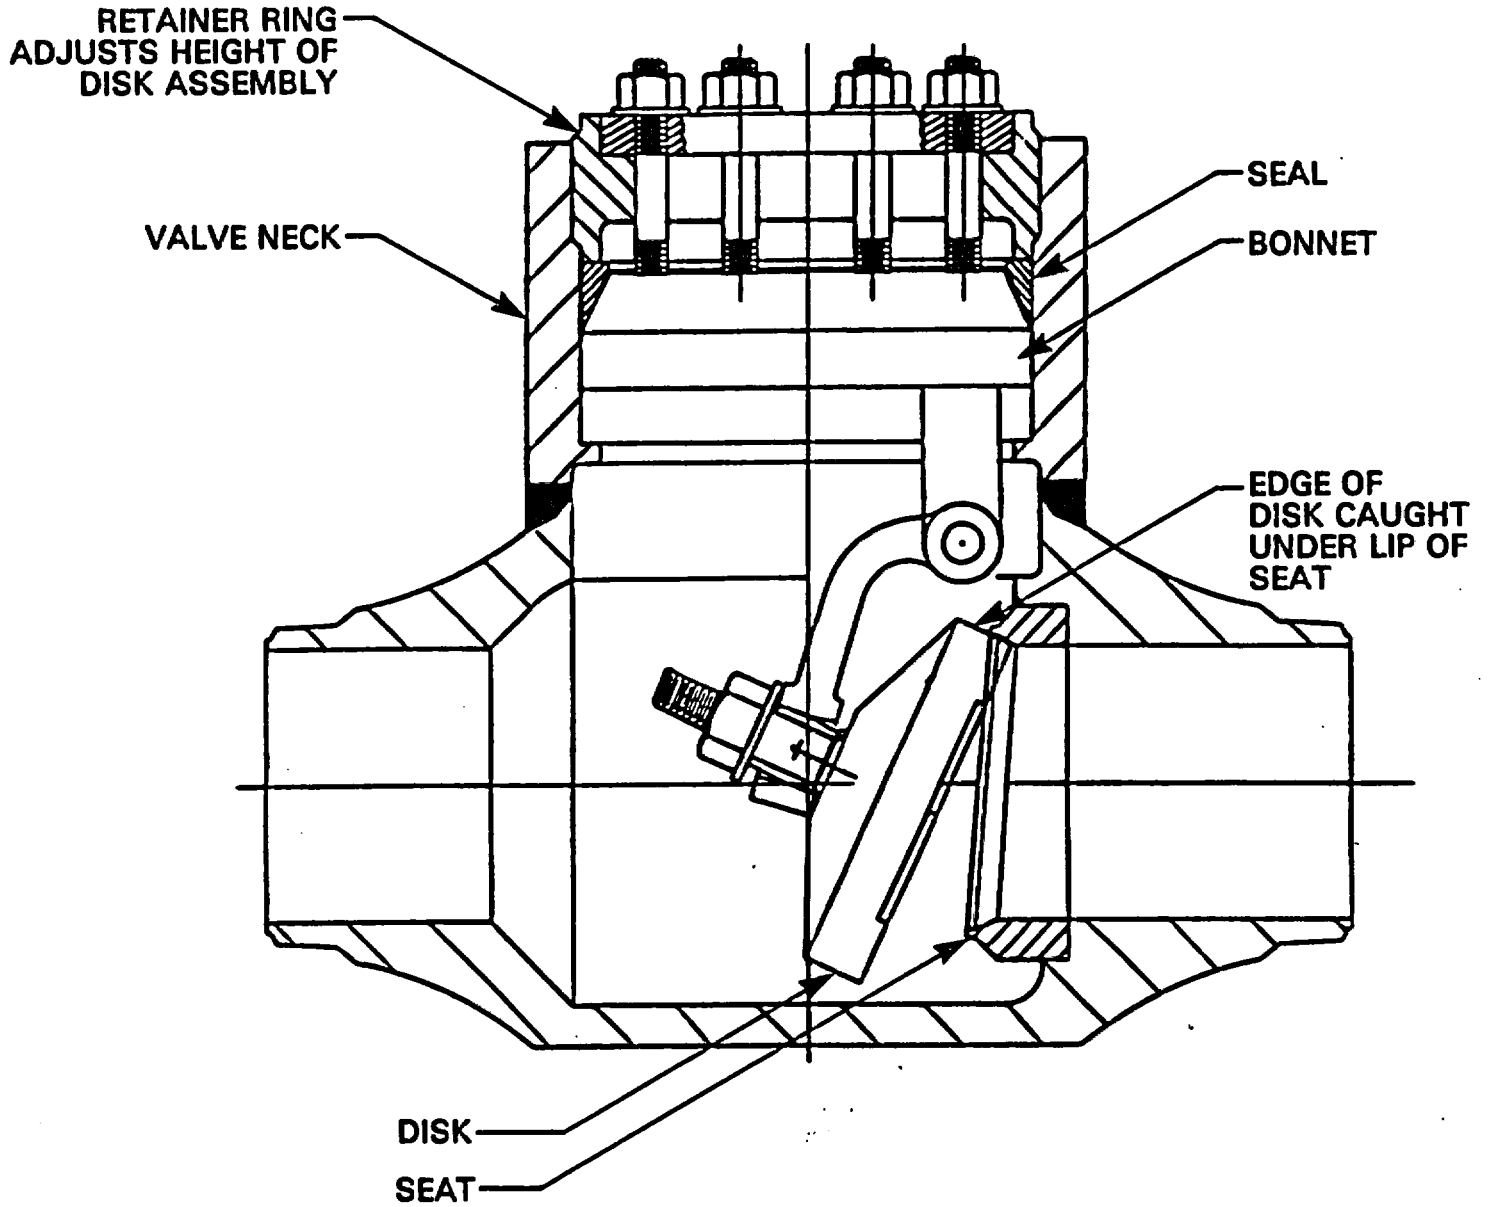
Investigation revealed that the valve disks of these three 3-inch valves, as well as the eight inoperable 4-inch valves, were all positioned too low in the valve body relative to the valve seats. As a result, when the valve disk moved toward the seat, the outside upper edge of the disk was caught under the inside upper edge of the seat causing the disk to be jammed open with the plane of the disk at a large angle relative to the plane of the seat (Figure 1). All eleven of the inoperable valves were of the 900 psi pressure seal bonnet type.

The reason that the disk assemblies of the malfunctioning check valves were positioned too low in the valve bodies was that an essential step was missing from the vendor's reassembly procedure. The disk assembly, as well as the valve bonnet and seal, is suspended from and positioned vertically by a threaded ring that is screwed into the top of the valve neck, called the retainer ring (Figure 1). The prescribed assembly procedure for the 3- and 4-inch valves (Borg-Warner Operation and Maintenance Manual, OMM 1003) was to install and bottom out the retainer ring. This had the effect of locating the disk assembly too low in the valve. The original factory assembly process included the backing

out of the retainer ring while observing the disk through the valve ports until the disk had been raised to the correct height. However, the necessary step of backing out the retainer ring to its original factory assembly height was not included in the reassembly procedure provided with the 3- and 4-inch valves. All of the auxiliary feedwater check valves had been disassembled and inspected in 1983 because of a concern about the adequacy of the disk stud fillet welds. During the following reassembly using the incorrect procedure, all of the 3- and 4-inch valve disks were positioned lower than the original factory adjusted position. Larger Borg-Warner check valves (6, 8 and 10-inch) could also be affected by this error.

**Figure 1. CHECK VALVE SHOWN WITH DISK
JAMMED IN OPEN POSITION**
