UNITED STATES
NUCLEAR REGULATORY COMMISSION
OFFICE OF NUCLEAR REACTOR REGULATION
WASHINGTON, D.C. 20555

September 8, 1989

**NRC INFORMATION NOTICE NO. 89-65: POTENTIAL FOR STRESS CORROSION CRACKING IN
STEAM GENERATOR TUBE PLUGS SUPPLIED BY
BABCOCK AND WILCOX**

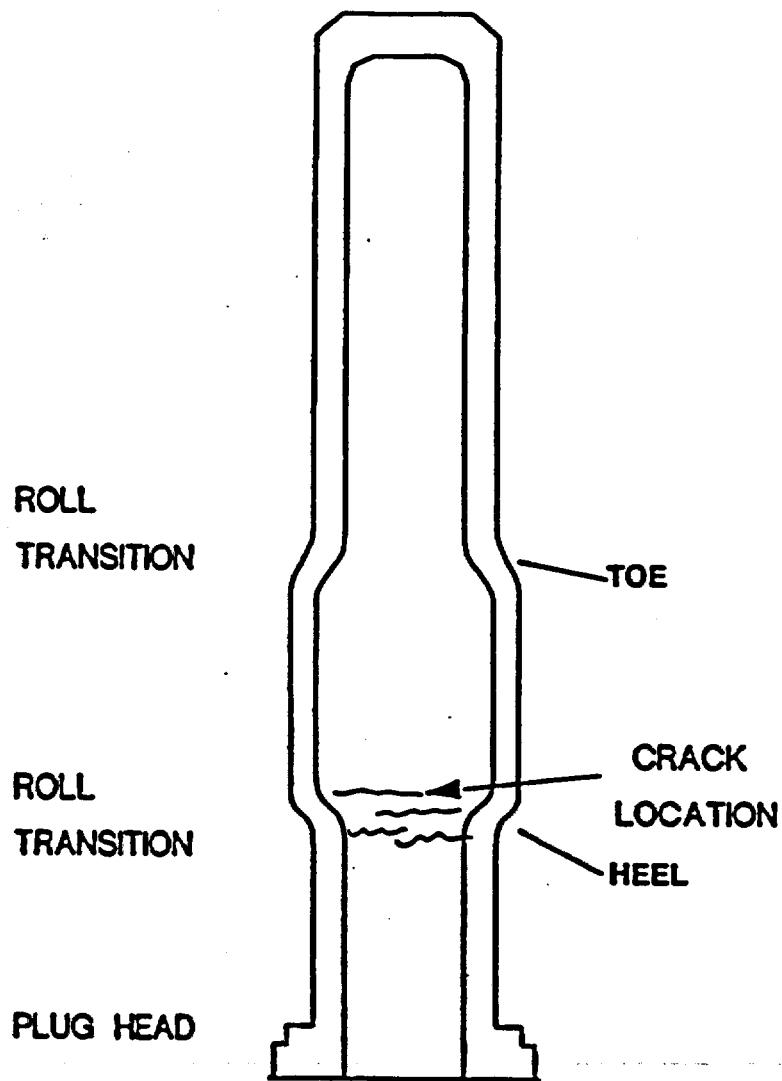
FIGURE 1. ROLLED PLUG

All cracks observed in the field in rolled plugs, as of April 21, 1989, were circumferentially oriented and were located at the "heel" (i.e., outermost) transition region, which is not part of the pressure boundary, rather than at the "toe" (i.e., innermost) transition region, which is part of the plug (and RCS) pressure boundary (See Figure 1). Because of their location, B&W does not believe that these heel transition cracks impair plug integrity.

With the exception of three plugs, all indications found during the recent McGuire Unit 2 inspections of the rolled plugs were located at the heel transition region. Examination of a sample of these plugs after they were removed from the field confirmed the presence of circumferential cracks at the heel transition region. Three plugs (from heat W592-1) found during field eddy current testing to contain indications at the heel transition region were also found to contain indications at the toe transition region. However, preliminary findings from examinations after the plugs were removed indicate that these indications at the toe transition region are not associated with cracks. It is the staff's understanding that the source of these indications is still under investigation..

Although known instances of cracking in B&W rolled plugs have been limited to the heel transition region (which is not part of the pressure boundary), such cracks may be a precursor to eventual cracks at the toe transition region (which is part of the pressure boundary). Therefore, eddy current inspections to identify heel as well as any toe transition cracks are important for ensuring the continued integrity of the B&W rolled plugs. Furthermore, until additional evidence becomes available from corrosion tests and/or experience, all Inconel 600 heats used for plugs should be considered potentially susceptible to PWSCC.

B&W provided the NRC staff, in a letter dated June 12, 1989, its recommendations to utility customers. These recommendations included the inspection of rolled plugs, both hot-and cold-leg, from heat W592-1 as well as sample inspections of rolled plugs from other heats. B&W ribbed plugs cannot be inspected with eddy current testing. Previously in a letter to the NRC staff dated May 19, 1989, B&W concluded that the ribbed plug design was not subject to a plug top release failure mode because of relatively low stresses in the plug associated with its installation. Nevertheless in its letter of June 12, 1989, B&W recommended the removal and replacement of all ribbed plugs fabricated from heat W592-1 at the next scheduled refueling outage. Regarding B&W taper welded plugs, B&W believes that the design of these plugs is such that there is no mechanism for a gross failure (i.e., plug top release failure). B&W noted that taper welded plugs from heat W592-1 may crack in the future and recommended their removal at a convenient time unless some other course of action is developed to eliminate potential future concerns regarding the integrity of these plugs.
