UNITED STATES
NUCLEAR REGULATORY COMMISSION
OFFICE OF NUCLEAR REACTOR REGULATION
WASHINGTON, D.C. 20555

September 29, 1989

NRC INFORMATION NOTICE NO. 89-69: LOSS OF THERMAL MARGIN CAUSED BY
CHANNEL BOX BOW

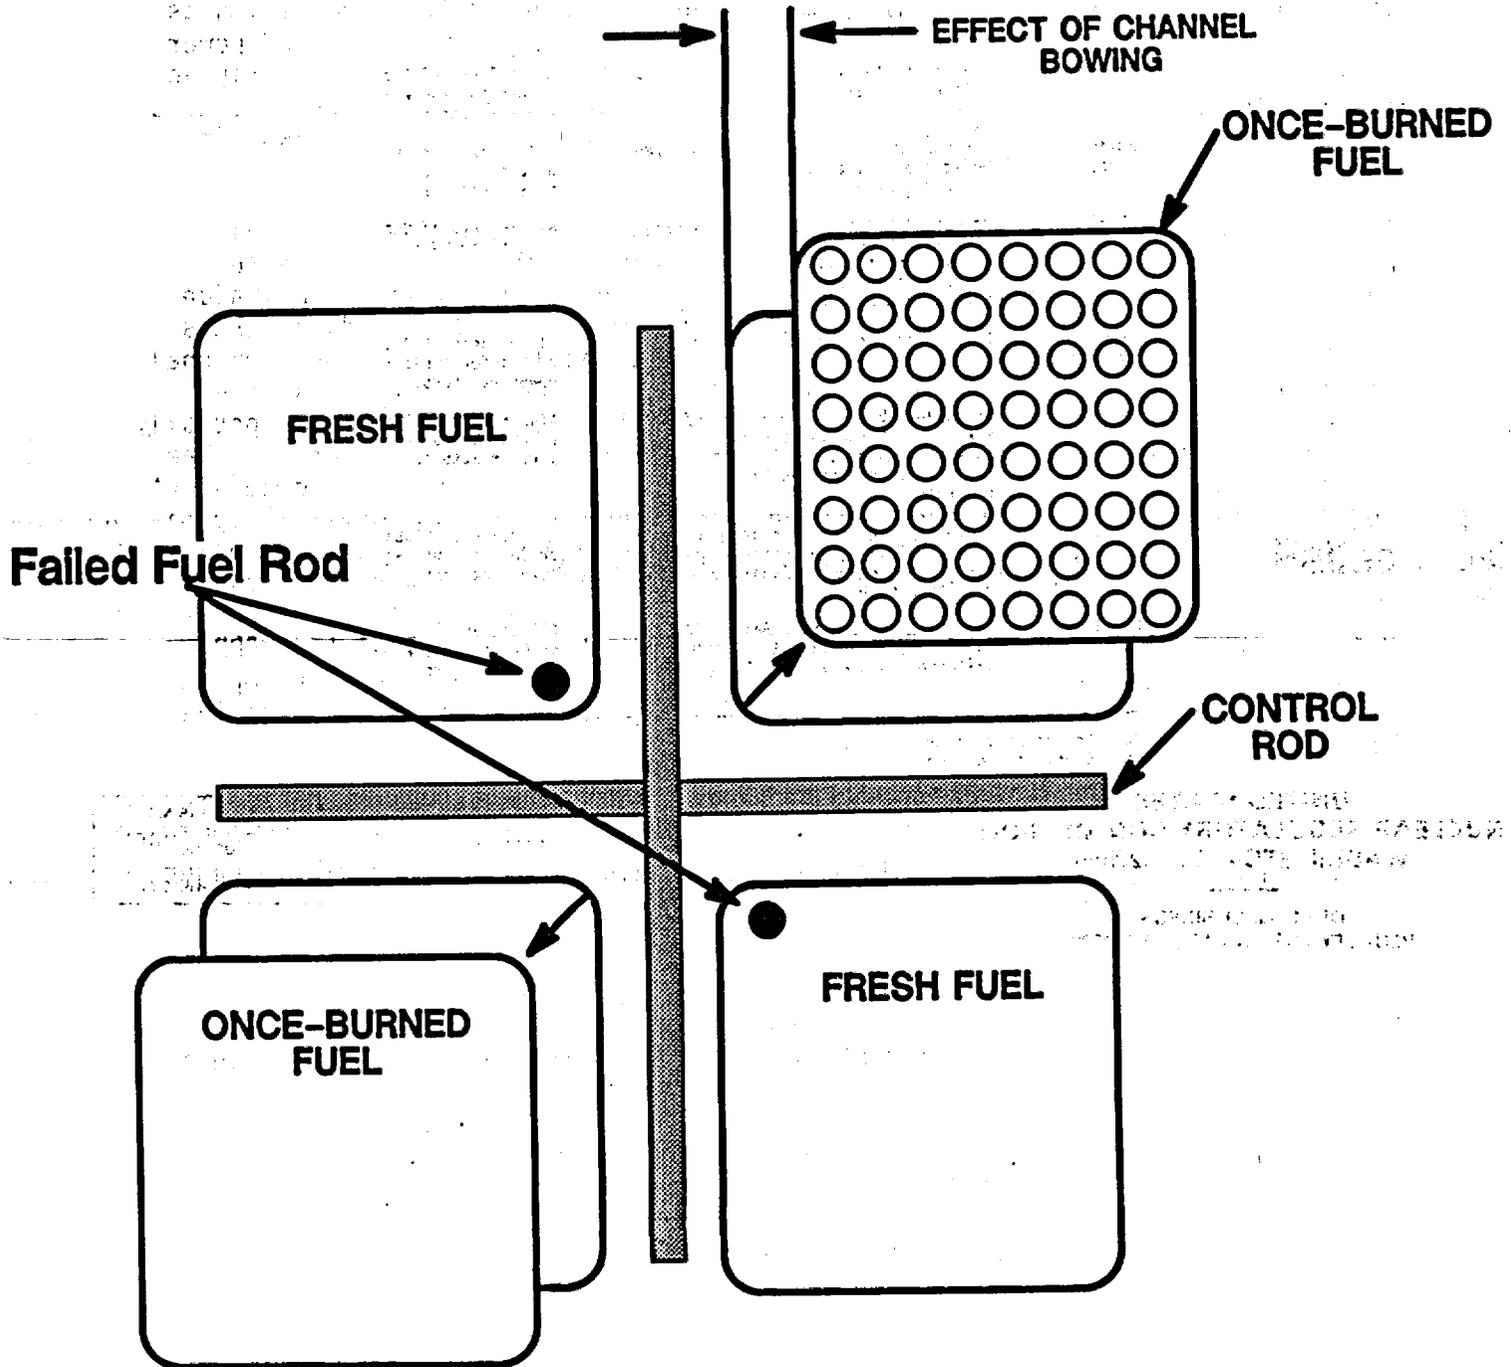
Figure 1 Channel Bow

The failed fuel rods were located symmetrically in the core. The fuel assemblies containing the rods that had failed were located adjacent to once-burned fuel assemblies with highly exposed fuel channels (see Figure 1). These fuel channels were in their second bundle lifetime and had excessive channel bowing. In each assembly with failed fuel, the corner rod facing the adjacent control rod was heavily oxidized and the cladding was penetrated just below the top spacer grid. In addition, each of the four failed rods had typical secondary internal hydriding damage near the bottom of the fuel rods, resulting in loss of fuel material.

modeling errors were caused by neglecting the effects of channel bowing and the geometric variation between the reloaded and once-burned fuel assemblies. These effects substantially increased the widths of the control rod water gaps for the assemblies that contained these four fuel rods beyond that assumed in the plant process computer calculations. The increased neutron moderation associated with the increased water gap widths led to very high localized power peaking at these four fuel rods. However, these effects were not properly accounted for in the MCPR calculations. For some time, the plant operators were misled by these erroneous MCPR calculations and were operating the plant in steady-state beyond the MCPR safety limit.

The modeling error of generic concern to all BWRs, regardless of the fuel supplier, relates only to the greater-than-expected bowing of fuel channel boxes, which contributed about 15 percent error in the calculated MCPR value for this foreign facility. Channel bowing is a manifestation of differences in the channel growth of opposite sides of the channel box and is proportional to channel growth. The information obtained by the NRC indicates that the channel growth shows an accelerated trend at higher burnup exposure, especially when the fuel channels are being reused in their second bundle lifetime. The effect on core operating MCPR is magnified when fresh fuel is located adjacent to the bowed fuel channels. Core operating limits imposed by technical specifications may be exceeded if the reduction in margin caused by fuel channel bowing is not properly accounted for in the plant process computer for thermal limits monitoring. Based on a preliminary evaluation by BWR fuel vendors of U.S. reactors, the impact of the new data on actual versus calculated MCPR values is expected to range from 0.0 to 0.03 CPR units. However, the impact could be much greater (about 15 percent) for any reactors operating with fuel channels being reused in their second bundle lifetime.
