UNITED STATES
NUCLEAR REGULATORY COMMISSION
OFFICE OF NUCLEAR REACTOR REGULATION
WASHINGTON, D.C. 20555

October 19, 1989

NRC INFORMATION NOTICE NO. 89-71: DIVERSION OF THE RESIDUAL HEAT REMOVAL
PUMP SEAL COOLING WATER FLOW DURING
RECIRCULATION OPERATION FOLLOWING A
LOSS-OF-COOLANT ACCIDENT

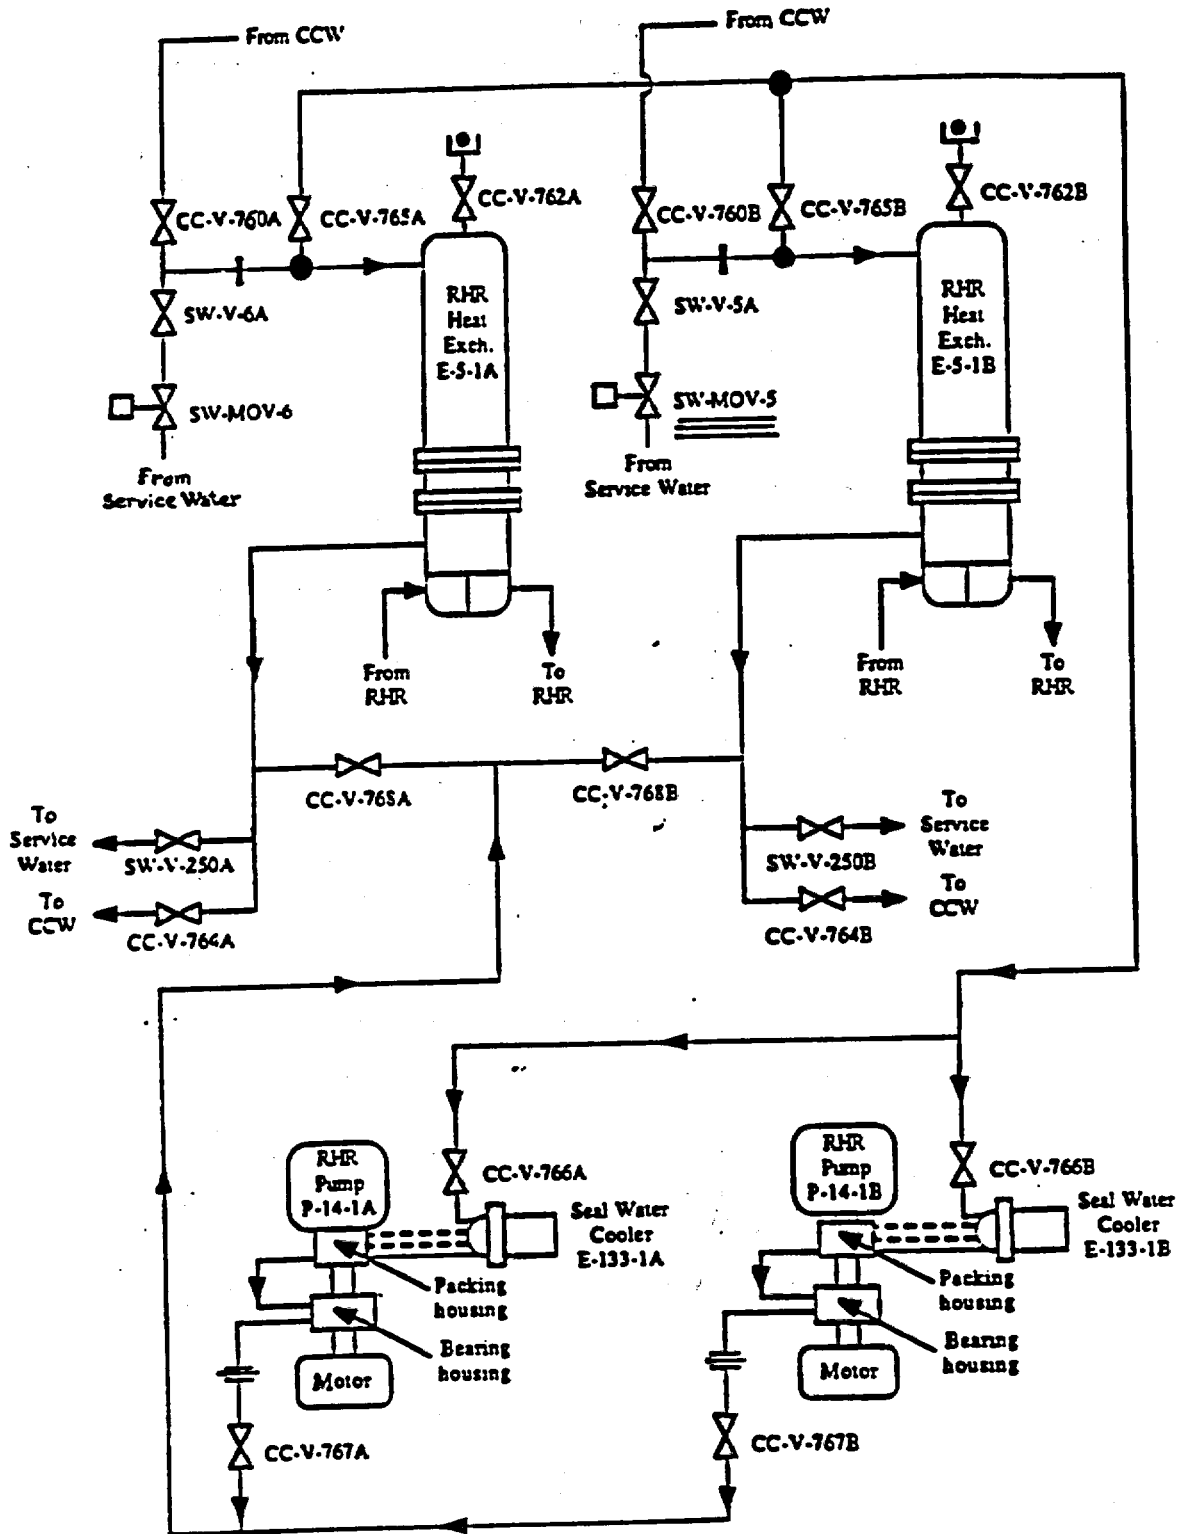
Diagram of Haddam Neck's Original RHR Cooling Water System

During a probabilistic risk assessment (PRA) study of the emergency core cooling system at Haddam Neck, the licensee discovered that a single failure in response to a LOCA could disable both RHR pumps. The single failure would cause the diversion of the cooling water flow from the RHR pump seal coolers resulting in inadequate seal cooling and possible pump failure.

As indicated in Attachment 1, cooling water for the RHR pump seal coolers comes from the cooling water inlet lines to each RHR heat exchanger. During normal operation, the component cooling water system provides cooling to the RHR heat exchangers and pump seal coolers. However, during a LOCA condition, component cooling water is isolated, and service water is used to provide cooling to the RHR components. Because the RHR pump seal cooler water supply line is cross-connected to both the component cooling and service water systems, a failure of one of the service water motor-operated valves to open following a LOCA would result in only one branch of service water being available to provide cooling to both RHR heat exchangers and the seal water coolers.
