UNITED STATES
NUCLEAR REGULATORY COMMISSION
OFFICE OF NUCLEAR REACTOR REGULATION
WASHINGTON, D.C. 20555

September 20, 1991

NRC INFORMATION NOTICE 91-58: DEPENDENCY OF OFFSET DISC BUTTERFLY VALVE'S
OPERATION ON ORIENTATION WITH RESPECT TO FLOW

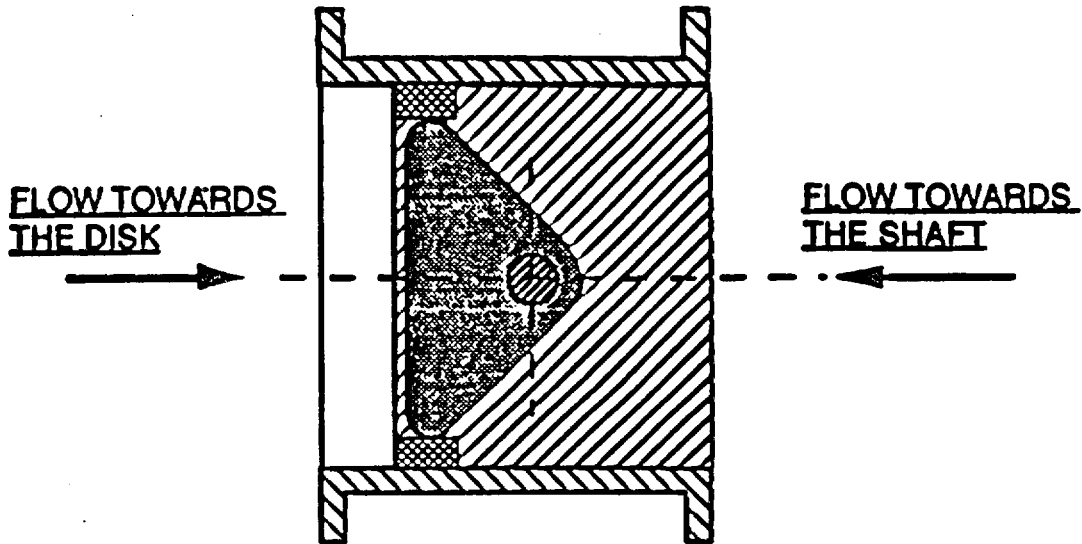
Figure 1

The valves are 16-inch, 150-pound offset disc butterfly MOVs. The licensee determined that the valves had been installed in an orientation such that the service water flow was toward the curved (shaft) side of the disc instead of toward the flat side of the disc as intended (see Figure 1). This orientation resulted in the need for a much higher torque than anticipated in order to open the valves under the conditions established for the test.

The licensee indicated that the valves were probably installed correctly by the architect/engineer with service water flow toward the flat side of the disc. The licensee concluded that a lack of maintenance controls most likely caused the reversal in the orientation. The licensee has also identified weaknesses in the torque calculation method such as poor modeling assumptions and a lack of consideration of the differences between the coefficients for symmetrical and offset discs.

The licensee removed the three valves and reversed them so that the service water would flow toward the flat side of the disc. The licensee marked the valves and the associated piping to indicate the direction of flow. Subsequent testing of the valves was satisfactory. The licensee is also reviewing and evaluating the models used for the service water system and the related calculations.

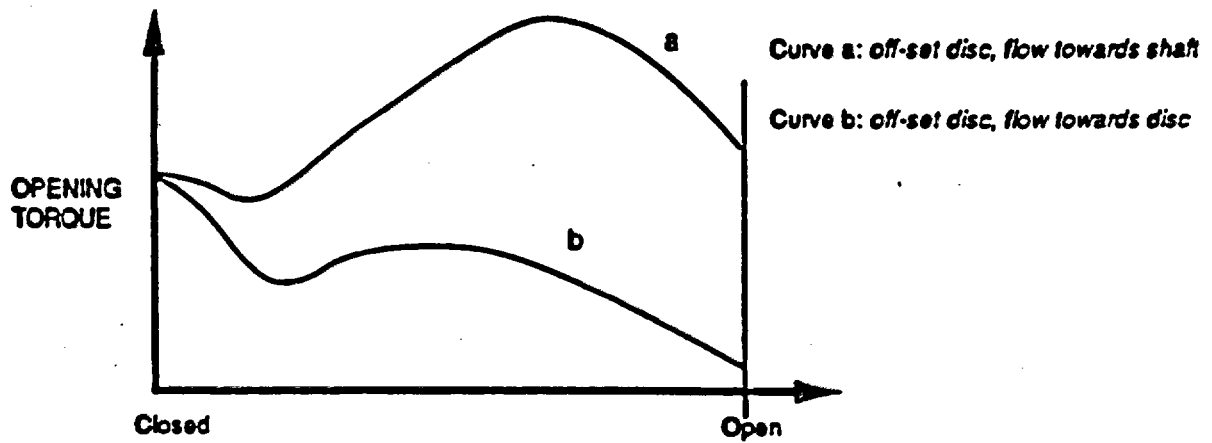
Figure 2
Typical Opening Torques for Offset Disc Butterfly Valves

For this type of valve disc, when flow is toward the flat side of the disc, the maximum torque on the opening stroke occurs during valve unseating, and the actuator rating and torque switch setting should be selected to achieve this torque. However, if the service water flows toward the curved (shaft) side of the disc, the hydrodynamic torque developed as the flow increases acts against the opening motion, and, thus, a much higher actuator torque is required to fully open the valve (see Figure 2). The actuators were not adequately sized and rated for this situation, and the torque switches operated to prevent damage to the actuators before the valves reached the fully open position.
