UNITED STATES
NUCLEAR REGULATORY COMMISSION
OFFICE OF NUCLEAR REACTOR REGULATION
WASHINGTON, D.C. 20555

NRC INFORMATION NOTICE 91-58: DEPENDENCY OF OFFSET DISC BUTTERFLY VALVE'S
OPERATION ON ORIENTATION WITH RESPECT TO FLOW

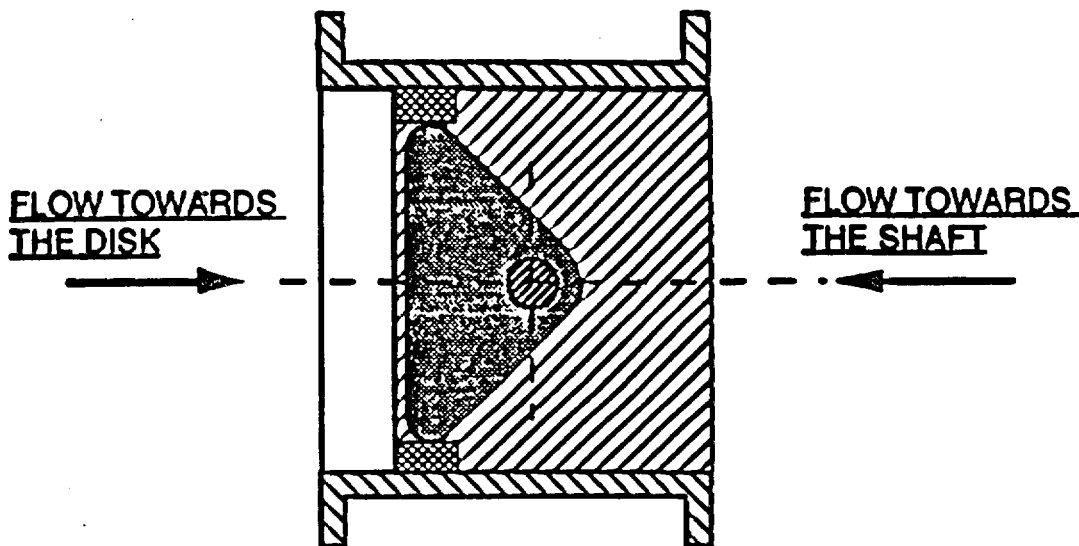
Figure 1

The valves are 16-inch, 150-pound offset disc butterfly MOVs. The licensee determined that the valves had been installed in an orientation such that the service water flow was toward the curved (shaft) side of the disc instead of toward the flat side of the disc as intended (see Figure 1). This orientation resulted in the need for a much higher torque than anticipated in order to open the valves under the conditions established for the test.

The licensee indicated that the valves were probably installed correctly by the architect/engineer with service water flow toward the flat side of the disc. The licensee concluded that a lack of maintenance controls most likely caused the reversal in the orientation. The licensee has also identified weaknesses in the torque calculation method such as poor modeling assumptions and a lack of consideration of the differences between the coefficients for symmetrical and offset discs.

The licensee removed the three valves and reversed them so that the service water would flow toward the flat side of the disc. The licensee marked the valves and the associated piping to indicate the direction of flow. Subsequent testing of the valves was satisfactory. The licensee is also reviewing and evaluating the models used for the service water system and the related calculations.

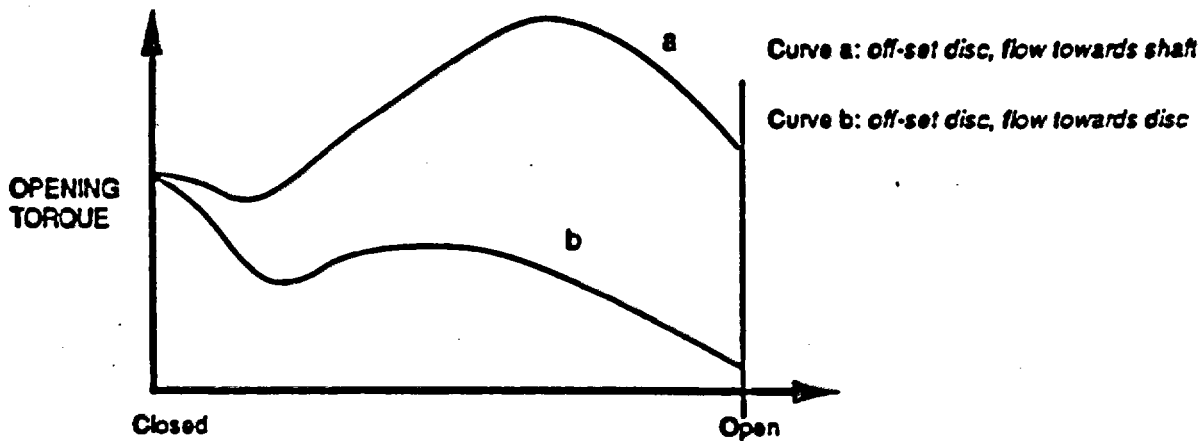
Figure 2
Typical Opening Torques for Offset Disc Butterfly Valves

For this type of valve disc, when flow is toward the flat side of the disc, the maximum torque on the opening stroke occurs during valve unseating, and the actuator rating and torque switch setting should be selected to achieve this torque. However, if the service water flows toward the curved (shaft) side of the disc, the hydrodynamic torque developed as the flow increases acts against the opening motion, and, thus, a much higher actuator torque is required to fully open the valve (see Figure 2). The actuators were not adequately sized and rated for this situation, and the torque switches operated to prevent damage to the actuators before the valves reached the fully open position.
