UNITED STATES
NUCLEAR REGULATORY COMMISSION
OFFICE OF NUCLEAR REACTOR REGULATION
WASHINGTON, D.C. 20555

September 16, 1991.

NRC INFORMATION NOTICE 91-55: FAILURES CAUSED BY AN IMPROPERLY ADJUSTED
TEST LINK IN 4.16 KV GENERAL ELECTRIC
SWITCHGEAR

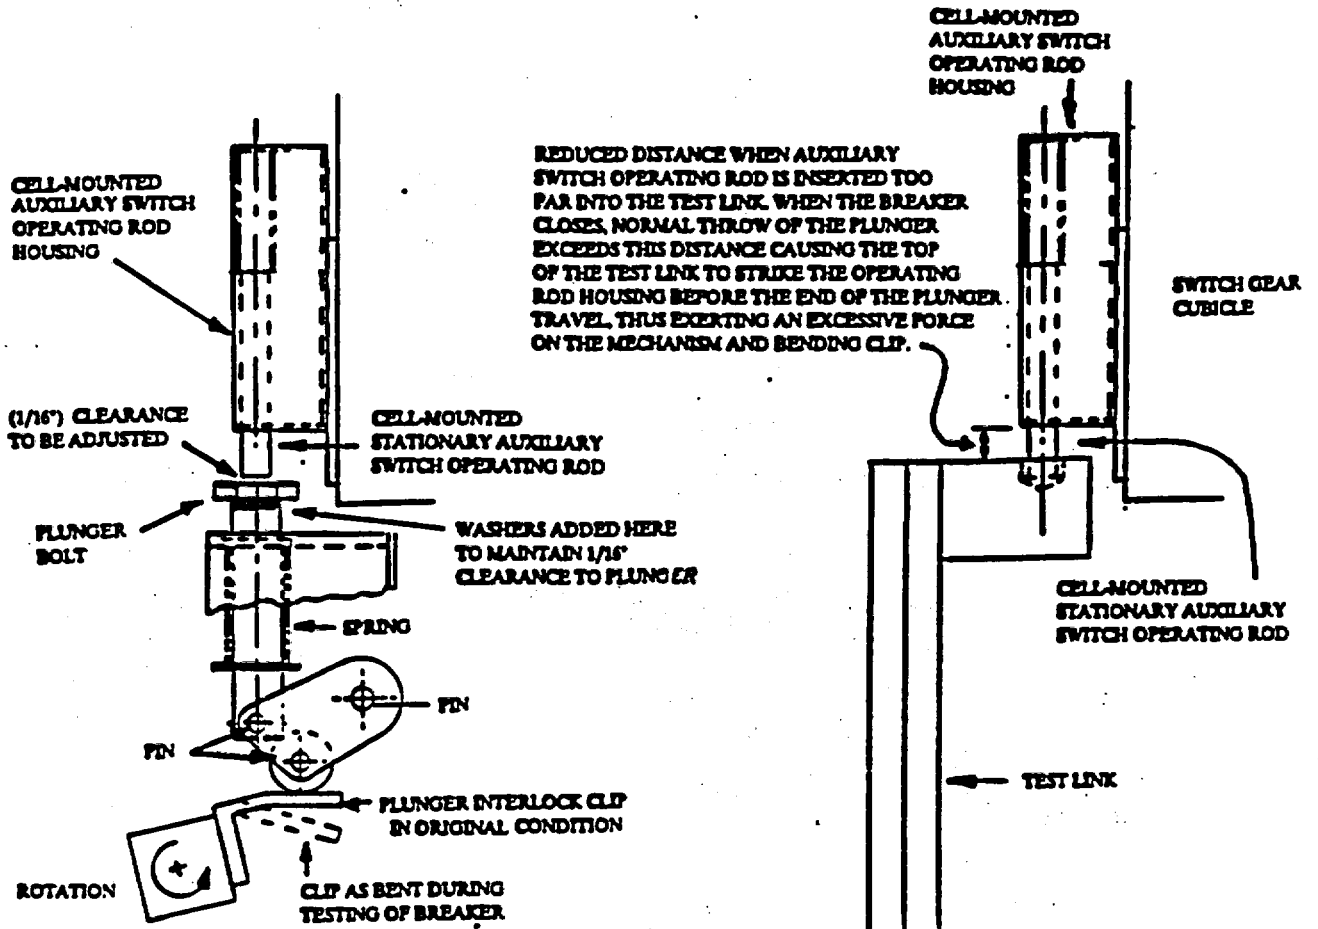
When the breaker is fully inserted in the cell and lifted vertically into the operating position, an interlock clip contacts a plunger bolt through a cam. When the breaker is being closed, the clip, which is bolted to the breaker crank-shaft, rotates, pushing the plunger upward by moving the cam. The plunger bolt pushes the operating rod of the cell-mounted auxiliary switch vertically to change the state of its contacts. After the circuit breaker is placed in the test position, a test link is inserted between the plunger bolt and the operating rod to bridge the gap between them to actuate the switch when the breaker is closed. The length of the test link has to be properly adjusted so that the depth that the rod is inserted into a recess in the test link provides the correct clearance between the top of the link and the bottom of the switch housing. A test link is improperly adjusted when this clearance is insufficient to permit the plunger to travel its designed distance and causes the top of the test link to strike the switch housing before the plunger completes its travel. In striking the switch housing, the link exerts an excessive force on the plunger mechanism and bends the interlock clip. Page 3 of attachment 1 includes an illustration of the orientation of an interlock clip in relation to the breaker in the operating and test positions with the existing test link.

FIGURE 1
 ORIENTATION OF THE CELL-MOUNTED AUXILIARY SWITCH AND THE FLUNGER INTERLOCK CLIP WITH THE CIRCUIT BREAKER IN THE OPERATING POSITION.

FIGURE 2
 ORIENTATION OF THE CELL-MOUNTED AUXILIARY SWITCH AND THE FLUNGER INTERLOCK CLIP WITH THE CIRCUIT BREAKER IN THE TEST POSITION.

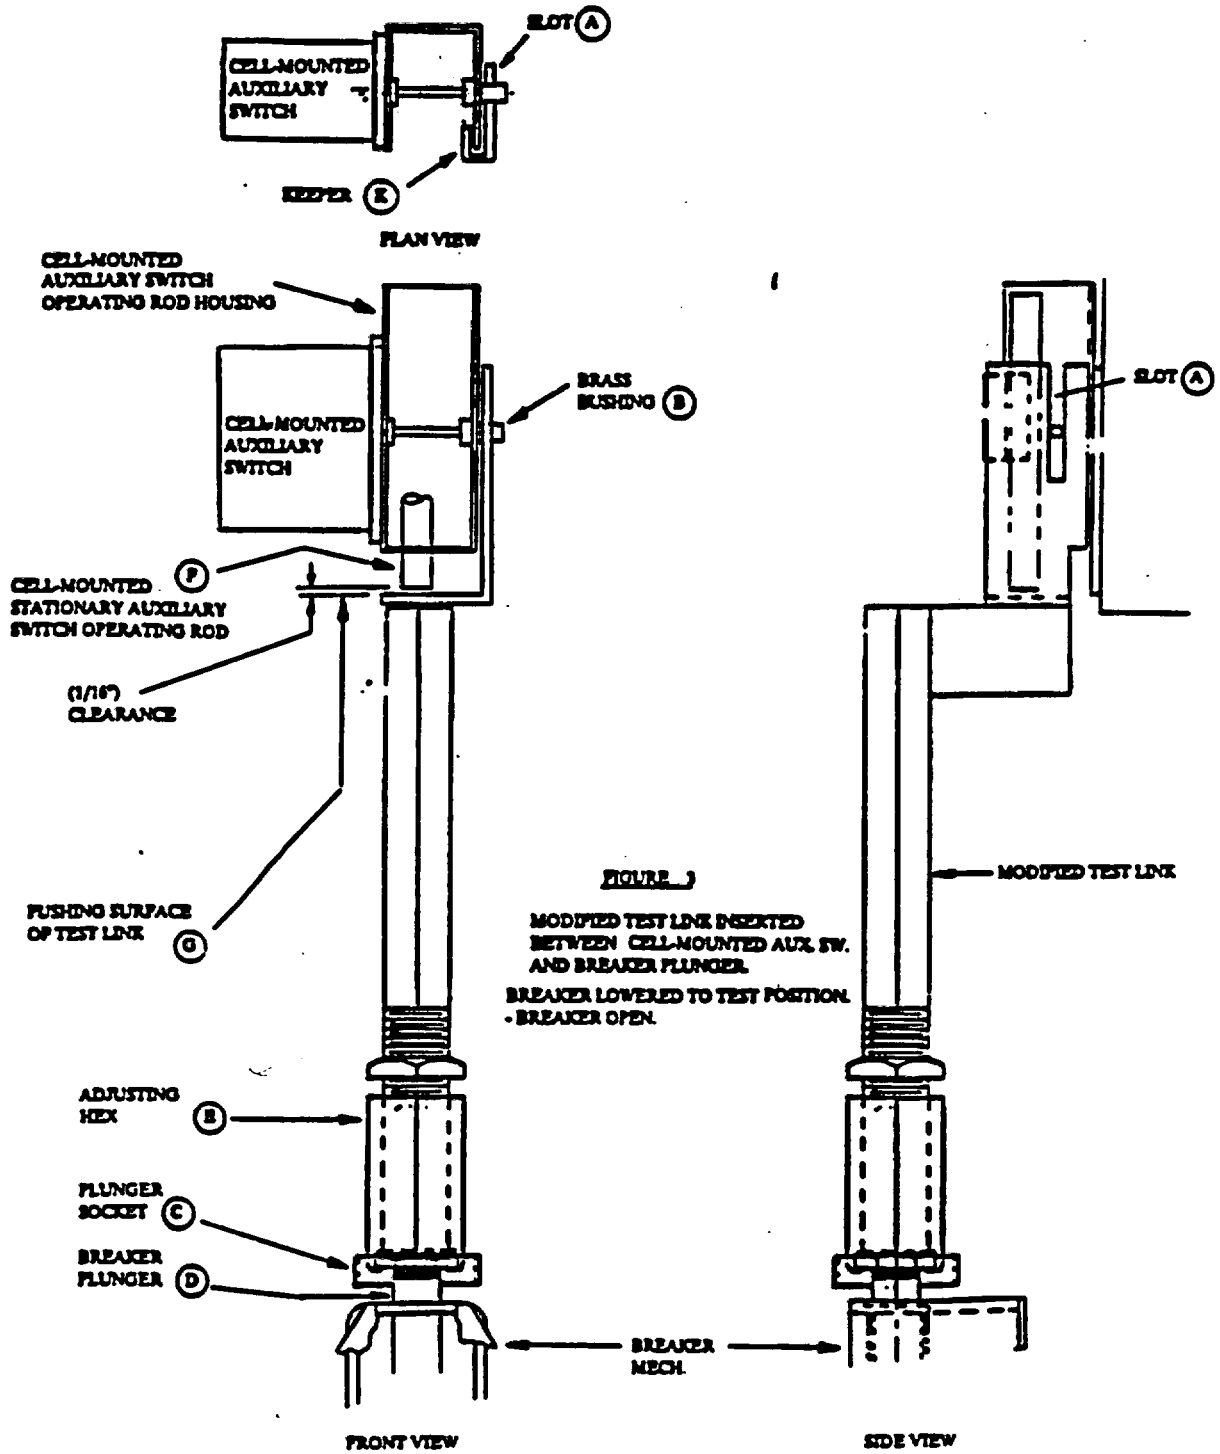
Page 4 of attachment 1 includes an illustration of the new modified test link. The test link is installed by sliding the open-ended slot "A" over the brass bushing "B" on the switch housing and then lowering the socket at the bottom end of the link onto the top of the plunger "D." The length of the test link can be adjusted by rotating the hexagonal nut "E" so that there is a 1/16-inch gap between the top surface "G" of the test link and the bottom of the rod "F." If the test link is improperly adjusted (allowing an insufficient gap) the clip can be bent.

When the circuit breaker operates from the "open" to the "closed" position, the test link will move the operating rod approximately 15/16 inch vertically and actuate the switch. When the breaker moves from the "closed" to the "open" position, the operating rod will drop down 15/16 inch vertically, and both the test link and the plunger will drop down 1 inch (15/16 plus 1/16) through the return springs. However, a deformed clip cannot reliably transmit the required 15/16-inch vertical motion to the plunger to operate the switch during normal breaker operation (or during subsequent tests with the link installed). Note in the plan view of page 4 of attachment 1, that while the slot in the operator engages the brass bushing, the test link keeper "K" engages the side of the housing. In this position, the test link is secure, and testing may proceed.

GE's evaluation of this deviation concluded that this problem could only exist where users have optional cell-mounted auxiliary switches and an improperly adjusted test link. Although GE concluded that the test link was a maintenance tool which did not directly perform a safety-related function, they also concluded that the original design of the test link, coupled with less than optimum maintenance practices, could result in bent interlock clips. This damage could degrade the safety-related function of the auxiliary switch. As corrective action, GE has developed a modified test link which should prevent recurrence of this maintenance problem. Addressees may wish to contact GE directly for further information concerning the modified test link.
