UNITED STATES
NUCLEAR REGULATORY COMMISSION
OFFICE OF NUCLEAR REACTOR REGULATION
WASHINGTON, D.C. 20555

September 16, 1991.

NRC INFORMATION NOTICE 91-55: FAILURES CAUSED BY AN IMPROPERLY ADJUSTED
TEST LINK IN 4.16 KV GENERAL ELECTRIC
SWITCHGEAR

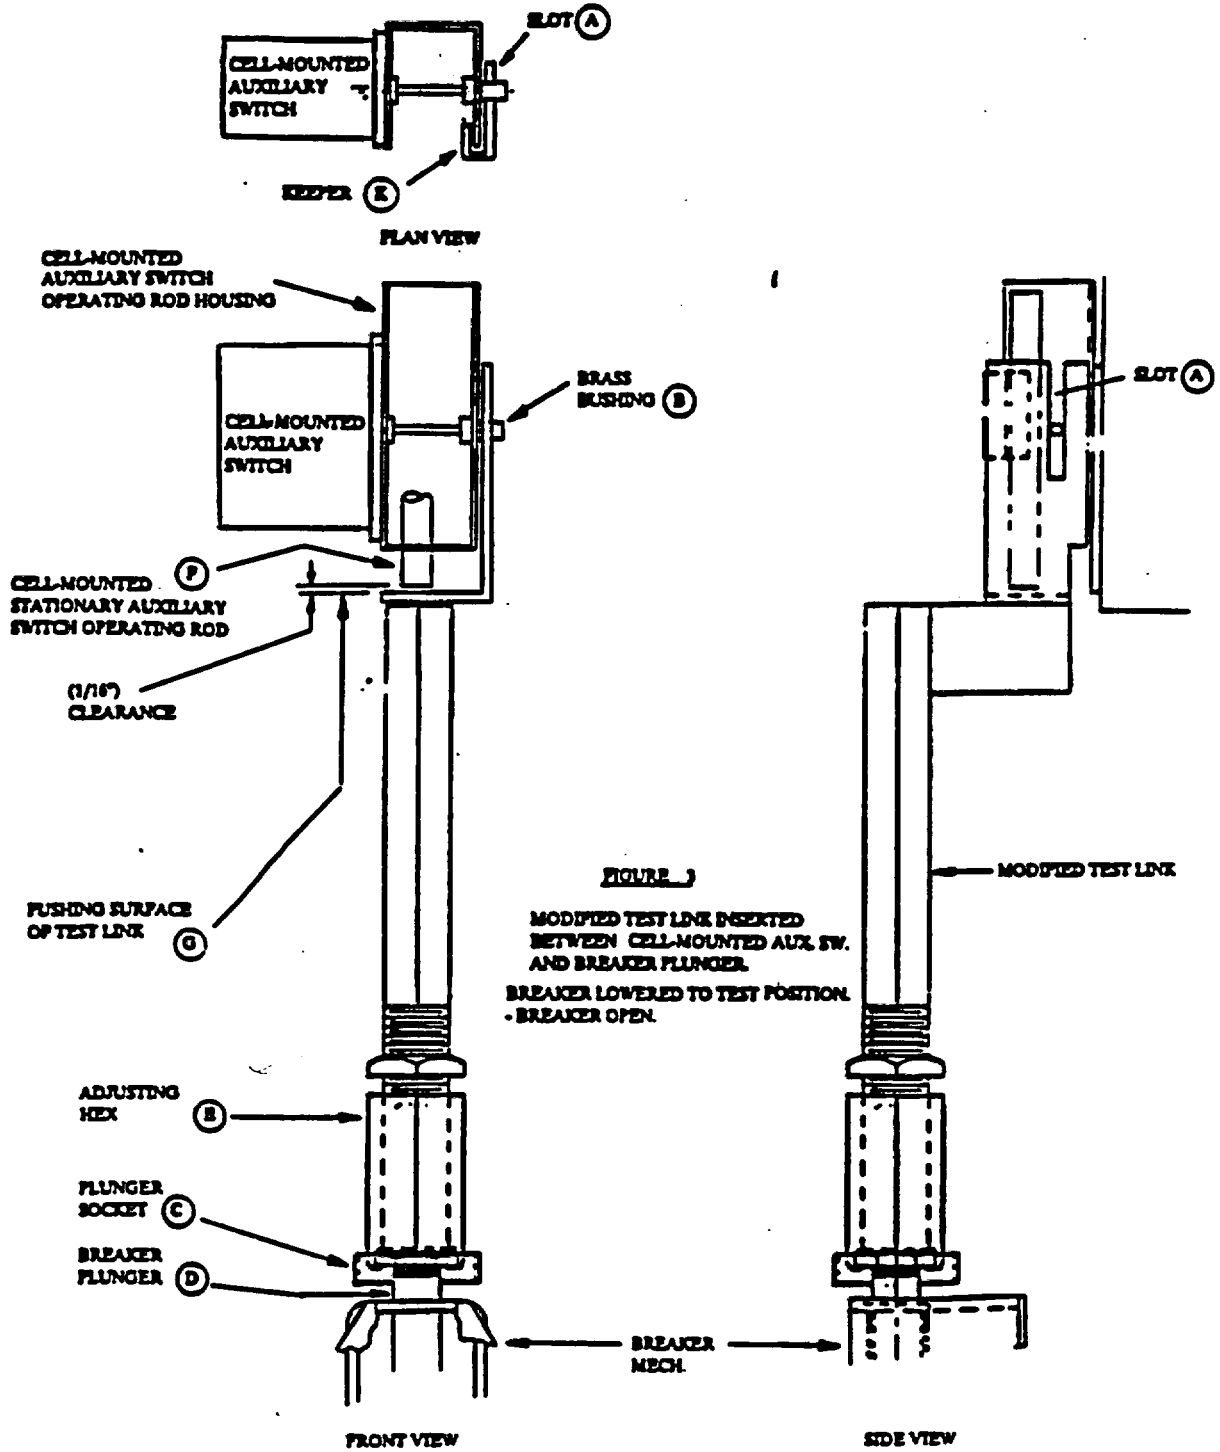
Page 4 of attachment 1 includes an illustration of the new modified test link. The test link is installed by sliding the open-ended slot "A" over the brass bushing "B" on the switch housing and then lowering the socket at the bottom end of the link onto the top of the plunger "D." The length of the test link can be adjusted by rotating the hexagonal nut "E" so that there is a 1/16-inch gap between the top surface "G" of the test link and the bottom of the rod "F." If the test link is improperly adjusted (allowing an insufficient gap) the clip can be bent.

When the circuit breaker operates from the "open" to the "closed" position, the test link will move the operating rod approximately 15/16 inch vertically and actuate the switch. When the breaker moves from the "closed" to the "open" position, the operating rod will drop down 15/16 inch vertically, and both the test link and the plunger will drop down 1 inch (15/16 plus 1/16) through the return springs. However, a deformed clip cannot reliably transmit the required 15/16-inch vertical motion to the plunger to operate the switch during normal breaker operation (or during subsequent tests with the link installed). Note in the plan view of page 4 of attachment 1, that while the slot in the operator engages the brass bushing, the test link keeper "K" engages the side of the housing. In this position, the test link is secure, and testing may proceed.

GE's evaluation of this deviation concluded that this problem could only exist where users have optional cell-mounted auxiliary switches and an improperly adjusted test link. Although GE concluded that the test link was a maintenance tool which did not directly perform a safety-related function, they also concluded that the original design of the test link, coupled with less than optimum maintenance practices, could result in bent interlock clips. This damage could degrade the safety-related function of the auxiliary switch. As corrective action, GE has developed a modified test link which should prevent recurrence of this maintenance problem. Addressees may wish to contact GE directly for further information concerning the modified test link.
