UNITED STATES  
NUCLEAR REGULATORY COMMISSION  
OFFICE OF NUCLEAR REACTOR REGULATION  
WASHINGTON, D.C. 20555

December 20, 1991

NRC INFORMATION NOTICE 91-83: SOLENOID-OPERATED VALVE FAILURES RESULTED  
IN TURBINE OVERSPEED

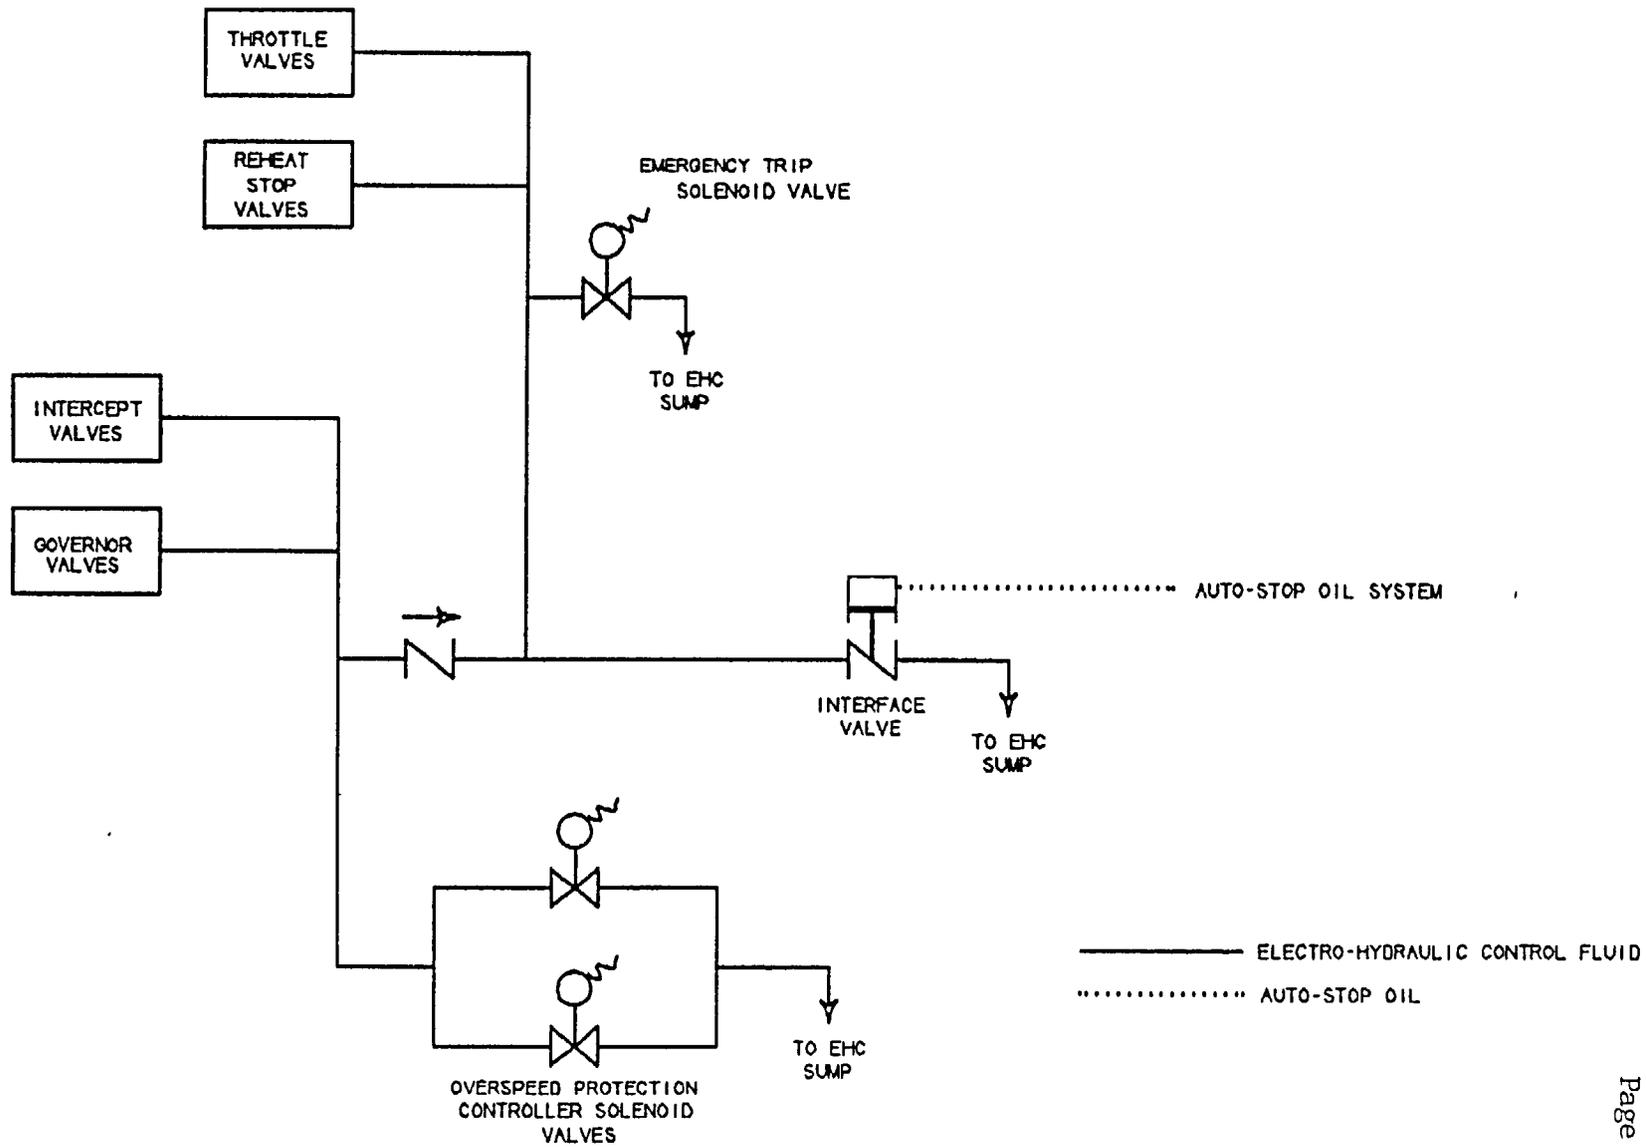
**WESTINGHOUSE ELECTRO-HYDRAULIC CONTROL SYSTEM**

Westinghouse turbines are tripped using a combination of electro-hydraulic control (EHC) fluid and auto-stop oil (Attachment 1). In the electro-hydraulic portion, SOVs dump the fluid to the EHC sump, causing the throttle valves, reheat stop valves, intercept valves, and the governor valves to shut, stopping the flow of steam to the turbine. Failure of the SOVs in the EHC system to open could lead to the turbine overspeeding. Several events have occurred in the industry that involved the failure of SOVs that must operate for turbine emergency trip and overspeed protection. The consequences of these failures have varied according to the initiating event and the type of SOV failure. These failures suggest that there are weaknesses in the preventive maintenance and testing of these SOVs.
