UNITED STATES
NUCLEAR REGULATORY COMMISSION
OFFICE OF NUCLEAR REACTOR REGULATION
WASHINGTON, D.C. 20555

December 20, 1991

NRC INFORMATION NOTICE 91-83: SOLENOID-OPERATED VALVE FAILURES RESULTED
IN TURBINE OVERSPEED

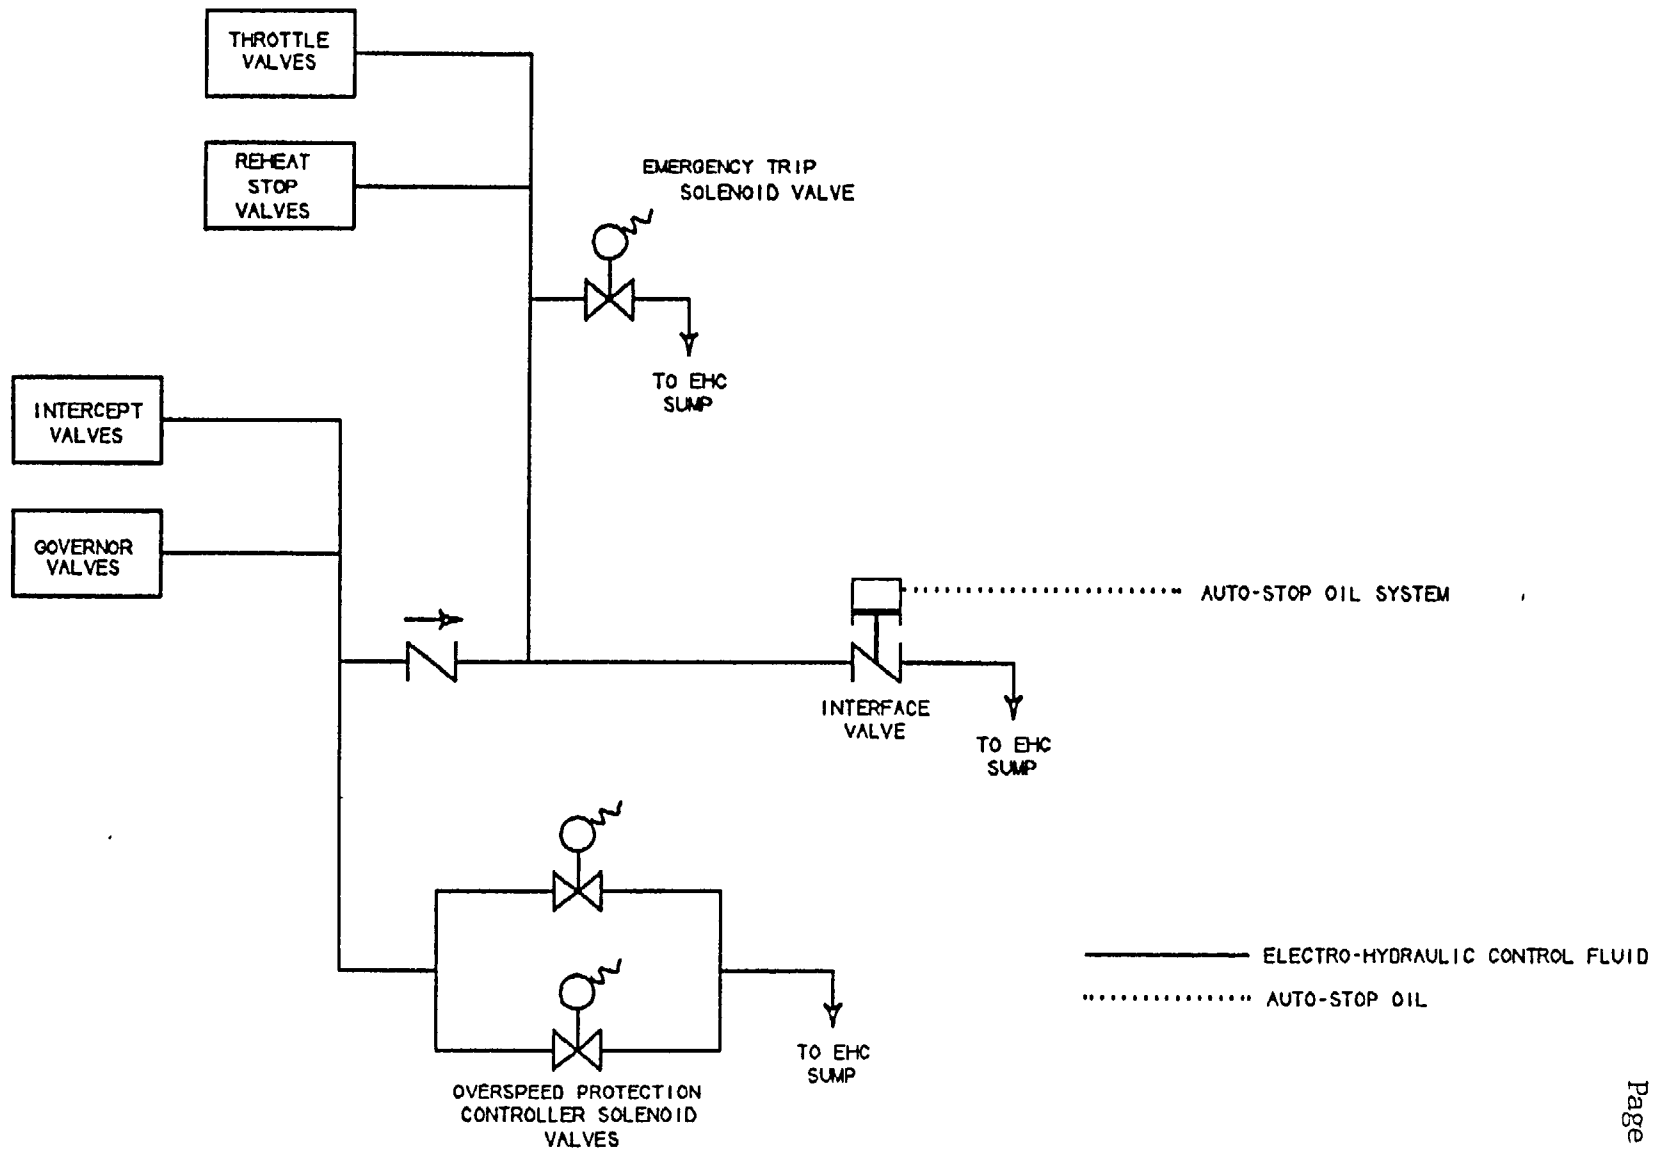
WESTINGHOUSE ELECTRO-HYDRAULIC CONTROL SYSTEM

Westinghouse turbines are tripped using a combination of electro-hydraulic control (EHC) fluid and auto-stop oil (Attachment 1). In the electro-hydraulic portion, SOVs dump the fluid to the EHC sump, causing the throttle valves, reheat stop valves, intercept valves, and the governor valves to shut, stopping the flow of steam to the turbine. Failure of the SOVs in the EHC system to open could lead to the turbine overspeeding. Several events have occurred in the industry that involved the failure of SOVs that must operate for turbine emergency trip and overspeed protection. The consequences of these failures have varied according to the initiating event and the type of SOV failure. These failures suggest that there are weaknesses in the preventive maintenance and testing of these SOVs.
