UNITED STATES  
NUCLEAR REGULATORY COMMISSION  
OFFICE OF NUCLEAR REACTOR REGULATION  
WASHINGTON, D.C. 20555

August 20, 1991

NRC INFORMATION NOTICE NO. 91-50: A REVIEW OF WATER HAMMER EVENTS AFTER 1985

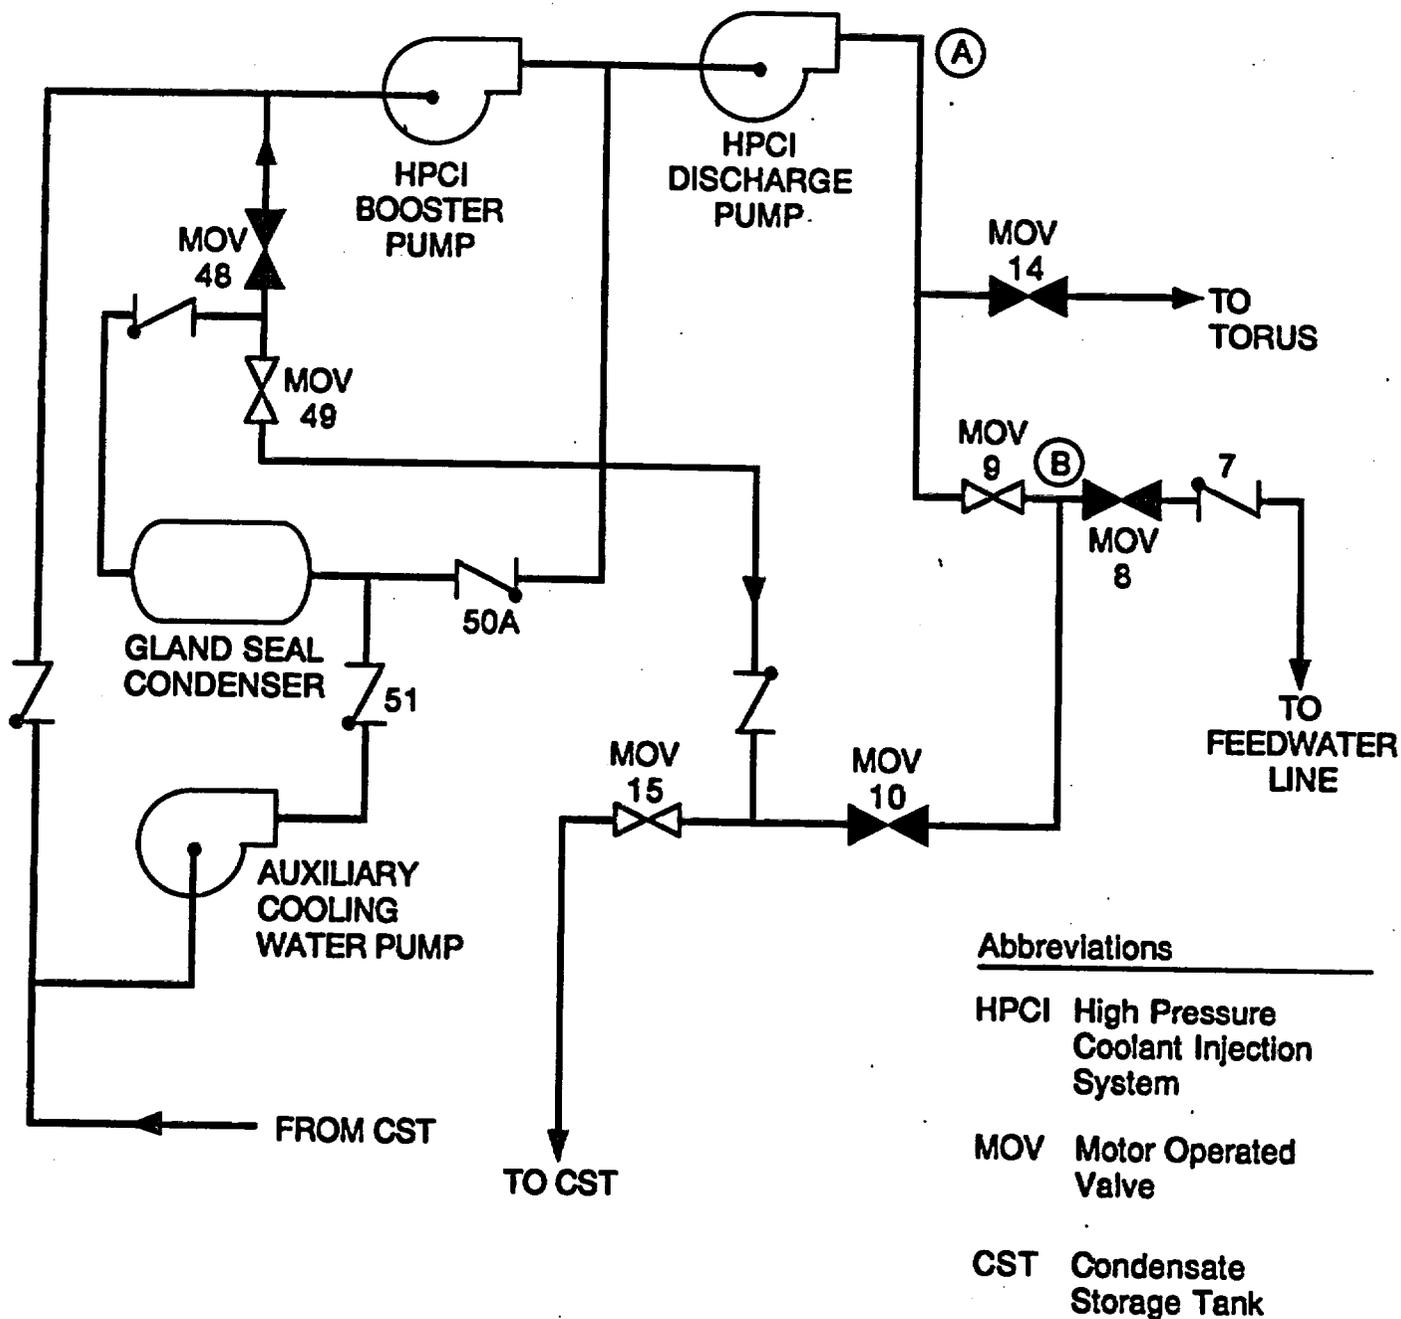
**Figure 1**  
**High Pressure Coolant Injection System Normal Valve Configuration**

Dresden Unit 2: A series of events occurred in the high pressure coolant injection (HPCI) system at Dresden Units 2 and 3 over several months. They are discussed in order of occurrence to enhance the understanding of changes in system valve positions. This event is also discussed, but in less detail, in NRC Information Notice No. 89-80, "Potential for Water Hammer, Thermal Stratification, and Steam Binding in High-Pressure Coolant Injection Piping," December 1, 1989. On October 31, 1989, while the plant was operating at 100 percent full power, the licensee declared an unusual event and began an orderly shutdown because time had expired for the limiting condition of operation (LCO) with the HPCI system inoperable. During the 5 months before taking this action, the licensee had observed high temperatures in the piping at the HPCI pump discharge and between two motor-operated valves (MOV's) (Points A and B on Figure 1 showing the normal configuration) near the interface between the HPCI system and the feedwater system. During this time, the licensee concluded that feedwater was leaking back through feedwater isolation check valve No. 7 and the normally closed HPCI injection MOV No. 8, found deficiencies in about one-half of the pipe supports (16/34), and concluded that steam voids could form. On October 23, the licensee declared the HPCI system inoperable. To correct the problem temporarily, the licensee realigned the HPCI system valves to open MOV No. 8 and close MOV No. 9 to serve as the normally closed HPCI injection valve. In a later inspection, the licensee found a bent stem and erosion of the disc and the seat in MOV No. 8. In the realignment, the normally closed MOV No. 10 becomes subject to feedwater pressure. If MOV No. 10 is not fully closed, then the open MOV No. 15 in the HPCI test return line to the condensate storage tank (CST) allows a condition conducive to water hammer when check valve No. 7 is leaking. This alignment permits hot pressurized feedwater to flow in a cold low pressure test system (LER 50-237/89-29-01).

Dresden Unit 3: On October 31, 1989, while the plant was operating at 100 percent full power, the licensee declared the HPCI system inoperable, having found conditions similar to those at Unit 2 described above: similarly elevated temperatures, deficiencies in about one-half of the pipe supports (21/40), and valves that could be leaking. The licensee found the discharge piping in the steam tunnel to be insulated, contrary to the original construction documentation. Initially, the licensee revised the alignment of the HPCI system as it had at Unit 2, to open MOV No. 8 and close MOV No. 9. The licensee later determined that feedwater was leaking back through MOV No. 10. Accordingly, the licensee closed MOV No. 15 to return the HPCI system to operable status. In a later inspection, the licensee identified damage in the seating surfaces in MOV's No. 8 and 10 and check valve No. 7 to confirm feedwater back leakage. Closure of MOV No. 15 offers protection from a potential water hammer condition that could develop if MOV No. 10 does not fully close when check valve No. 7 is leaking (also LER 50-237/89-29-01).

Dresden Unit 2: On March 19, 1990, while the plant was operating at 96 percent full power, the licensee was conducting HPCI system surveillance. Before testing, the valve alignment corresponded to that described above for the short-term correction to the October 23, 1989 event, i.e., MOV No. 8 was open and MOV No. 9 was closed. To conduct certain tests, the licensee temporarily closed MOV No. 8 to isolate the HPCI system from the feedwater system, even though both MOV No. 8 and check valve No. 7 were still leaking. After completing the routine surveillance tests, including a test of MOV No. 10, the

licensee began a quarterly valve timing test of the HPCI pump discharge valve MOV No. 9. The licensee heard banging noises and observed HPCI pump discharge pipe movement. The licensee terminated the timing test, restored system valves to the pretest configuration, and monitored the noises and movement until they ceased about one and a half hours later (also LER 50-237/89-29-01).

Subsequent valve manipulation and HPCI pump discharge pipe temperature measurement led the licensee to conclude that the root cause of the event was feedwater that had leaked back through the HPCI test return MOV No. 10. The licensee postulated that this valve did not fully close after one of the required manipulations. This valve did not have a seal-in feature to complete the stroke after initiation, and the limit switch was set to bypass the torque switch in the open direction until the valve was 25 percent open. This same limit switch also controlled illumination of the "valve closed" indication light in the control room. Consequently, the "valve closed" light would be illuminated over the part of the valve stroke for which the open torque switch was bypassed. Thus, a control room operator who removed a closure signal when the light indicated the valve was closed would leave the valve approximately 25 percent open. Accordingly, the licensee revised the appropriate procedures to maintain the closure signal for 30 seconds after the "valve closed" light illuminates.

In addition, the licensee revised the valve alignment of the HPCI system to protect against backleakage through MOV No. 10 by closing MOV No. 15.
