UNITED STATES  
NUCLEAR REGULATORY COMMISSION  
OFFICE OF NUCLEAR REACTOR REGULATION  
WASHINGTON, D.C. 20555

December 16, 1991

NRC INFORMATION NOTICE 91-81: SWITCHYARD PROBLEMS THAT CONTRIBUTE TO  
LOSS OF OFFSITE POWER

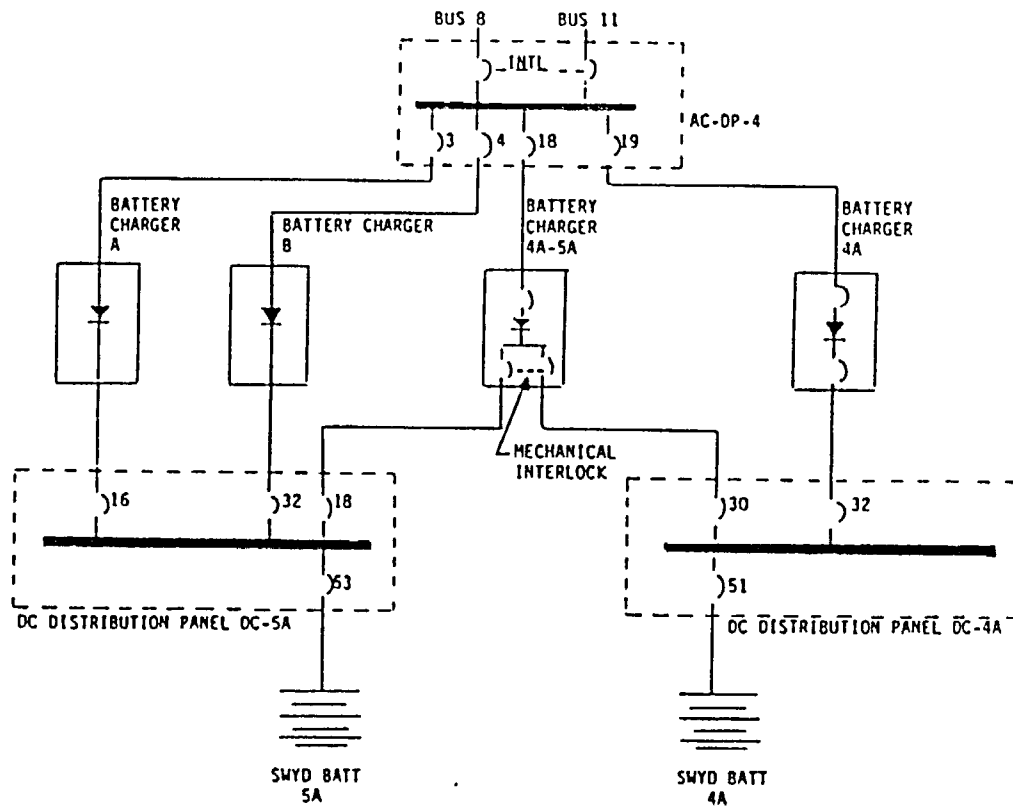
Figure 1: Switchyard House DC Distribution One Line Diagram

On April 23, 1991, a complete loss of offsite power occurred at the Vermont Yankee Nuclear Power Station as a result of maintenance activities in the switchyard. Maintenance workers were installing a new battery for one of the two non-1E 125 VDC buses. The two normally independent buses were cross tied through the swing battery charger 4A-5A after defeating a mechanical interlock (Figure 1). Furthermore, the licensee was paralleling the battery chargers on bus DC-4A without a battery on this bus. When the 4A-5A battery charger output breaker feeding bus DC-5A was opened prior to connection of the new battery 4A to bus DC-4A, a voltage transient propagated through the switchyard DC control system that caused all but one of the 345kV and 115kV circuit breakers to trip and lock open. The loss of offsite power which occurred caused a main turbine and automatic reactor trip. Restoration of full offsite power took thirteen hours.

Three of the four non-1E battery chargers (4A, B, and 4A-5A) in the switchyard DC control system were in a degraded condition at the time of the event. In each of the degraded battery chargers, manufactured by Exide, the output filter circuit was not functional. The problems included blown fuses in one filter circuit, blown and wrong-sized fuses in another, and a failed capacitor in the third filter circuit. If the 4A-5A battery charger output filter circuit had been functional, the effect of the voltage transient may have been mitigated and loss of offsite power might have been prevented. The problems resulted directly from infrequent preventive maintenance on the battery chargers. The licensee had no regular maintenance program for the chargers and it appeared that the last maintenance was performed in 1985. These battery chargers are not safety related and no surveillance testing or preventive maintenance is required. However, at this facility, the switchyard battery system, including the switchyard batteries, their associated chargers, and associated distribution panels, is part of the auxiliary electrical power system and is required to be operable by the plant's Technical Specifications.

The voltage spike in the switchyard DC control system destroyed zener diodes in the stuck breaker failure units (SBFUs) of two switchyard circuit breakers which led to a chain reaction that caused most of the breakers in the 345kV and 115kV switchyard to trip and lock open. These SBFUs are manufactured by ASEA Brown Boveri, and previous models were made by the Westinghouse Electric Corporation. The manufacturer has developed new units that are not as susceptible to voltage spikes because the new units do not contain zener diodes.

All of the SBFU relays are powered from a single bus (DC-4A) even though two DC buses are available in the switchyard DC control system. This design is subject to a single failure. Other facilities may have similar protective relaying designs that could be vulnerable to a common cause failure.
