UNITED STATES
NUCLEAR REGULATORY COMMISSION
OFFICE OF NUCLEAR REACTOR REGULATION
WASHINGTON, D.C. 20555

December 16, 1991

NRC INFORMATION NOTICE 91-81: SWITCHYARD PROBLEMS THAT CONTRIBUTE TO
LOSS OF OFFSITE POWER

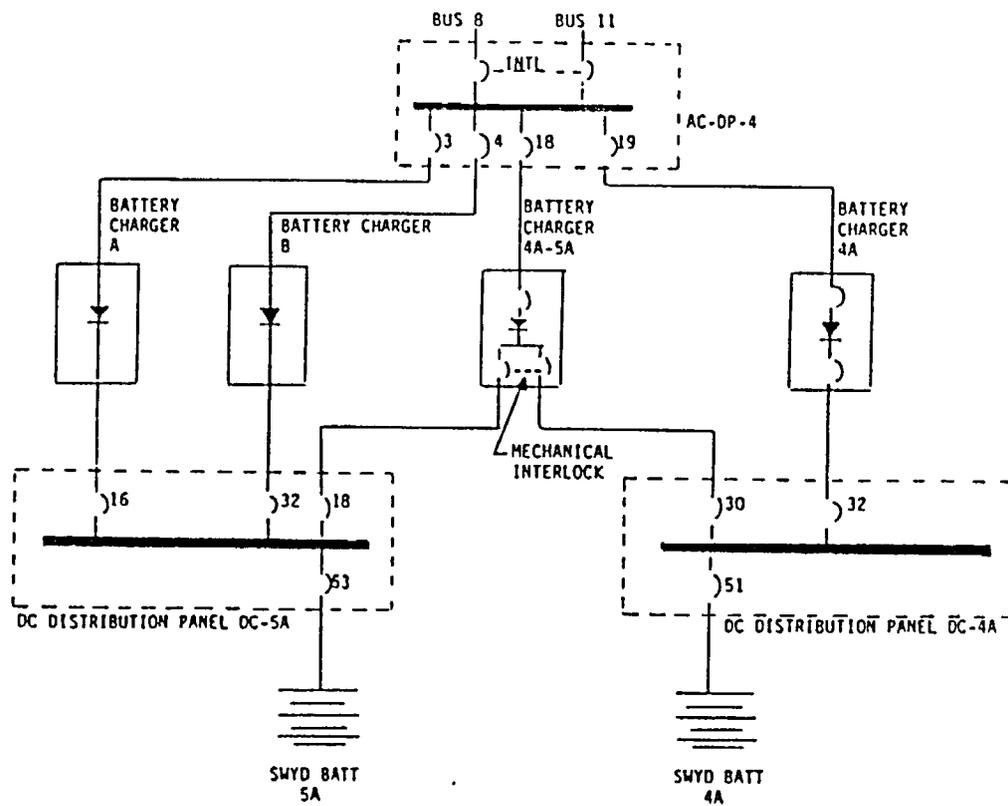
Figure 1: Switchyard House DC Distribution One Line Diagram

On April 23, 1991, a complete loss of offsite power occurred at the Vermont Yankee Nuclear Power Station as a result of maintenance activities in the switchyard. Maintenance workers were installing a new battery for one of the two non-1E 125 VDC buses. The two normally independent buses were cross tied through the swing battery charger 4A-5A after defeating a mechanical interlock (Figure 1). Furthermore, the licensee was paralleling the battery chargers on bus DC-4A without a battery on this bus. When the 4A-5A battery charger output breaker feeding bus DC-5A was opened prior to connection of the new battery 4A to bus DC-4A, a voltage transient propagated through the switchyard DC control system that caused all but one of the 345kV and 115kV circuit breakers to trip and lock open. The loss of offsite power which occurred caused a main turbine and automatic reactor trip. Restoration of full offsite power took thirteen hours.

Three of the four non-1E battery chargers (4A, B, and 4A-5A) in the switchyard DC control system were in a degraded condition at the time of the event. In each of the degraded battery chargers, manufactured by Exide, the output filter circuit was not functional. The problems included blown fuses in one filter circuit, blown and wrong-sized fuses in another, and a failed capacitor in the third filter circuit. If the 4A-5A battery charger output filter circuit had been functional, the effect of the voltage transient may have been mitigated and loss of offsite power might have been prevented. The problems resulted directly from infrequent preventive maintenance on the battery chargers. The licensee had no regular maintenance program for the chargers and it appeared that the last maintenance was performed in 1985. These battery chargers are not safety related and no surveillance testing or preventive maintenance is required. However, at this facility, the switchyard battery system, including the switchyard batteries, their associated chargers, and associated distribution panels, is part of the auxiliary electrical power system and is required to be operable by the plant's Technical Specifications.

The voltage spike in the switchyard DC control system destroyed zener diodes in the stuck breaker failure units (SBFUs) of two switchyard circuit breakers which led to a chain reaction that caused most of the breakers in the 345kV and 115kV switchyard to trip and lock open. These SBFUs are manufactured by ASEA Brown Boveri, and previous models were made by the Westinghouse Electric Corporation. The manufacturer has developed new units that are not as susceptible to voltage spikes because the new units do not contain zener diodes.

All of the SBFU relays are powered from a single bus (DC-4A) even though two DC buses are available in the switchyard DC control system. This design is subject to a single failure. Other facilities may have similar protective relaying designs that could be vulnerable to a common cause failure.
