UNITED STATES
NUCLEAR REGULATORY COMMISSION
OFFICE OF NUCLEAR REACTOR REGULATION
WASHINGTON, D.C. 20555

October 9, 1991

NRC INFORMATION NOTICE 91-64: SITE AREA EMERGENCY RESULTING FROM A LOSS OF
NON-CLASS 1E UNINTERRUPTIBLE POWER SUPPLIES

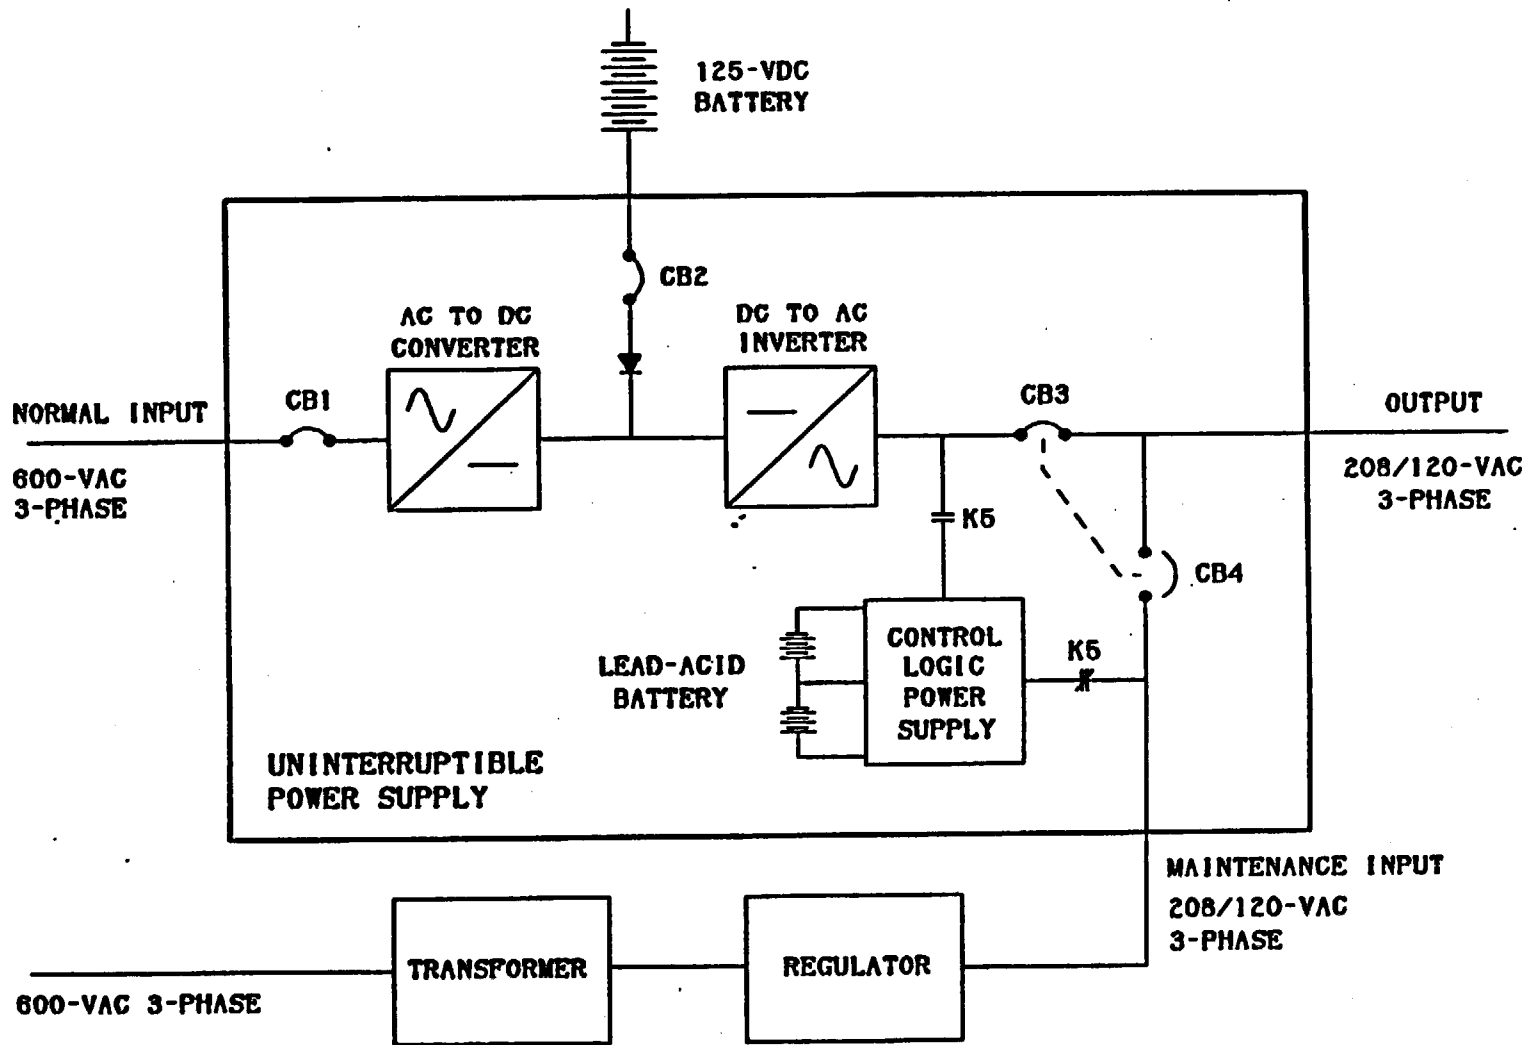
UNINTERRUPTIBLE POWER SUPPLY BEFORE DESIGN CHANGE

As shown in Attachment 1, each uninterruptible power supply cabinet receives 3-phase 600-Vac power from the plant's electrical distribution system. This system is connected to either the generator or the grid. Inside the cabinet, the 600-Vac input power passes through an ac-to-dc converter to obtain approximately 140-Vdc power which then passes through an inverter to generate quality 3-phase 208/120-Vac power that is within specified limits for voltage amplitude, frequency, and phase. The output from the cabinet is distributed to critical loads, many of which are sensitive to the voltage irregularities that are sometimes present with normal ac power. To prevent the interruption of power to these loads when the normal supply of power is lost, a 125-Vdc battery is connected to the uninterruptible power supply between the ac-to-dc converter and the dc-to-ac inverter.

The uninterruptible power supply cabinet also receives three-phase 208/120-Vac maintenance power. This power is provided through a voltage regulator and is used to supply critical loads when the supply of uninterruptible power from the inverter is not available. Within the cabinet, a control logic system selects either inverter or maintenance power for distribution to the critical loads.

Prior to and at the time of the event, the control logic power supply normally received power from phase B of the maintenance power source. If maintenance power was not available, the input for the control logic power supply automatically transferred to the output of the inverter. However, on August 13, 1991, the control logic tripped the uninterruptible power supply in response to the transient on phase B of the maintenance power source. The licensee had expected that the control logic power supply would transfer to the output of the inverter and, when inplant electrical distribution system voltages returned to normal, would transfer back to the maintenance source. Had this happened, the uninterruptible power supply would have continued to supply the critical loads.

If the control logic power supply had been wired to receive its normal power from the inverter and backup power from the maintenance source, the control logic would have had a continuous source of power and the loss of power output from the uninterruptible power supplies would not have occurred. The control logic power supplies for the three nonsafety-related and the two safety-related uninterruptible power supplies that were not lost during the event normally receive dc power for control logic through a dc-to-dc converter.

The licensee has modified the uninterruptible power supplies to provide normal input power to the control logic power supplies from the output of the inverter and alternate power from the maintenance source. The licensee has also replaced the battery packs for the control logic and has established an annual replacement schedule. The licensee intends to evaluate the performance of the switching circuitry for supplying input power to the control logic under various conditions and to process appropriate changes to the vendor's manual.
