UNITED STATES  
NUCLEAR REGULATORY COMMISSION  
OFFICE OF NUCLEAR REACTOR REGULATION  
WASHINGTON, D.C. 20555

March 19, 1991

**NRC INFORMATION NOTICE NO. 91-20: ELECTRICAL WIRE INSULATION DEGRADATION  
CAUSED FAILURE IN A SAFETY-RELATED MOTOR  
CONTROL CENTER**

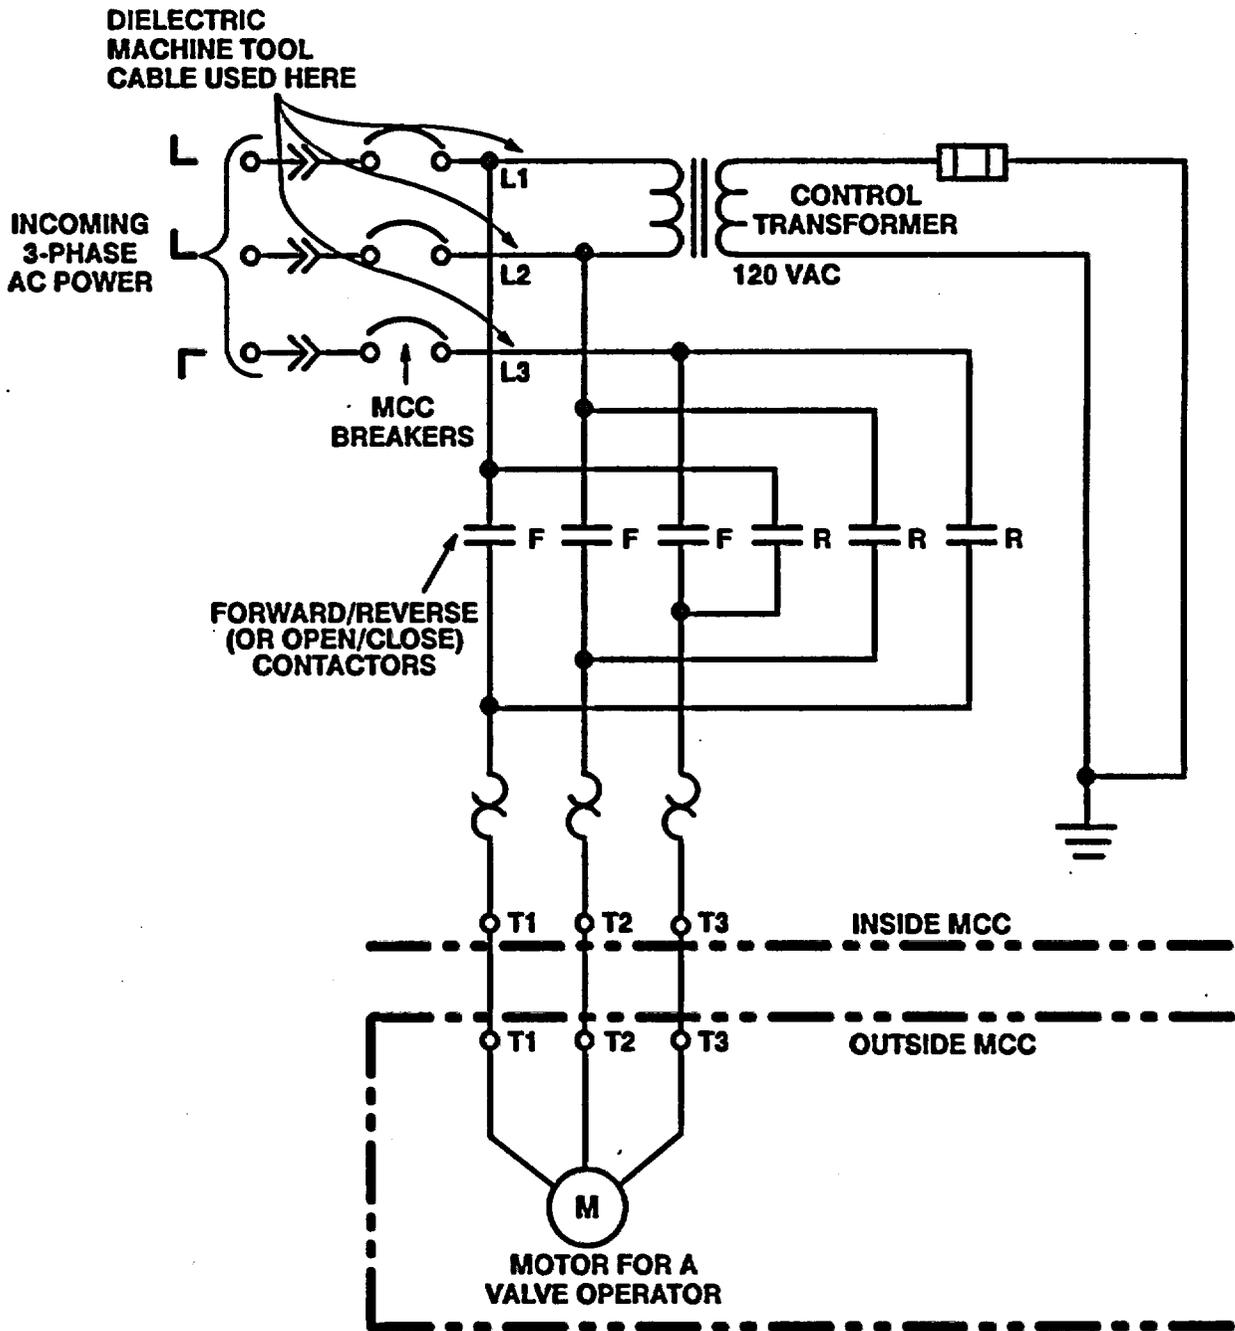
### A TYPICAL MCC COMPARTMENT

On January 4, 1991, during a refueling outage at the H. B. Robinson Steam Electric Plant, Unit 2, the "B" feedwater motor-operated isolation valve failed to close during surveillance testing. The licensee investigated the incident and identified a clear, hardened coating on one of the contactors in one of the compartments in the associated Class 1E (safety-related) motor control center (MCC). During further investigation, the licensee identified a green "liquescent" substance coming out of the wires that connect the associated MCC electrical breaker to its forward and reverse contactors and that was hardening on the contactors (see Attachment 1).

Licensees may wish to inspect their facilities for similar dielectric PVC machine tool wire and take appropriate action, as necessary.
