UNITED STATES
NUCLEAR REGULATORY COMMISSION
OFFICE OF NUCLEAR REACTOR REGULATION
WASHINGTON, D.C. 20555

March 19, 1991

**NRC INFORMATION NOTICE NO. 91-20: ELECTRICAL WIRE INSULATION DEGRADATION
CAUSED FAILURE IN A SAFETY-RELATED MOTOR
CONTROL CENTER**

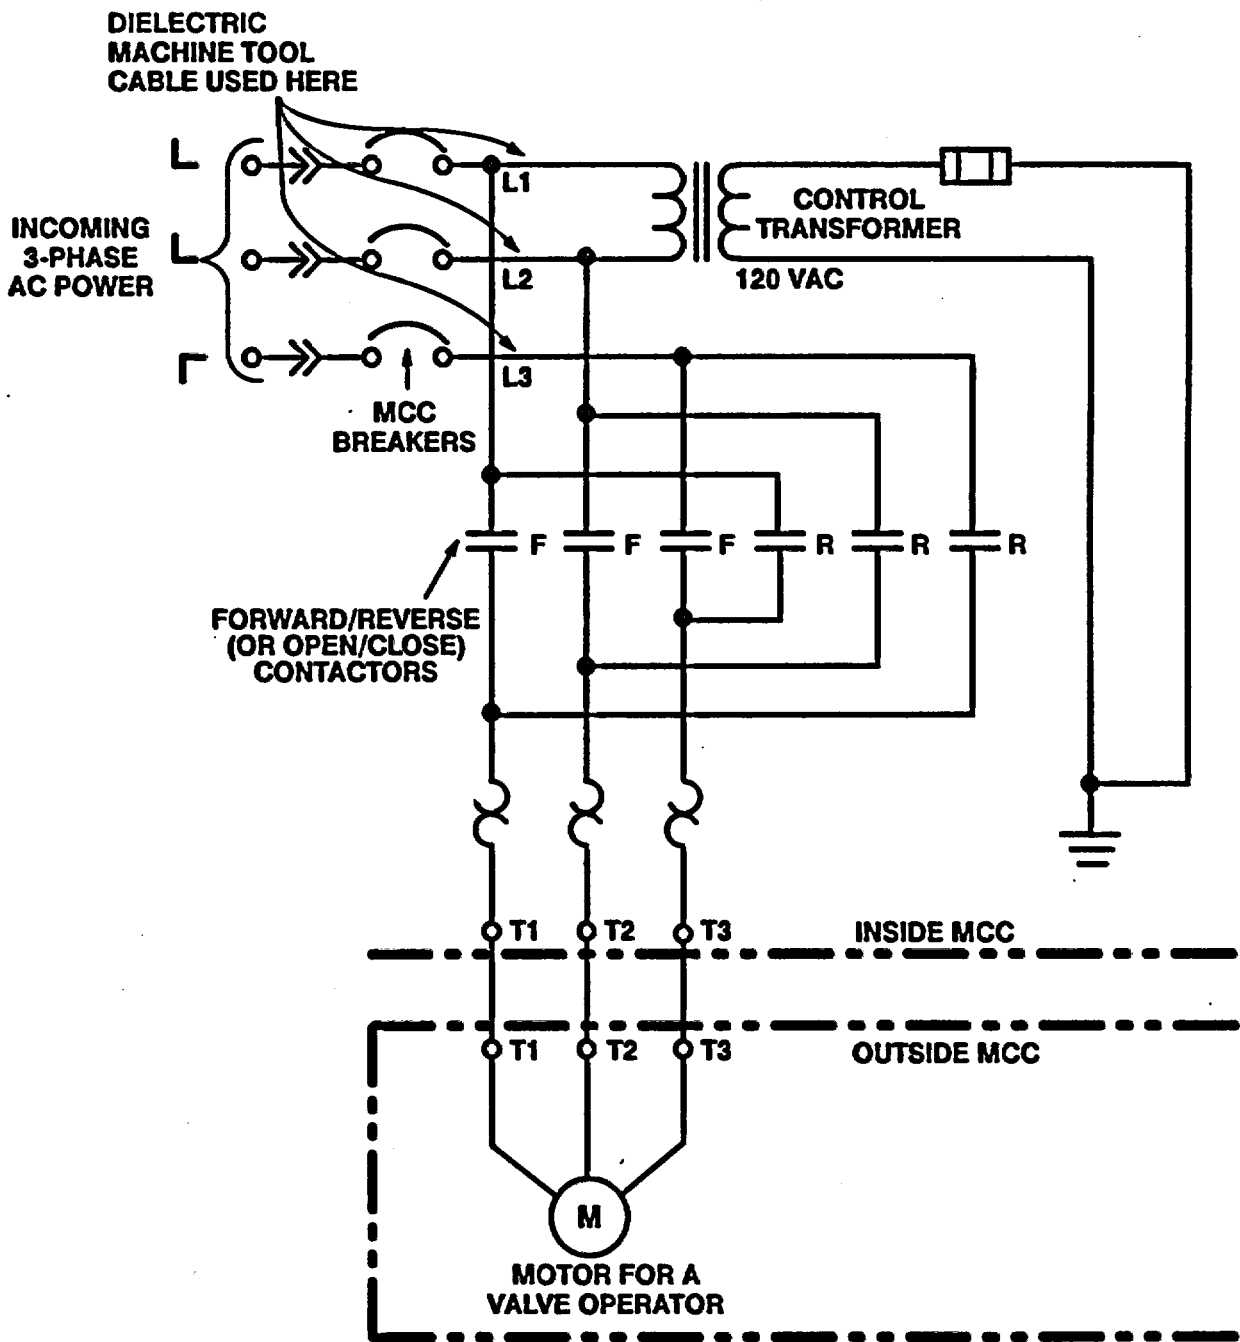
A TYPICAL MCC COMPARTMENT

On January 4, 1991, during a refueling outage at the H. B. Robinson Steam Electric Plant, Unit 2, the "B" feedwater motor-operated isolation valve failed to close during surveillance testing. The licensee investigated the incident and identified a clear, hardened coating on one of the contactors in one of the compartments in the associated Class 1E (safety-related) motor control center (MCC). During further investigation, the licensee identified a green "liquescent" substance coming out of the wires that connect the associated MCC electrical breaker to its forward and reverse contactors and that was hardening on the contactors (see Attachment 1).

The H. B. Robinson licensee performed a laboratory analysis and identified the green liquescent substance as a "vegetable oil plasticizer," which is present in the composition of the cable's PVC insulation. The analysis indicated that the green liquescent substance is a conductor in liquid form, but when dried, may either be a conductor or an insulator, depending on the amounts of copper oxide salts present. In addition, the color of the substance can vary depending on the amount of copper oxide salts present.

Licensees may wish to inspect their facilities for similar dielectric PVC machine tool wire and take appropriate action, as necessary.
