UNITED STATES
NUCLEAR REGULATORY COMMISSION
OFFICE OF NUCLEAR REACTOR REGULATION
WASHINGTON, D.C. 20555

March 12, 1991

NRC INFORMATION NOTICE NO. 91-18: HIGH-ENERGY PIPING FAILURES CAUSED BY WALL THINNING

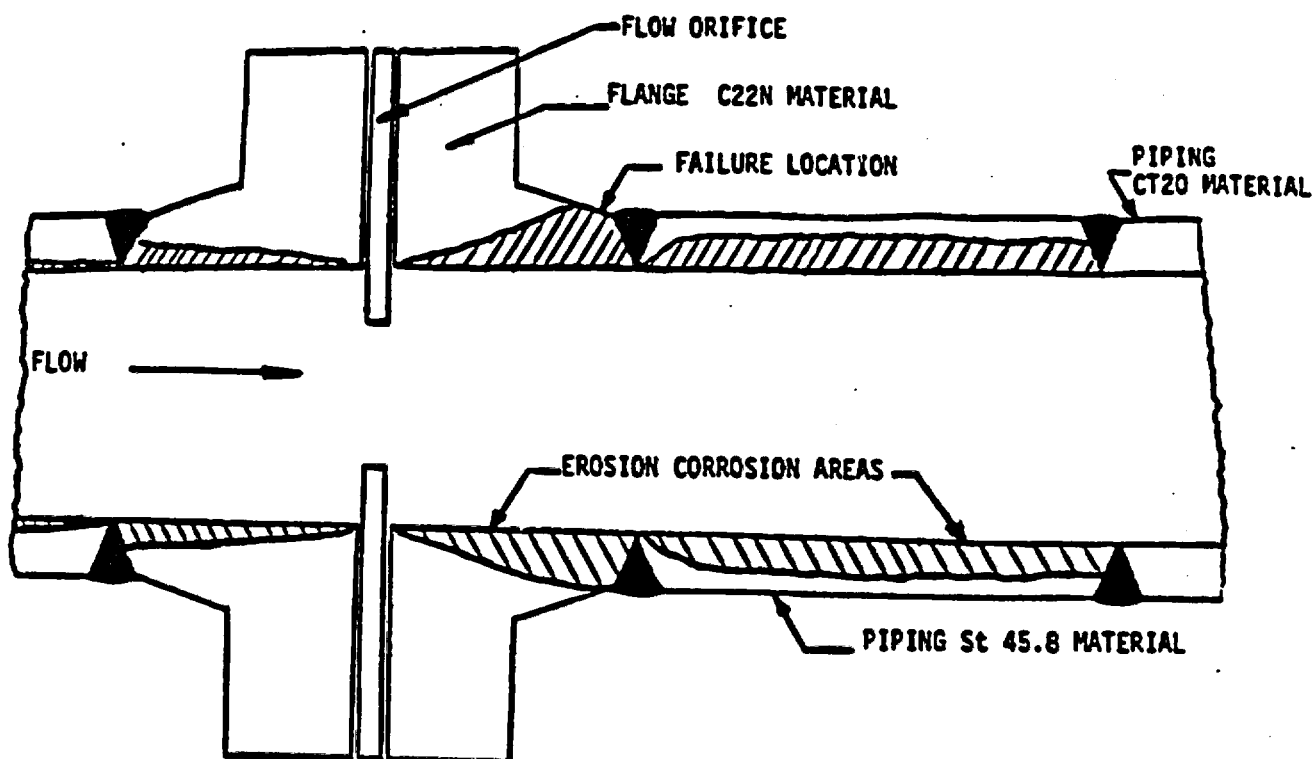
FIGURE 1. LOVIISA UNIT-1 EROSION/CORROSION AREAS

The feedwater pipe rupture at Loviisa Unit 1 occurred in the flange of the flow-measuring orifice (Figure 1). The 360-degree thinning of the interior wall of the flange started near the orifice plate and increased to the point of the rupture. In the area of the rupture, the flange wall had thinned to 0.039 inch. A 20 inch long pipe section attached to the downstream end of the flange had circumferential wall thinning from an initial wall thickness of 0.7 inch to a residual wall thickness of 0.195 - 0.390 inch. Neither this section of pipe nor the flange contained significant amounts of alloying elements. However, the piping downstream of the 20 inch pipe, which contained 0.20 percent chromium, 0.30 percent nickel and 0.30 percent copper, did not exhibit wall thinning.

The utility conducted an investigation and determined that the thinning was caused by erosion/corrosion. In 1982, the utility established a pipe inspection program for two phase (steam/water) systems and, in 1986, augmented the program to include single phase systems; however, the program concentrated on pipe elbows and tee fittings. To check for other degraded flanges, the utility inspected the flow-orifice flanges at Units 1 and 2 and found that 9 of 10 flanges were below minimum wall requirements. The utility replaced the flanges with the same material as the original flanges but is considering changing to a more erosion/corrosion resistant material as a final repair.
