UNITED STATES
NUCLEAR REGULATORY COMMISSION
OFFICE OF NUCLEAR REACTOR REGULATION
WASHINGTON, D.C. 20555

March 12, 1991

NRC INFORMATION NOTICE NO. 91-19: STEAM GENERATOR FEEDWATER DISTRIBUTION
PIPING DAMAGE

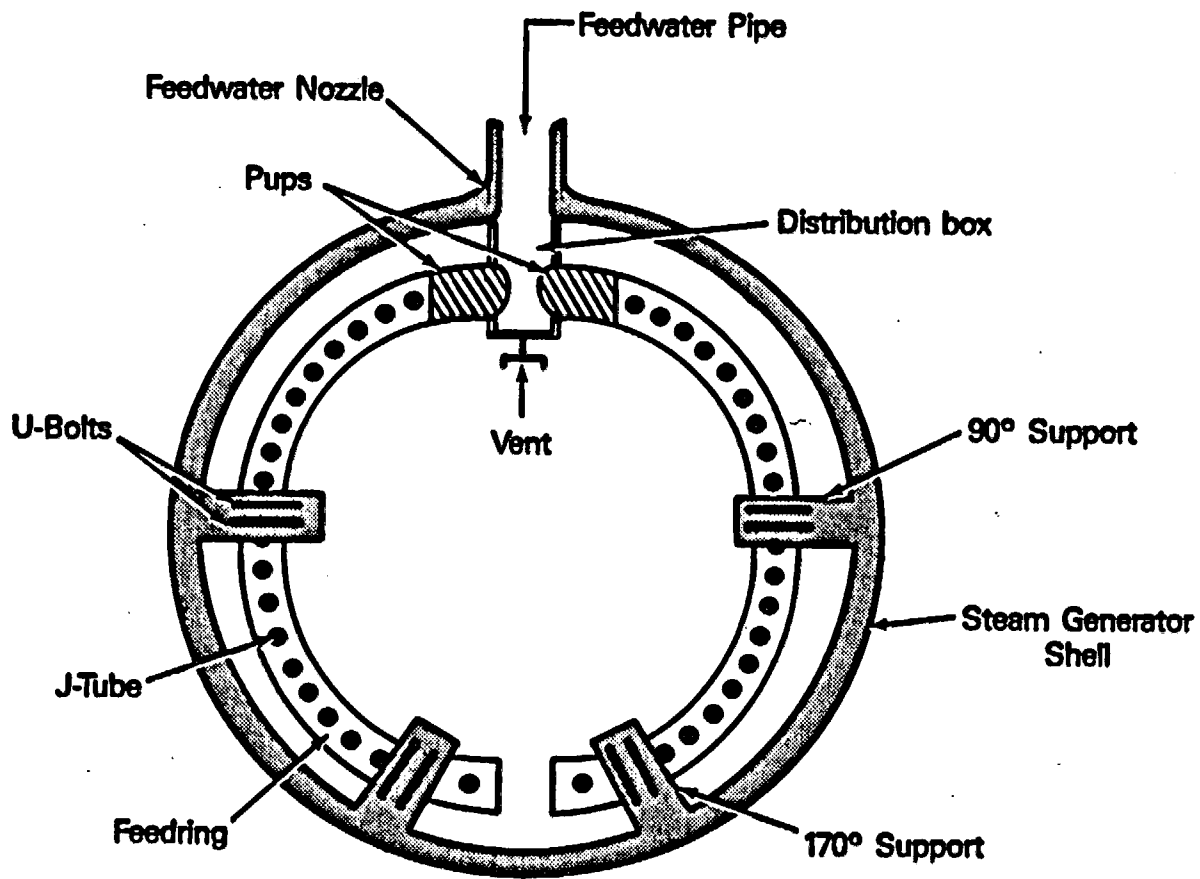
Figure 1: Top View of the Feedwater Distribution Piping

At San Onofre Units 2 and 3, both main feedwater and auxiliary feedwater enter the steam generators through a feedwater nozzle. The feedwater enters a distribution box and 12-inch diameter piping (feedring) that distributes the flow through top-mounted discharge elbows (J-tubes) around the periphery of the steam generator shell (Figure 1). The feedring is attached by two U-bolts at each of four supports that are welded to the shell wall. A 3-inch elbow and tee vent assembly is attached to the upper portion of the innermost (toward the interior of the steam generator) end of the distribution box (Figure 2).

On May 10, 1990, the licensee found several pieces of carbon steel debris during a routine inspection of the secondary side of the tubesheet of one steam generator (LER 50-362/90-05-01). During further inspection of the internal components of this and the other steam generator, the licensee found material missing from the lower portion of the feedring at its intersection with the distribution box, surface cracks in the heat-affected zone at the toe of the weld at that intersection, erosion and corrosion indications on the interior surfaces of the distribution boxes, erosion of the vent assemblies, "T" section tops missing from the vent assemblies, and deformation of several U-bolt supports.

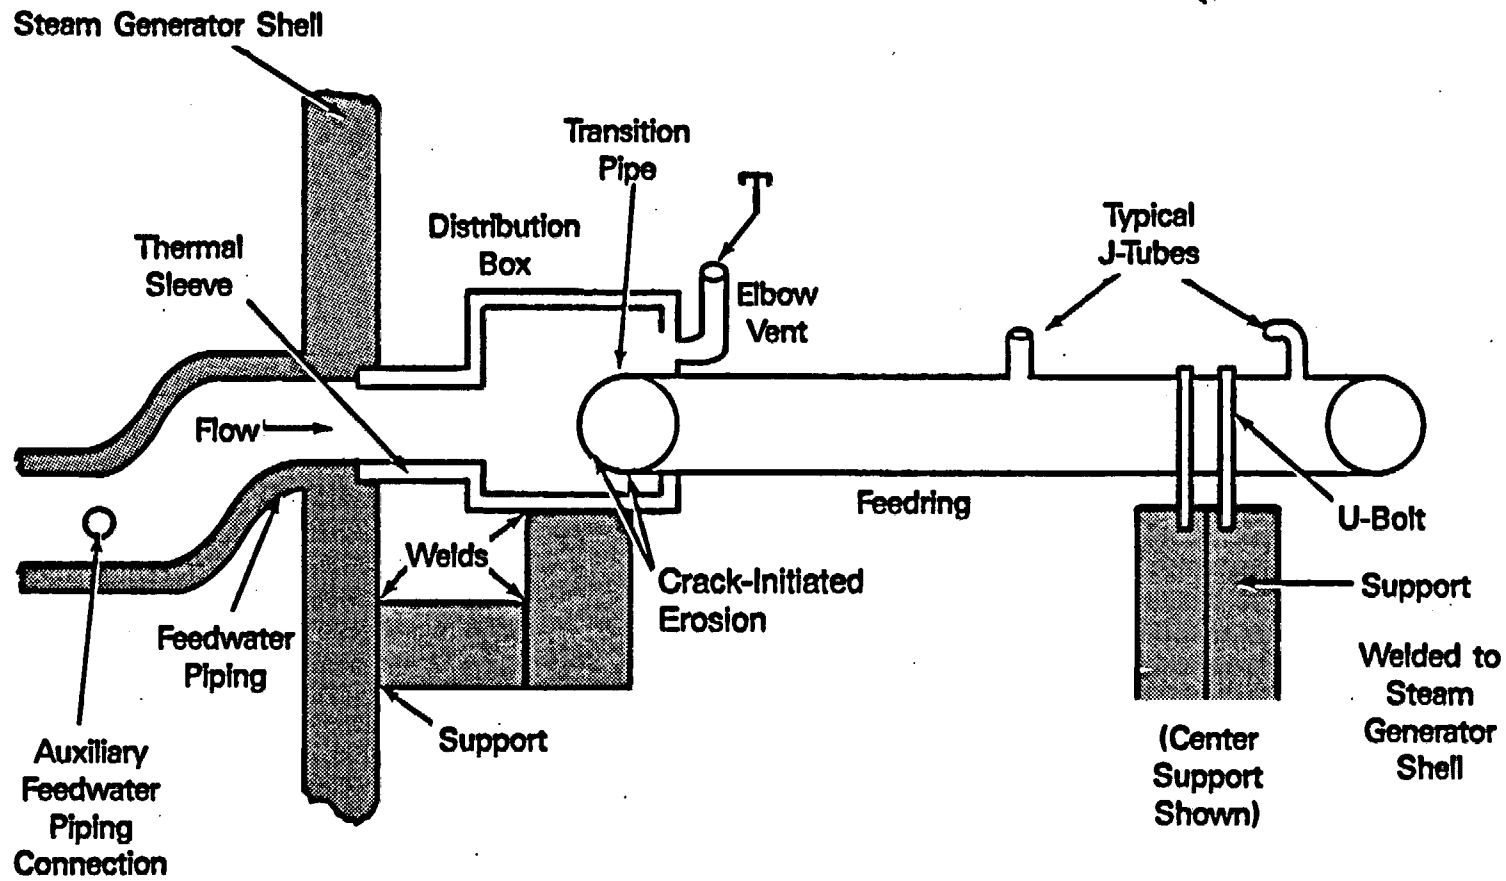
Figure 2: Side View of the Feedwater Distribution Piping

The licensee determined the root cause contributing to the degradation of the feedwater distribution system piping to be inadequate design of the feedring and feedring supports. The design did not adequately consider the thermal stresses resulting from normal operating conditions, in particular the batch process of auxiliary feedwater addition during startup operations. In addition, the design of the vent assembly had not properly considered the potential for erosion and corrosion resulting from localized high velocity flow. The corrective actions taken by the licensee included replacing the remaining Schedule 40 piping material with Schedule 120 piping material, replacing the distribution box-feedring weld configuration with weld-o-let forgings, removing the distribution box vents from the design, repairing local thinning of the distribution box by weld buildup and removal of local interior surface discontinuities, modifying the feedring supports to provide flexibility for thermal expansion, and using stronger U-bolts. The licensee had previously modified the auxiliary feedwater system to provide continuous feeding of the steam generator rather than the batch feeding that was used during startup operations.
