UNITED STATES
NUCLEAR REGULATORY COMMISSION
OFFICE OF NUCLEAR REACTOR REGULATION
WASHINGTON, D.C. 20555

November 10, 1992

NRC INFORMATION NOTICE 92-74: POWER OSCILLATIONS AT WASHINGTON NUCLEAR POWER
UNIT 2

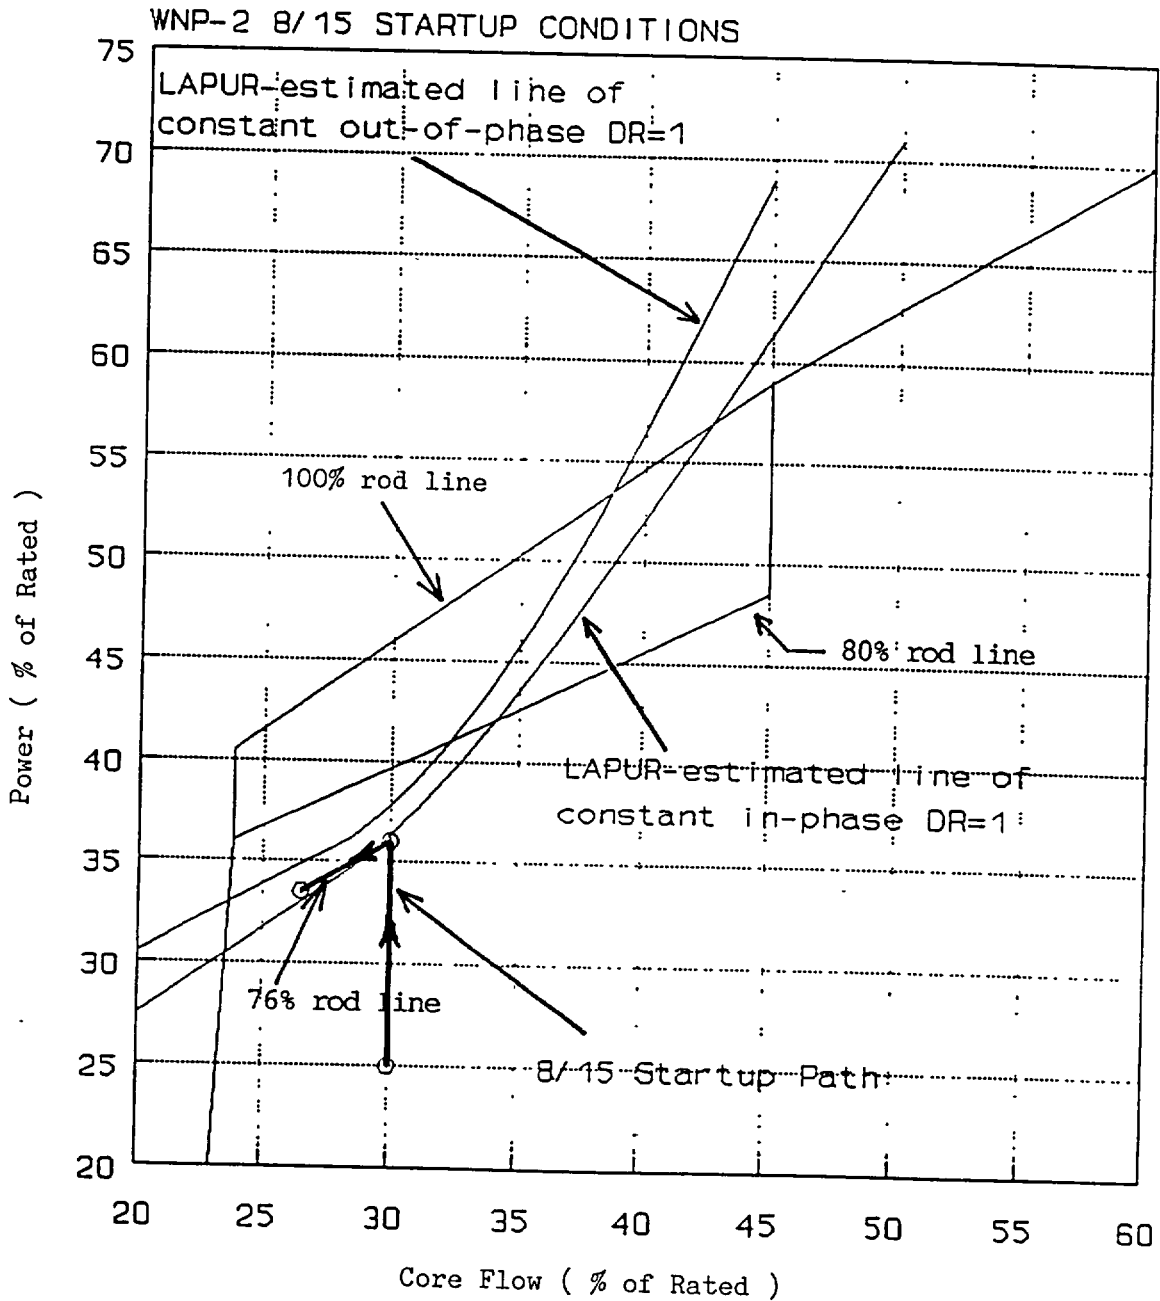
After completing the tests, the operators continued the restart up the (approximately) 30-percent flow line to about 36-percent power (Figure 1). This is at a power above the recirculation pump cavitation region. The operators then began closing one of the two FCVs in preparation for shifting the associated recirculation pump to fast speed. During this change, in which power and flow decreased along the 76-percent rod line to a power/flow of about 34/27 percent, the operators observed power oscillations first on the average power range monitors (APRMs) and then by local power range monitors (LPRMs) downscale indications. Upon recognizing the power oscillations, the plant operators manually initiated a reactor scram. Post-event review indicated that the 2-second-period oscillations were in-phase (core-wide) and had grown to a peak-to-peak amplitude of about 25 percent of rated power. Most of the oscillation amplitude increase occurred in an interval of about 1 minute with the oscillations continuing at the limiting (maximum) amplitude for an additional minute before scram. The oscillations occurred while the reactor was operating at a power about 4 percent of rated power below the lower exclusion region boundary line (the nominal 80-percent rod line). During later review, the licensee found no indication that fuel had failed because of the event.

The NRC sent an Augmented Inspection Team (AIT) to the site to determine the possible causes and relevant facts of this event. The AIT concluded that the primary cause of the oscillations was very skewed radial and bottom peaked axial power distributions in the reactor (1.92 radial peaking factor and 1.62 core average axial peaking factor). These power distributions resulted from (1) the control rod pattern that the shift technical advisor selected for increasing the power and shifting the recirculation pump speed, and (2) the relationship of this control rod pattern to the specific WNP-2 cycle 8 core fuel loading configuration. These rod patterns were primarily directed towards achieving the target full power configuration and did not consider stability concerns.

Figure 1 Best-estimate lines of constant decay ratio=1.0 for actual conditions of 8/15 event, assuming constant power distribution
