UNITED STATES  
NUCLEAR REGULATORY COMMISSION  
OFFICE OF NUCLEAR REACTOR REGULATION  
WASHINGTON, D.C. 20555

NRC INFORMATION NOTICE 92-74: POWER OSCILLATIONS AT WASHINGTON NUCLEAR POWER  
UNIT 2

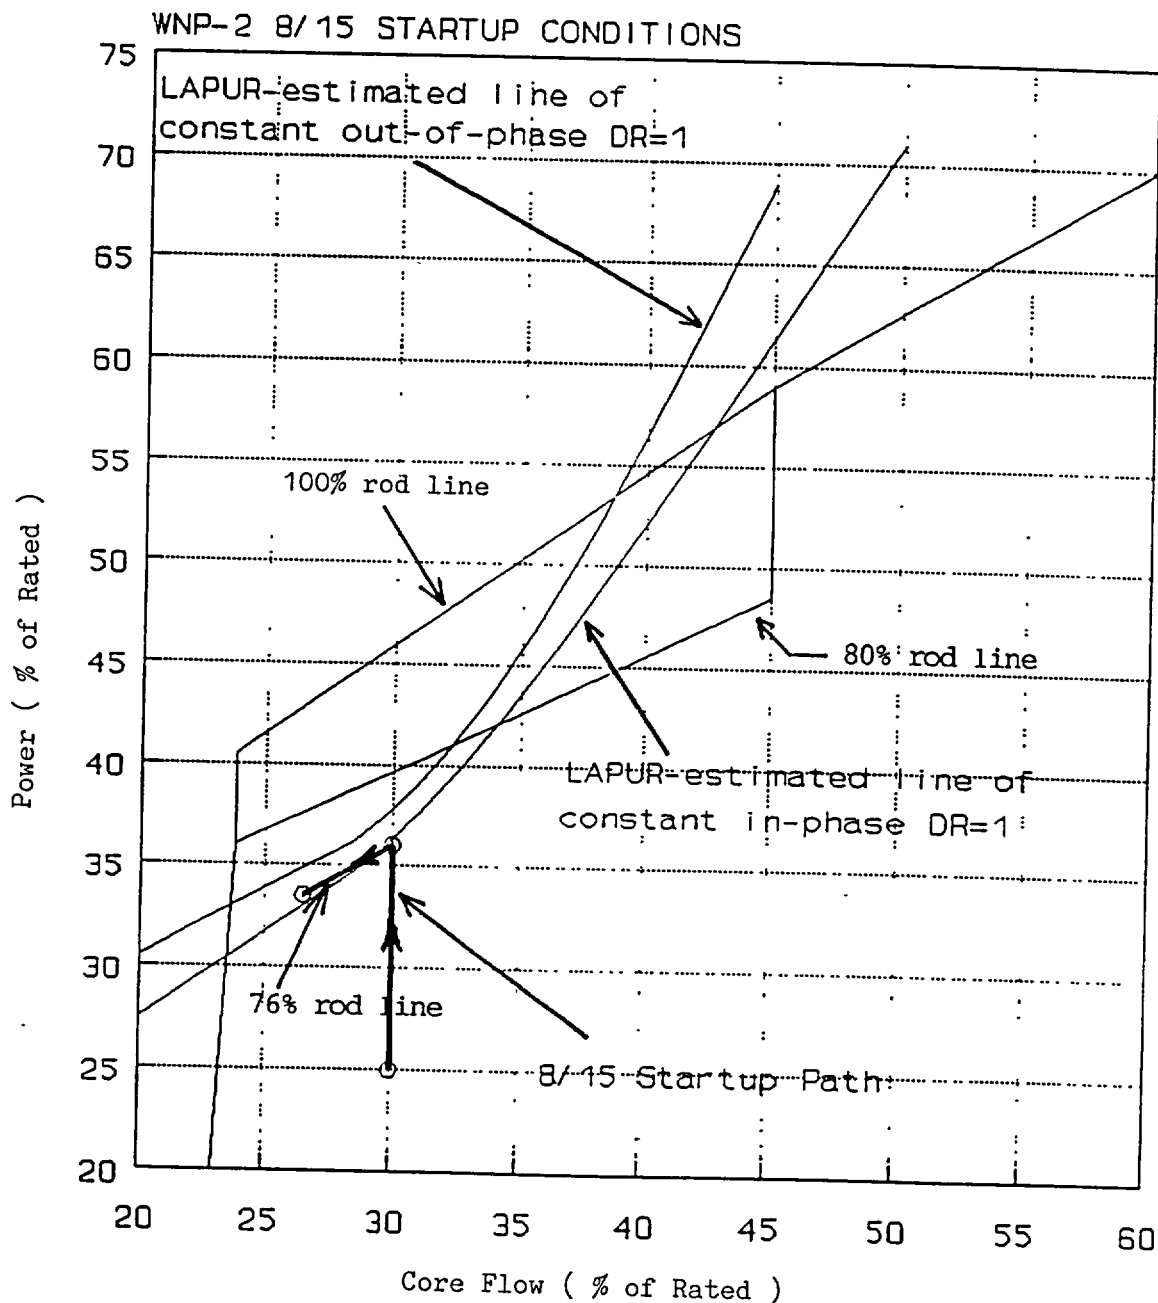
Figure 1 Best-estimate lines of constant decay ratio=1.0 for actual conditions of 8/15 event, assuming constant power distribution

After completing the tests, the operators continued the restart up the (approximately) 30-percent flow line to about 36-percent power (Figure 1). This is at a power above the recirculation pump cavitation region. The operators then began closing one of the two FCVs in preparation for shifting the associated recirculation pump to fast speed. During this change, in which power and flow decreased along the 76-percent rod line to a power/flow of about 34/27 percent, the operators observed power oscillations first on the average power range monitors (APRMs) and then by local power range monitors (LPRMs) downscale indications. Upon recognizing the power oscillations, the plant operators manually initiated a reactor scram. Post-event review indicated that the 2-second-period oscillations were in-phase (core-wide) and had grown to a peak-to-peak amplitude of about 25 percent of rated power. Most of the oscillation amplitude increase occurred in an interval of about 1 minute with the oscillations continuing at the limiting (maximum) amplitude for an additional minute before scram. The oscillations occurred while the reactor was operating at a power about 4 percent of rated power below the lower exclusion region boundary line (the nominal 80-percent rod line). During later review, the licensee found no indication that fuel had failed because of the event.

The NRC sent an Augmented Inspection Team (AIT) to the site to determine the possible causes and relevant facts of this event. The AIT concluded that the primary cause of the oscillations was very skewed radial and bottom peaked axial power distributions in the reactor (1.92 radial peaking factor and 1.62 core average axial peaking factor). These power distributions resulted from (1) the control rod pattern that the shift technical advisor selected for increasing the power and shifting the recirculation pump speed, and (2) the relationship of this control rod pattern to the specific WNP-2 cycle 8 core fuel loading configuration. These rod patterns were primarily directed towards achieving the target full power configuration and did not consider stability concerns.

The AIT also found, by analyses using the LAPUR code, that a contributor to the oscillations was the core loading, consisting of a mixed core with unbalanced flow characteristics between the new 9x9-9x fuel and the old 8x8 fuel. The analyses indicated that a full core of the 9x9-9x fuel would be significantly less stable than the old 8x8 fuel, and that the mixed core was less stable than a fully loaded core of either fuel type. The analyses also indicated that while the oscillations would be in-phase (core-wide), as observed in the event, the out-of-phase (regional) instability boundary would be very close to the in-phase boundary (Figure 1). The AIT found that small changes in operating conditions could have resulted in out-of-phase oscillations, which would have been more difficult for the APRM system to detect.

- The licensee analyzed the control rod patterns for stability before startup, and the operator could not change these patterns without analysis and review.
- The calculated maximum total peaking factor was less than 3.4.

- The calculated core average axial peaking factor was less than 1.45.
- The Minimum Critical Power Ratio was greater than 2.2.
- The licensee analyzed the conditions at FCV closure and found a decay ratio of less than 0.5. The recirculation pump was shifted to fast speed with the reactor power less than 33 percent and the feedwater temperature greater than 146.1 °C (295 °F).
- The licensee continuously used the ANNA monitor when the reactor was operating above 25 percent power and below 50 percent flow.
