UNITED STATES
NUCLEAR REGULATORY COMMISSION
OFFICE OF NUCLEAR REACTOR REGULATION
WASHINGTON, D.C. 20555

August 20, 1992

NRC INFORMATION NOTICE 92-61: LOSS OF HIGH HEAD SAFETY INJECTION

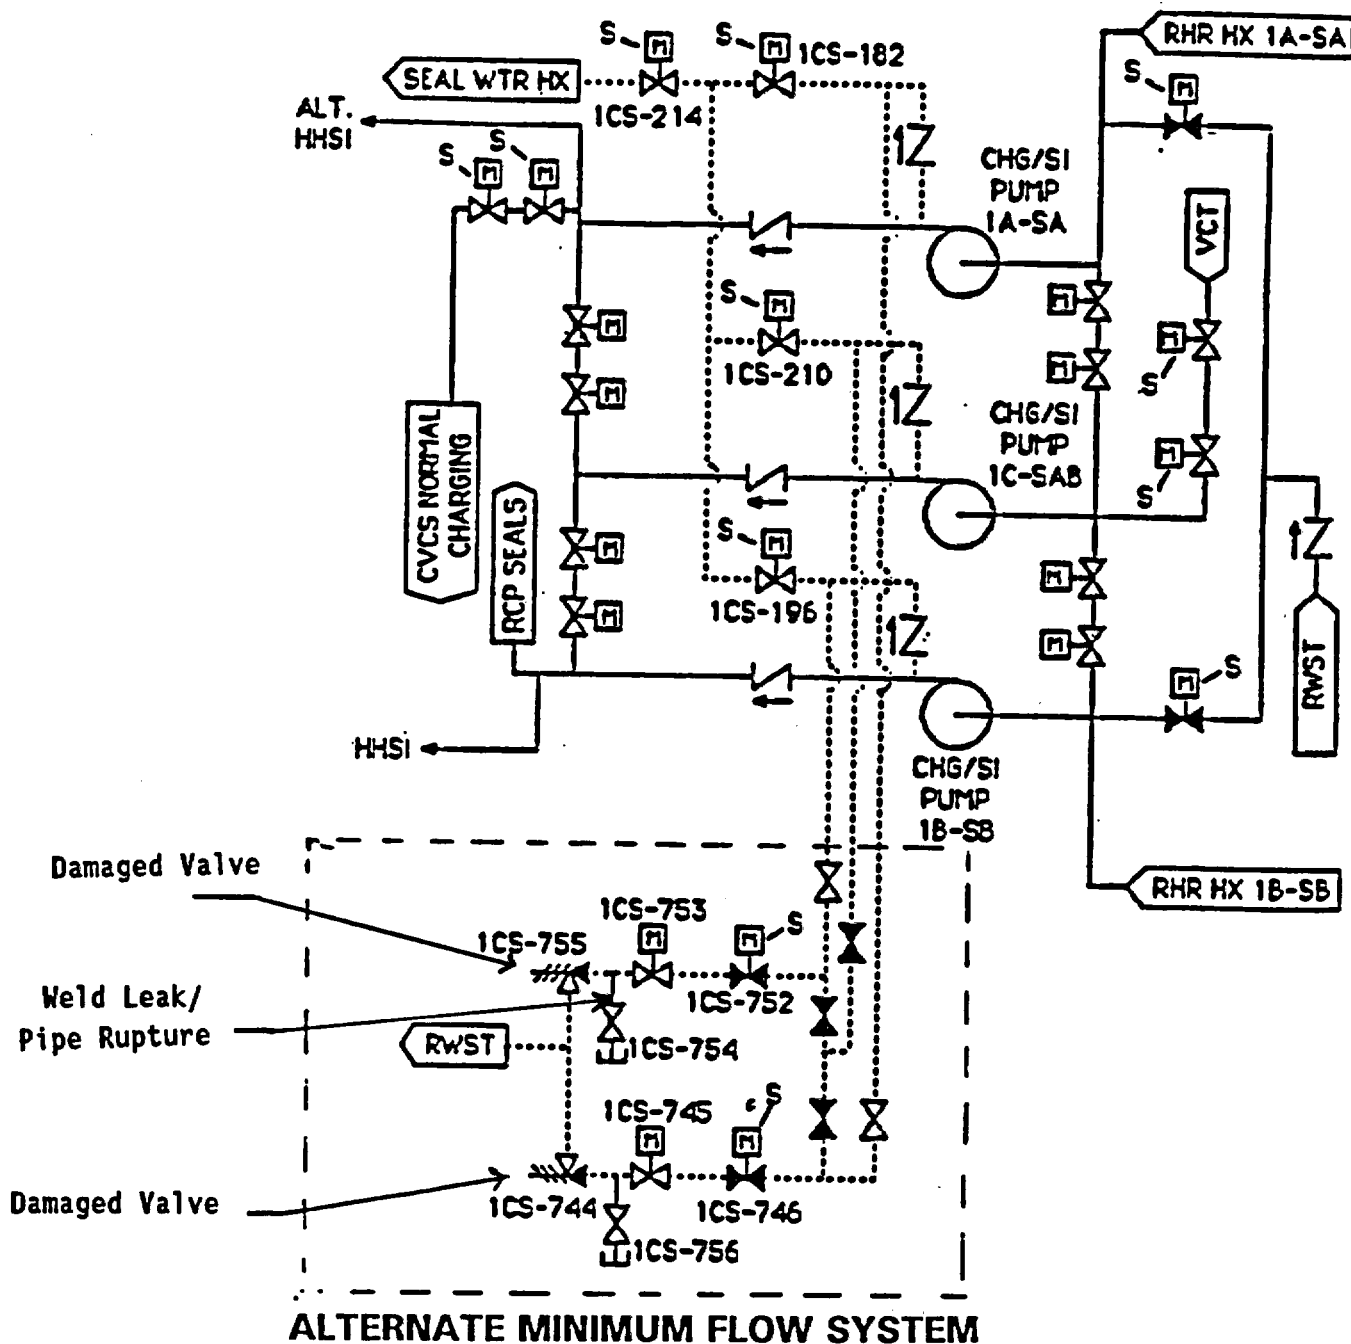
SHEARON HARRIS HIGH HEAD SAFETY INJECTION SYSTEM

The AMF system (Attachment 1) is designed to prevent a deadhead condition on the CSIPs by providing a flow path for these pumps to the refueling water storage tank if the reactor repressurizes following a main steam line break or feedwater line break accident. The AMF system is designed only to pass flow when the CSIP discharge pressure is above the lift setpoint of 2300 +/- 69 psig for relief valves 1CS-744 and 1CS-755. The AMF system was a modification to the original design in response to a Westinghouse 10 CFR Part 21 report. This report identified the potential for deadheading the CSIPs during repressurization of the RCS following secondary side breaks.

- 1) Relief valve 1CS-744 had a broken bellows and a cracked spring and was found to have a reduced relief setpoint of 1100 psig.

- 2) Relief valve ICS-755 had a broken bellows. Its relief setpoint could not be determined due to valve seat leakage.
- 3) The piping connection upstream of ICS-754 failed due to a water hammer during engineered safety feature (ESF) testing. A small leak had previously existed in this weld and was scheduled for repair during the 1991 refueling outage.

The physical layout of the AMF system piping at the Shearon Harris Nuclear Power Plant results in air being trapped upstream and downstream of the relief valves when they are removed and reinstalled in the system. The upstream isolation valves ICS-746 and ICS-752 remain closed until an SI signal is received. This prevents water from refilling this piping. Also, piping upstream of the relief valves does not have high point vents to remove the trapped air.

The licensee has taken corrective actions by revising plant procedures to require the piping upstream of the relief valves to be refilled prior to installation of the relief valves and vented through the relief valves by hydraulic pressure to eliminate the air. The licensee has also repaired the damage identified above. The licensee reported this event to the NRC in LER 050-400/91-008-01 in May of 1991. The licensee is currently evaluating the potential for water hammer downstream of the relief valves.
