UNITED STATES
NUCLEAR REGULATORY COMMISSION
OFFICE OF NUCLEAR REACTOR REGULATION
WASHINGTON, D.C. 20555

July 2, 1992

NRC INFORMATION NOTICE 92-50: CRACKING OF VALVES IN THE CONDENSATE RETURN LINES OF A BWR EMERGENCY CONDENSER SYSTEM

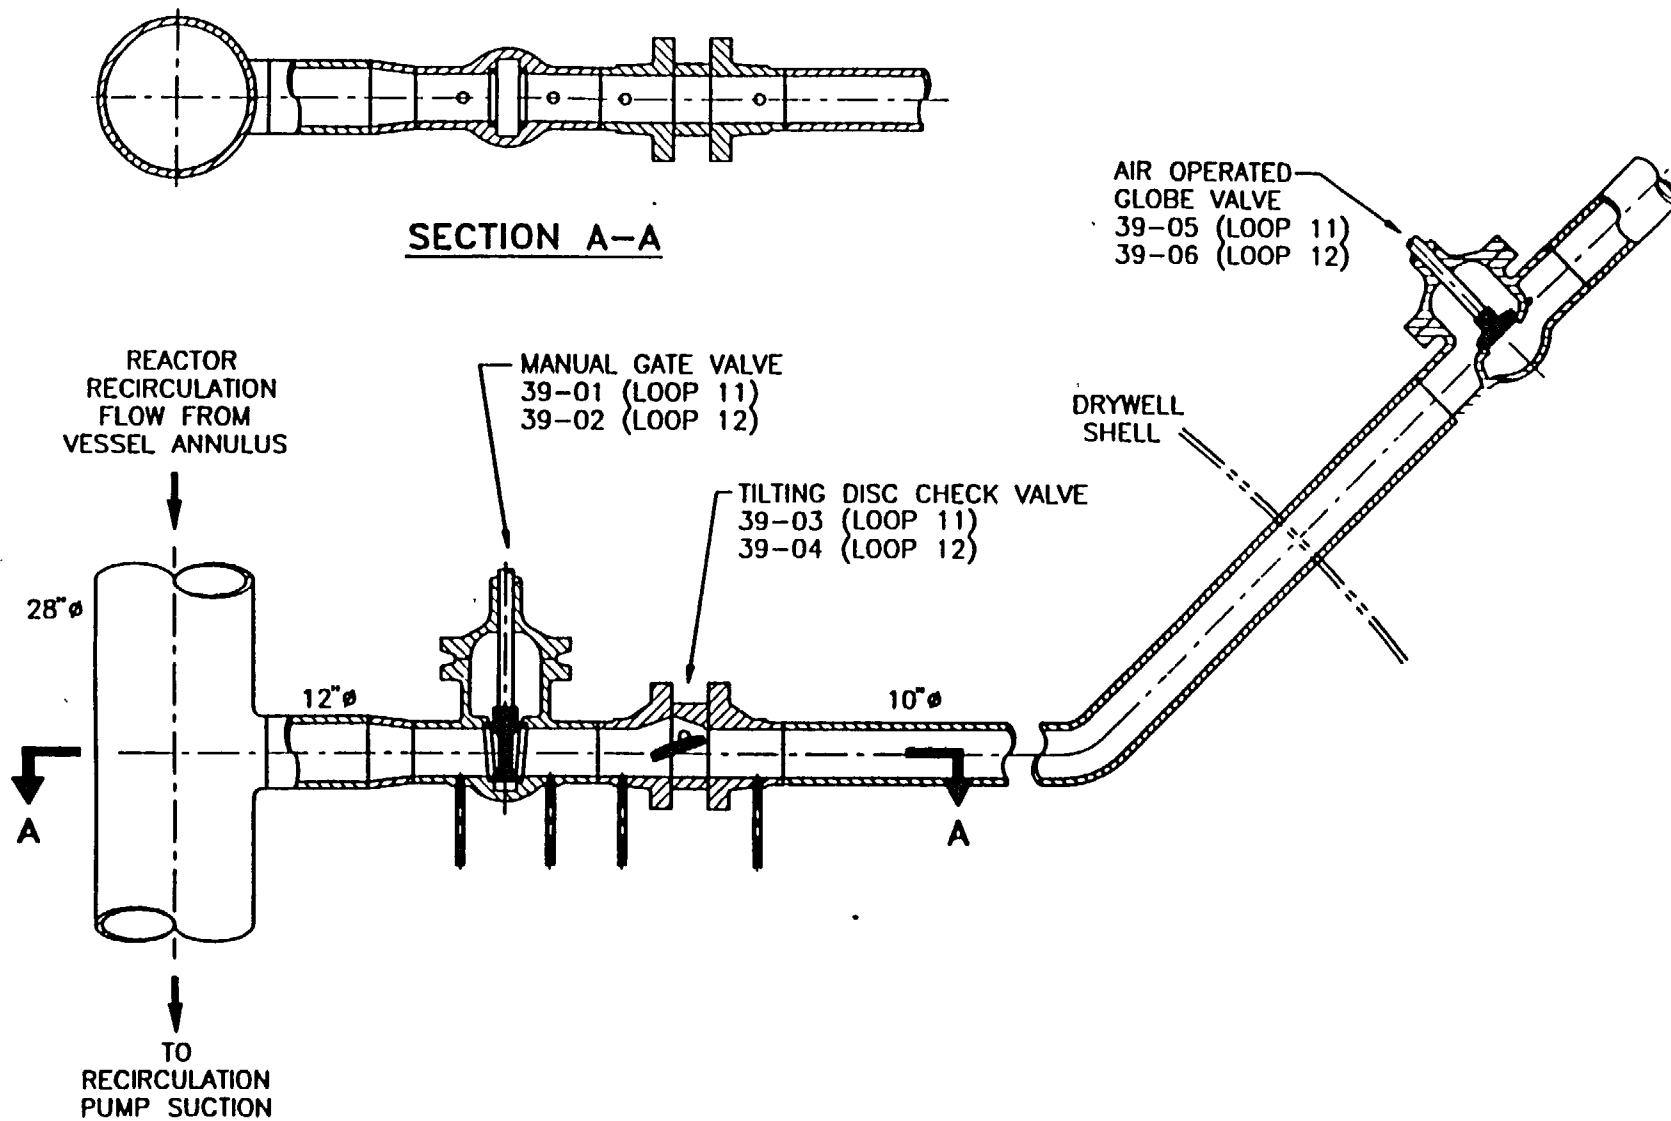
FIGURE 1
NMP-1 EMERGENCY CONDENSER SYSTEM
CONDENSATE RETURN LINE
CONFIGURATION INSIDE DRYWELL

The emergency condenser system has two independent loops (loops 11 and 12). Figure 1 shows the configuration of the condensate return line in loops 11 and 12. In the condensate return line, a manual gate valve is connected downstream of a tilting disc check valve. At each of those two valves, two 1-inch drain lines are connected to the bottom part of the valve body with one drain line at the upstream side and the other one at the downstream side of the valve. The valve bodies are made of CF8M cast stainless steel.

While investigating the leakage at the manual gate valve 39-02, the licensee removed the internal components of the adjacent check valve to perform a visual test (VT), a radiographic test (RT), and an ultrasonic test (UT). The licensee visually observed cracks on the inside surfaces at both valves in loop 12. At gate valve 39-02, the licensee found cracks near each of the two drain holes. At check valve 39-04, the licensee found cracks near a downstream drain hole and found evidence of cracking in the threads of the

upstream drain. These cracks were further examined radiographically and ultrasonically. The licensee found four cracks including a throughwall crack near the drain hole upstream of gate valve 39-02. The licensee reported the throughwall crack to be about 3.5 inches long and oriented radially outward from the hole. The other three cracks were all reported to be within 0.15 to 0.35 inch of passing through the wall (1.25 inch wall thickness). The licensee found two cracks in the drain hole area downstream of the gate valve (39-02), which is the unisolable side of the valve body. The licensee reported the deepest crack to be about 1 inch long and within 0.15 inch of passing through the wall. The licensee found four cracks near the drain hole downstream of check valve 39-04 with the deepest reported to be within 0.1 inch of passing through the wall. The licensee visually observed one small indication on the seat ring in manual gate valve 39-02. The licensee also examined valves 39-01 and 39-03 in the condensate return line for loop 11 of the emergency condenser system and found two cracks near the drain hole upstream of manual gate valve 39-01. The largest crack was reported to be about 1.25 inch long and 1 inch deep. The licensee reported the cracking of the valve body in loop 11 to be less severe than that in loop 12. The licensee observed cracking indications on the inside surface of a butt weld that joins the gate valve to the check valve but did not confirm these indications by the radiographic examination. The licensee ultrasonically examined selected piping welds inboard of the condensate return isolation valves and found no indications.

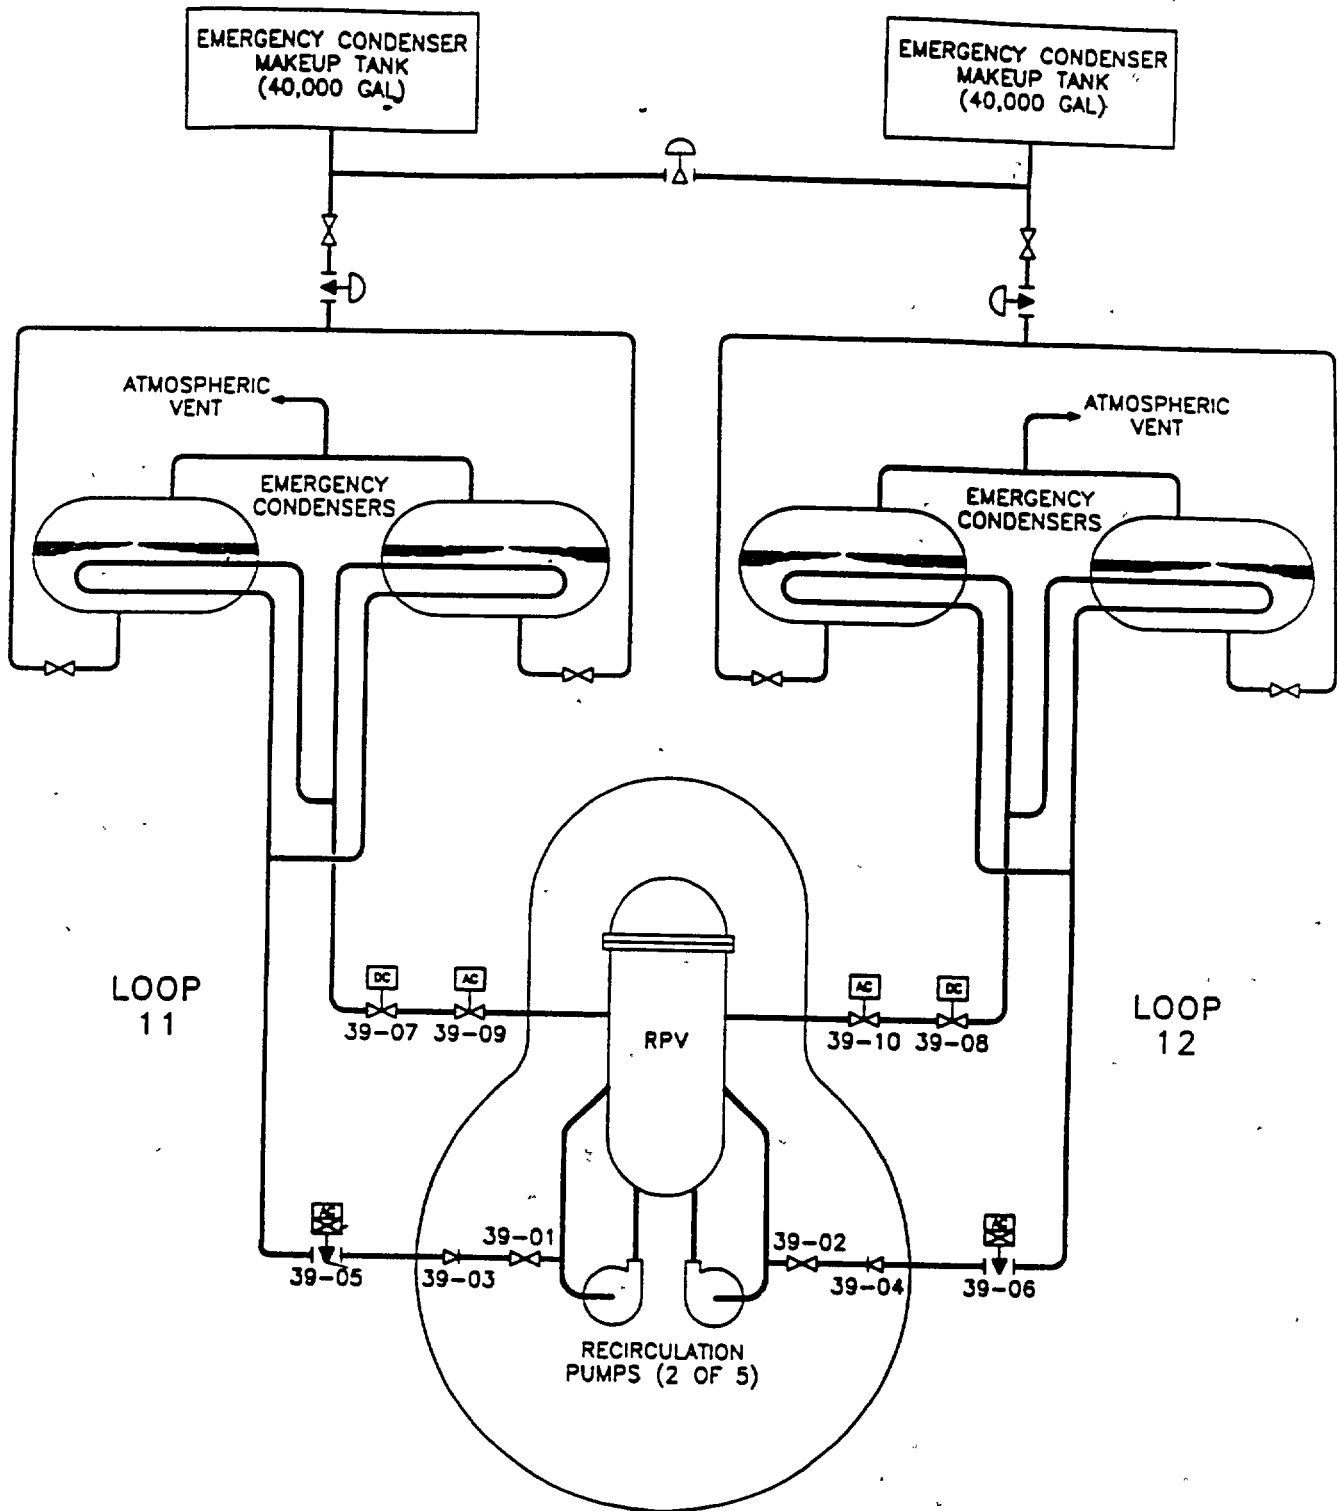
**FIGURE 2 NINE MILE POINT UNIT ONE
EMERGENCY CONDENSER SYSTEM
SIMPLIFIED DIAGRAM**

The emergency condensate system at Nine Mile Point, Unit 1, which is connected directly to the reactor coolant system, operates by natural circulation and acts as a backup for the main condenser to remove the reactor decay heat following a reactor isolation. The emergency condenser system at Nine Mile Point, Unit 1, as shown in Figure 2, has two loops (loop 11 and loop 12) with two condensers in each loop. During normal plant operation, the condensate return isolation valves (39-05 and 39-06) are closed, and the steam isolation valves (39-07, 08, 09, and 10) are open in each loop. As shown in Figure 1, two valves, a manual gate valve and a tilting disc check valve, are located in horizontal sections of the condensate return line. The horizontal sections are connected to the suction side of the recirculation piping system. The manual gate valves are maintenance valves and are open during normal operation.
