UNITED STATES  
NUCLEAR REGULATORY COMMISSION  
OFFICE OF NUCLEAR REACTOR REGULATION  
WASHINGTON, D.C. 20555

NRC INFORMATION NOTICE 92-44: PROBLEMS WITH WESTINGHOUSE DS-206 AND  
DSL-206 TYPE CIRCUIT BREAKERS

Subject DS-206 AND DSL-206 BREAKERS - MECHANICAL FRICTION OF MAIN CONTACT ASSEMBLIES		Number NSD-TB- 91-06-RO	
System(s) ALL PLANT SYSTEMS		Date 9/24/91	
Affected Plants ALL PLANTS WITH W TYPE DS-206 AND DSL-206 AIR CIRCUIT BREAKERS		S.O.(s) VARIOUS	
References SEE BELOW	Affects Safety Related Equipment	Yes <input checked="" type="checkbox"/> No <input type="checkbox"/>	Sheet 1 of 7

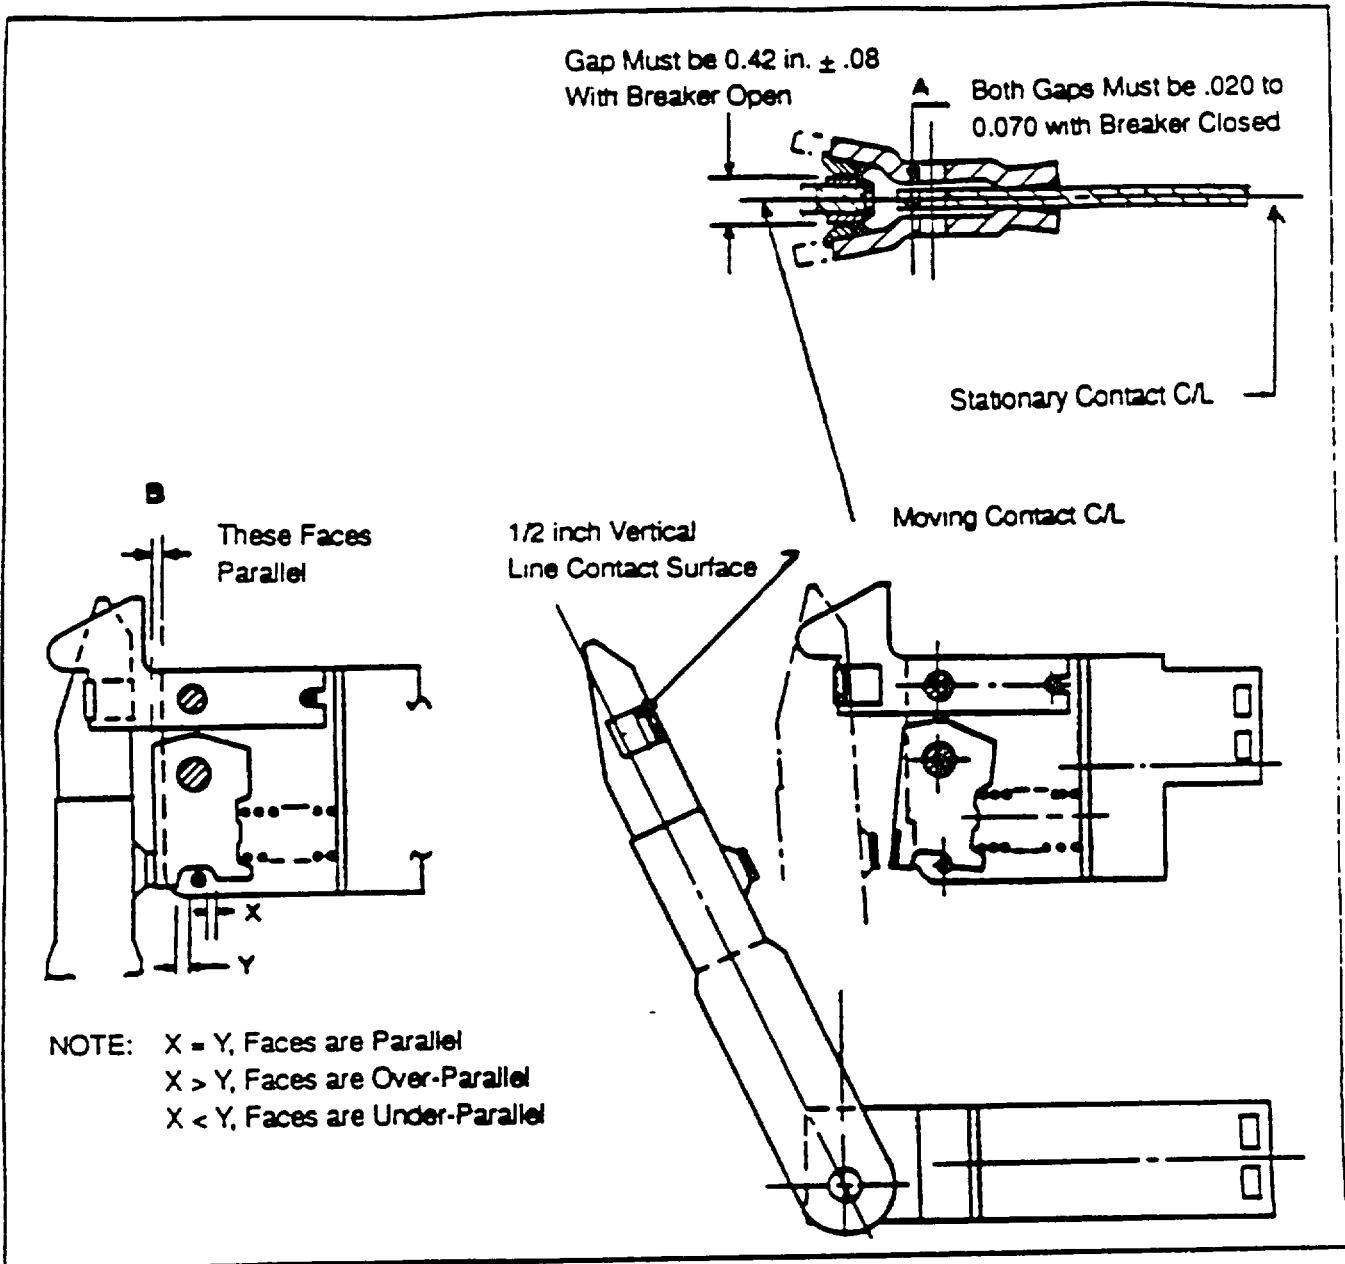
FIGURE 1: CONTACTS AND THEIR ADJUSTMENTS, DS-206 BREAKER

5. Manually charge the closing springs and close the breaker.
6. Visually inspect the faces between the main stationary contact fingers and the leading edge of the vertical stationary contact bar on each phase. See dimension B in the attached figure. Record whether the faces are under-parallel ( $x < y$ ), parallel ( $x = y$ ), or over-parallel ( $x > y$ ).

- a. The moving contact assembly center line should visually line up with the center line of the stationary contact assembly within plus/minus 1/16 inch. If this cannot be achieved by loosening and moving the individual contact assemblies, then new assemblies should be installed.
- b. The 0.020 minimum dimension A should not exceed 0.070 since this may result in excessive compression of the arcing contact springs.

- c. The adjustment of the stationary contacts should be such that the moving contact and the stationary contact rubbing surfaces are parallel to each other and touch each other with line contact over the 1/2 inch length.
13. If arcing contacts still do not part, obtain additional opening force margin by adjusting the contacts of each pole assemble as follows:
  - a. Loosen the locking nut and turn the adjusting nut of each insulating link an additional full turn (six flats) in the clockwise direction (when looking at the breaker from the front).

Per the attached figure, the individual stationary arcing contacts should be adjusted using the following information:

NOTE: DO NOT OVER ADJUST. THE MAIN MOVING CONTACT ARM MUST NOT CONTACT THE STATIONARY CONTACT ARMS EXCEPT AS SHOWN IN THE FIGURE.
