UNITED STATES NUCLEAR REGULATORY COMMISSION OFFICE OF NUCLEAR REACTOR REGULATION WASHINGTON, D.C. 20555

May 6, 1992

NRC INFORMATION NOTICE 92-35: HIGHER THAN PREDICTED EROSION/CORROSION IN UNISOLABLE REACTOR COOLANT PRESSURE BOUNDARY PIPING INSIDE CONTAINMENT AT A BOILING WATER REACTOR

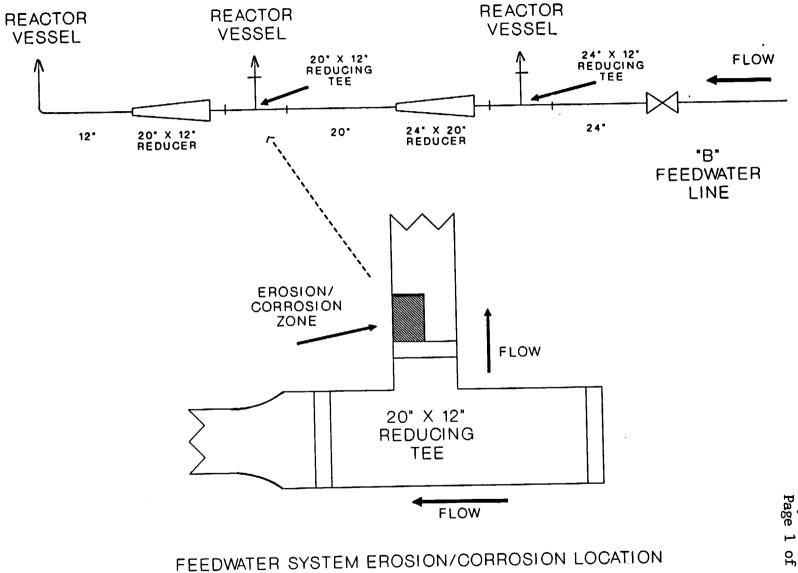
Attachment 1 IN 92-35 May 6, 1992 Page 1 of 1

The Pennsylvania Power and Light Company (the licensee) recently performed erosion/corrosion inspections at the Susquehanna Steam Electric Station, Unit 1, and may have identified an unexpectedly high rate of erosion/corrosion in certain main feedwater (FW) piping inside containment (Attachment 1). Erosion of this portion of FW piping is of particular concern since this portion cannot be isolated from the reactor vessel, and erosion/corrosion inspection strategies may not direct attention to that part of the FW system.

When the licensee began operating the unit commercially in June 1982, the nominal wall thickness for the pipe was about 0.688 inch. During the current refueling outage, wall thinning was found in one of the 20 inch by 12 inch reducing tee risers approximately 10 inches downstream from the tee in the 12 inch pipe section, immediately above a circumferential pipe weld. During the previous refueling outage (18 months ago) the licensee had measured the pipe wall as 0.619 inch thick at that location. During the current refueling outage, the licensee measured a thickness of 0.521 inch at the same location. The licensee measured a thickness of 0.482 inch within about 2 inches of that location. The licensee calculated a minimum allowable wall thickness of 0.440 inch for that portion of FW pipe. Previous experience and models had indicated inch for that portion of FW pipe. Previous experience and moders had indicated an erosion wear rate of no more than 0.085 inch each cycle. However, the most ATTACHMENT FILD IN JACKET 9205010009 PDR IFE NOTICE 92-035 920506 IDJR-11 C

recent measurement indicates a higher wear rate that may be greater than 0.100 inch each cycle.

The licensee determined that although it had expected to find erosion/corrosion at this location, the magnitude of wall thinning exceeded expectations. The licensee is continuing its investigation to determine the root cause of the unexpected erosion/corrosion rate.

The licensee evaluated the data for the FW system and determined that continued operation could not be justified for another fuel cycle. Therefore, the licensee repaired, rather than replaced, the FW pipe in accordance with Section XI of the American Society of Mechanical Engineers (ASME) Boiler and Pressure Vessel Code.
