UNITED STATES  
NUCLEAR REGULATORY COMMISSION  
OFFICE OF NUCLEAR REACTOR REGULATION  
WASHINGTON, D.C. 20555

May 6, 1992

NRC INFORMATION NOTICE 92-35: HIGHER THAN PREDICTED EROSION/CORROSION IN  
UNISOLABLE REACTOR COOLANT PRESSURE BOUNDARY  
PIPING INSIDE CONTAINMENT AT A BOILING  
WATER REACTOR

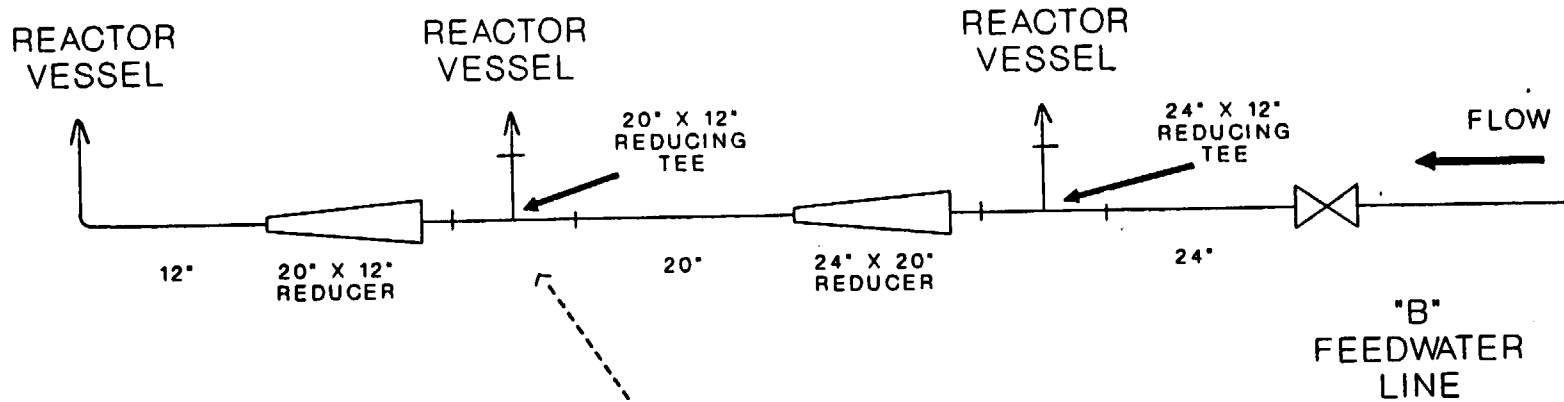
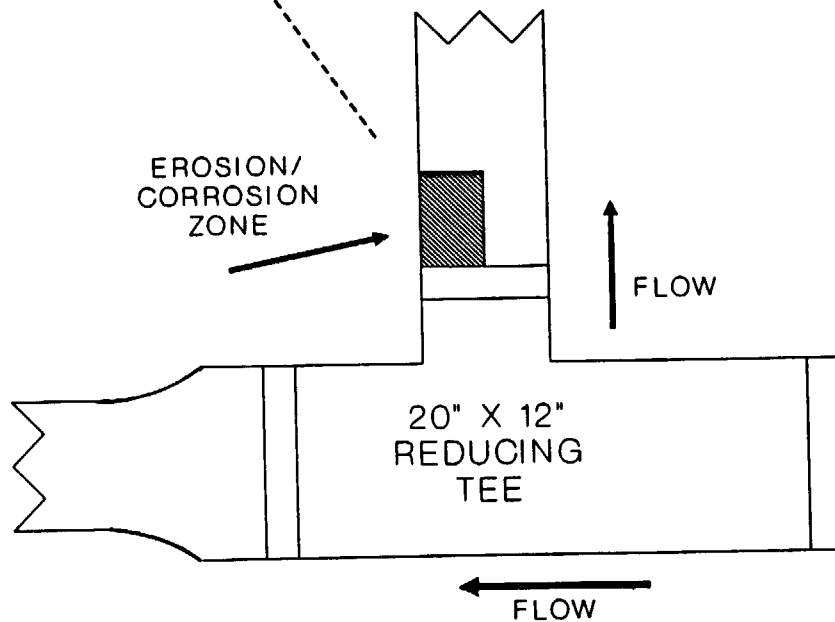
FEEDWATER SYSTEM EROSION/CORROSION LOCATION

The Pennsylvania Power and Light Company (the licensee) recently performed erosion/corrosion inspections at the Susquehanna Steam Electric Station, Unit 1, and may have identified an unexpectedly high rate of erosion/corrosion in certain main feedwater (FW) piping inside containment (Attachment 1). Erosion of this portion of FW piping is of particular concern since this portion cannot be isolated from the reactor vessel, and erosion/corrosion inspection strategies may not direct attention to that part of the FW system.

When the licensee began operating the unit commercially in June 1982, the nominal wall thickness for the pipe was about 0.688 inch. During the current refueling outage, wall thinning was found in one of the 20 inch by 12 inch reducing tee risers approximately 10 inches downstream from the tee in the 12 inch pipe section, immediately above a circumferential pipe weld. During the previous refueling outage (18 months ago) the licensee had measured the pipe wall as 0.619 inch thick at that location. During the current refueling outage, the licensee measured a thickness of 0.521 inch at the same location. The licensee measured a thickness of 0.482 inch within about 2 inches of that location. The licensee calculated a minimum allowable wall thickness of 0.440 inch for that portion of FW pipe. Previous experience and models had indicated an erosion wear rate of no more than 0.085 inch each cycle. However, the most

recent measurement indicates a higher wear rate that may be greater than 0.100 inch each cycle.

The licensee determined that although it had expected to find erosion/corrosion at this location, the magnitude of wall thinning exceeded expectations. The licensee is continuing its investigation to determine the root cause of the unexpected erosion/corrosion rate.

The licensee evaluated the data for the FW system and determined that continued operation could not be justified for another fuel cycle. Therefore, the licensee repaired, rather than replaced, the FW pipe in accordance with Section XI of the American Society of Mechanical Engineers (ASME) Boiler and Pressure Vessel Code.
