November 8, 1977
IE Bulletin 77-05

ELECTRICAL CONNECTOR ASSEMBLIES

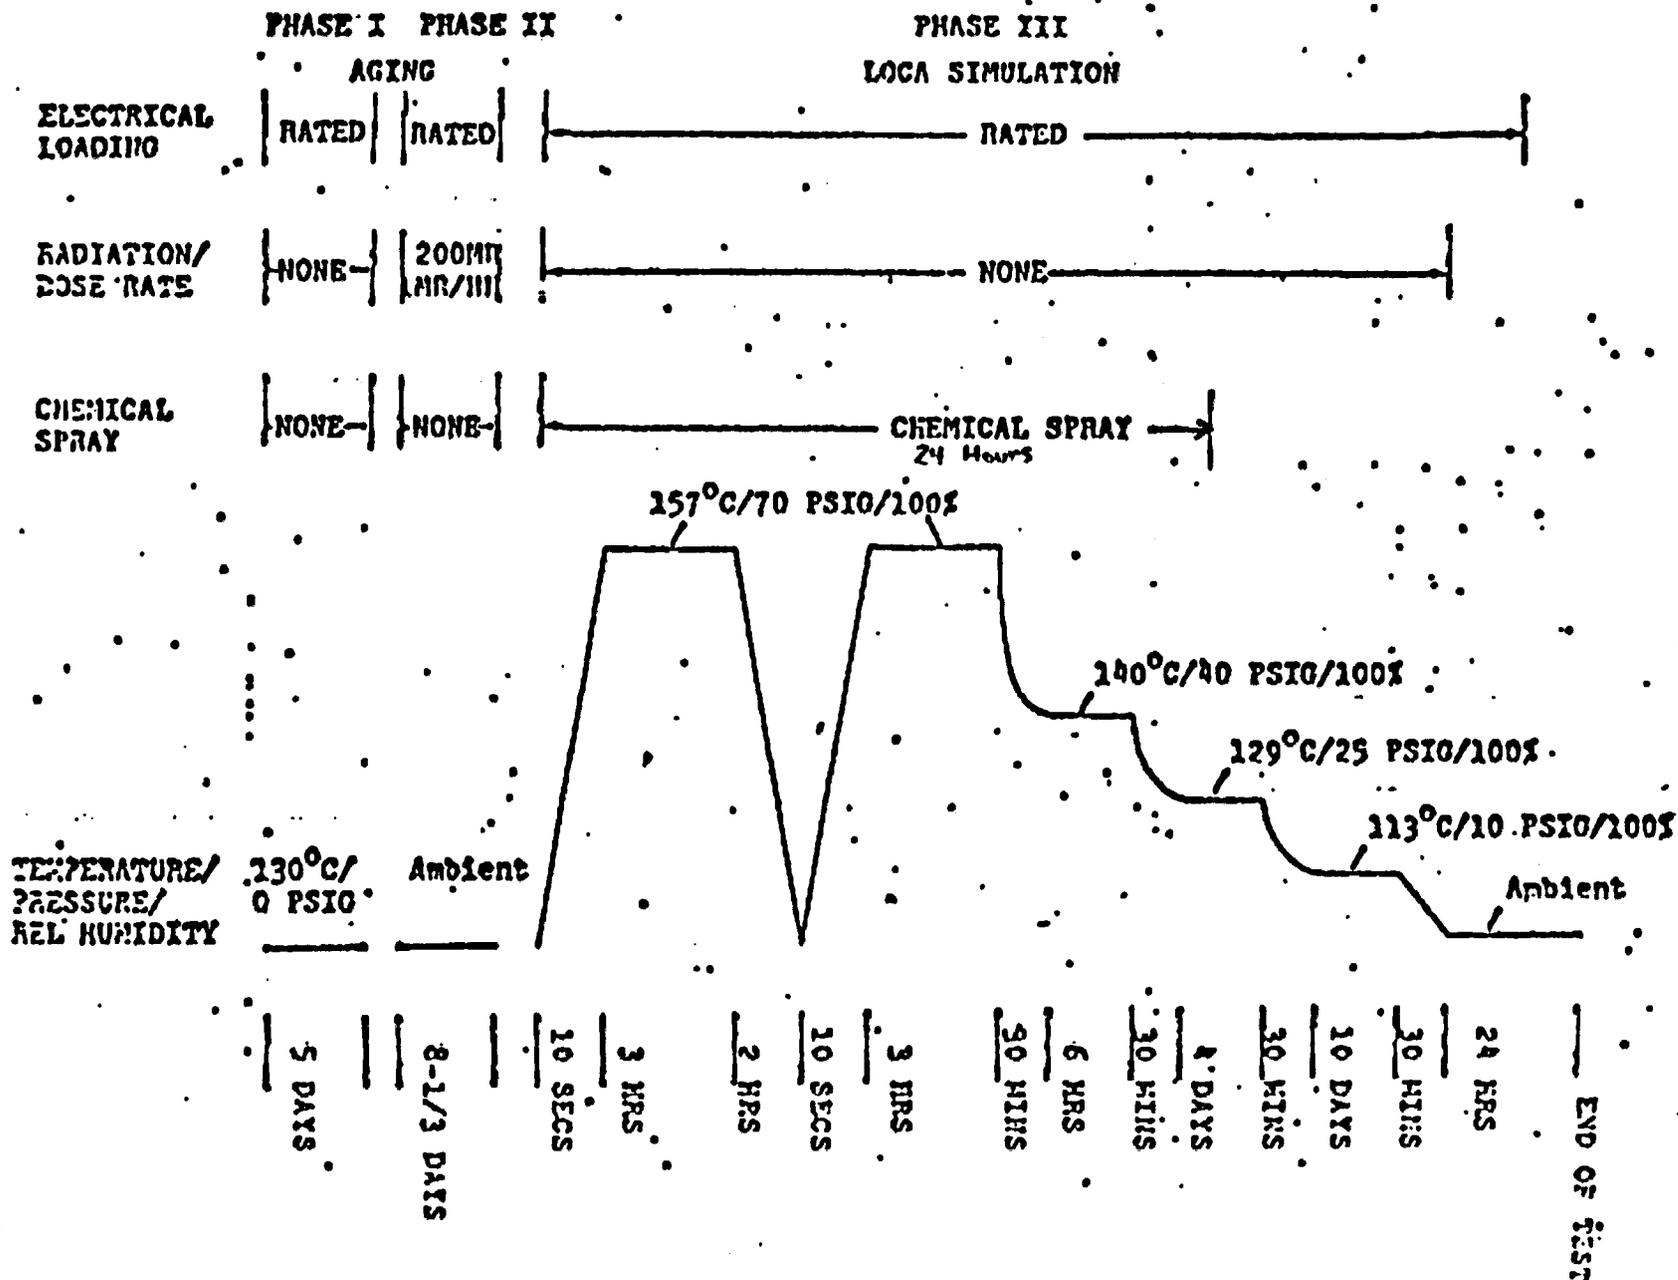
Figure 1

SEQUENTIAL TEST PROFILE

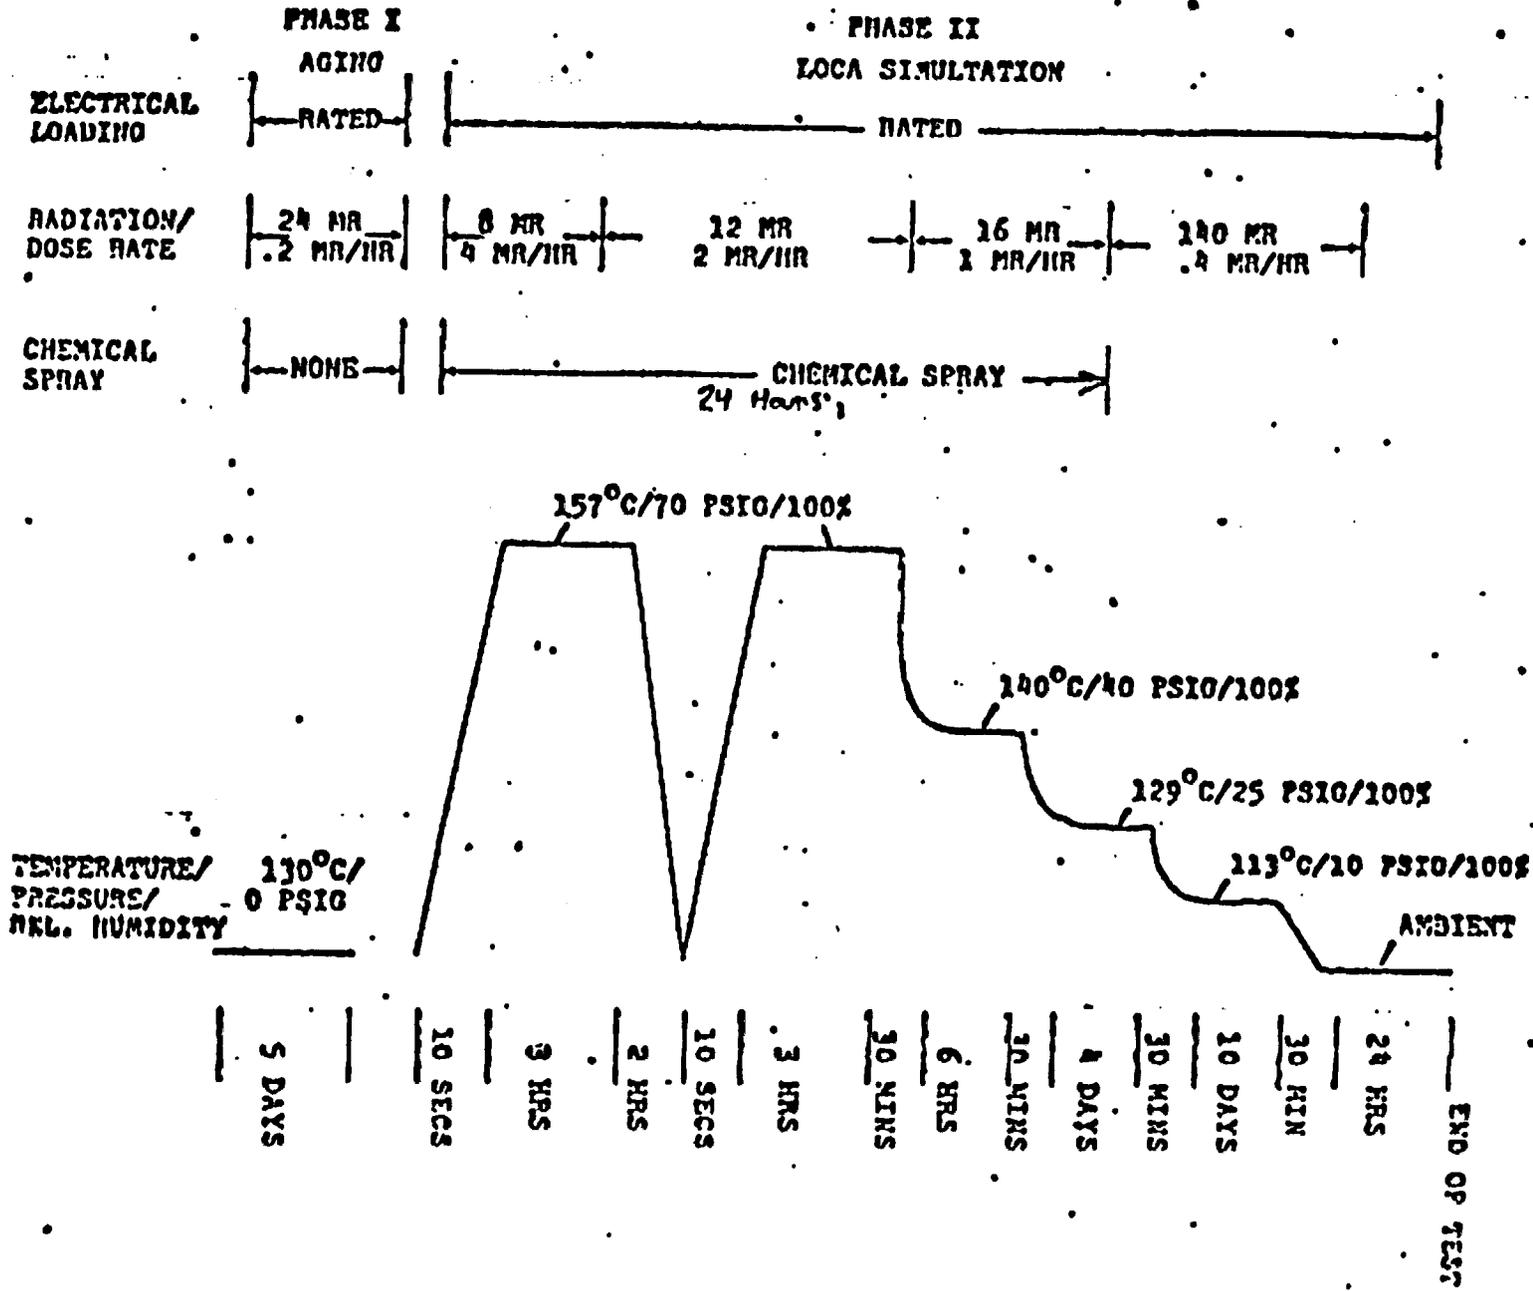
Figure 2

SIMULTANEOUS TEST PROFILE
