November 8, 1977
IE Bulletin 77-05

ELECTRICAL CONNECTOR ASSEMBLIES

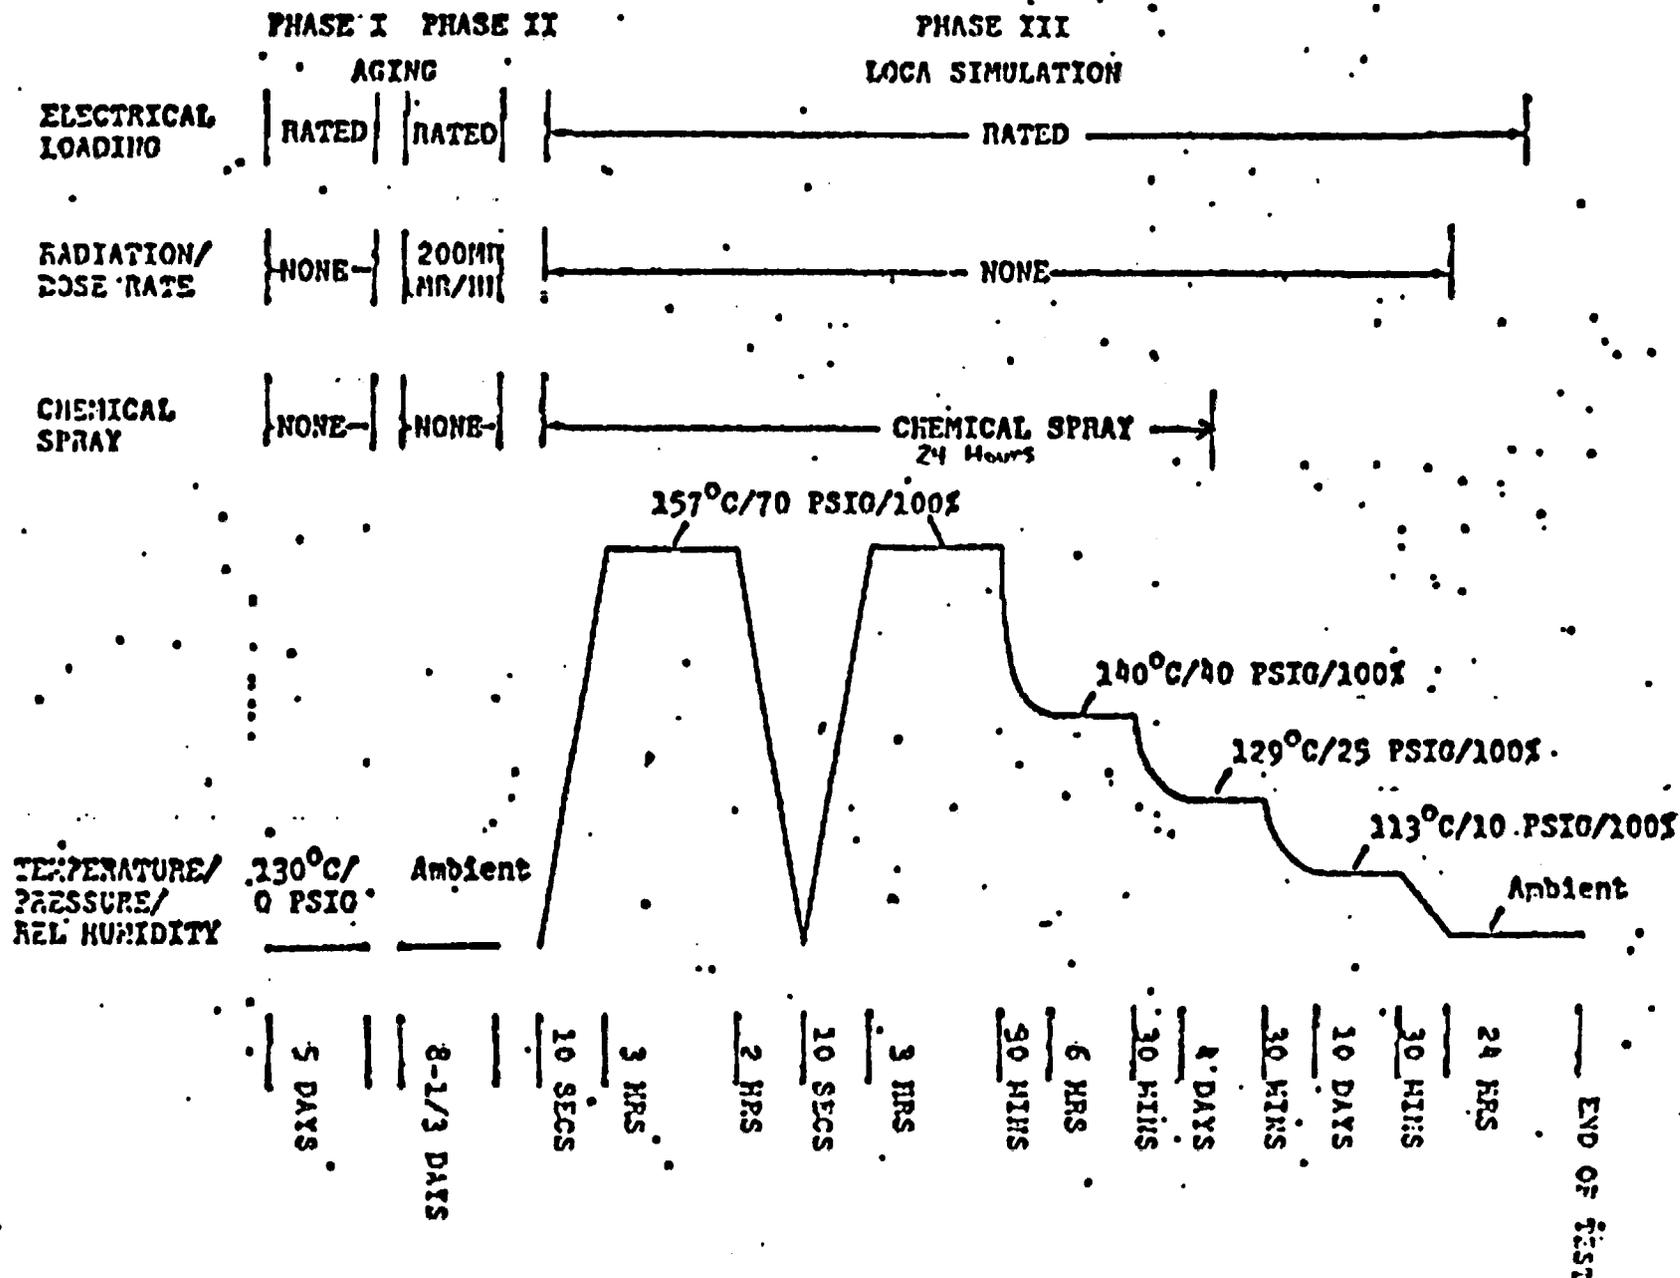
Figure 1

The three tests performed by Sandia were composed of two sequential and one simultaneous exposure to LOCA environments. In each case the equipment was exposed to radiation and thermal aging prior to operating under the simulated LOCA conditions. Figures 1 and 2 describe the test profiles for sequential and simultaneous tests respectively (Sandia tests were designed to study synergistic effects). Each of the tests satisfy the intent of IEEE 323-1974. The assemblies were electrically loaded to 20 amperes and 600 volts at the start of the tests. Insulation resistance and capacitance measurements were recorded during the tests to indicate damage.

SEQUENTIAL TEST PROFILE
