UNITED STATES
NUCLEAR REGULATORY COMMISSION
OFFICE OF NUCLEAR MATERIAL SAFETY AND SAFEGUARDS
WASHINGTON, D.C. 20555

February 21, 1992

NRC INFORMATION NOTICE 92-14: URANIUM OXIDE FIRES AT FUEL CYCLE FACILITIES

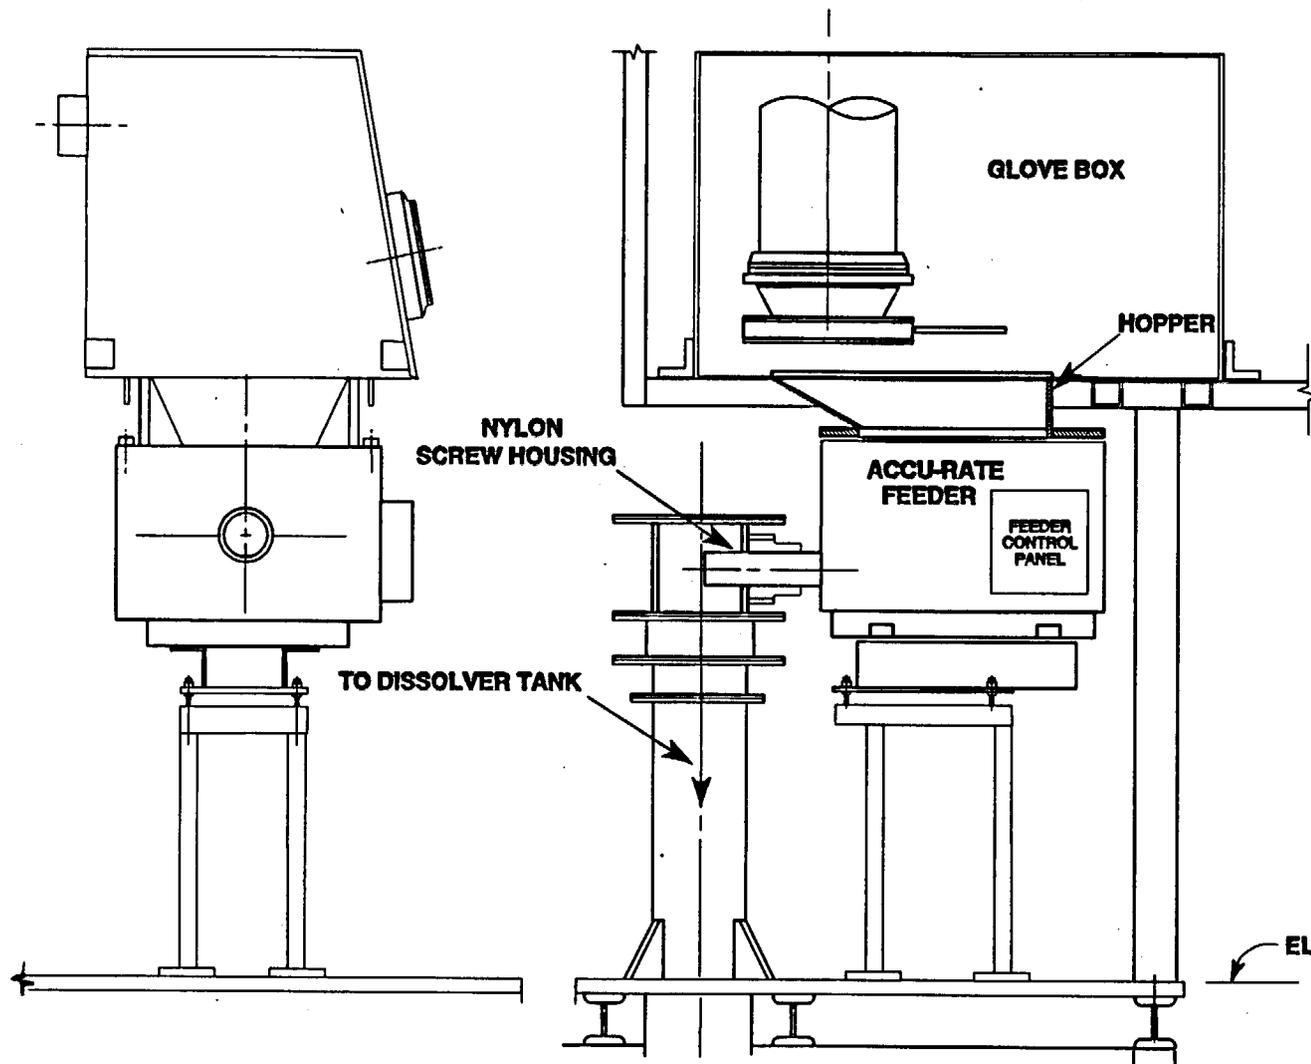
Figure 1. Uranium oxide feeder assembly.

In the most recent incident, a fire was discovered, in a fuel-fabrication facility, involving a hood, hopper, and feed-screw assembly, which was being used to transfer calciner drop powder (uranium oxide) to a nitric acid dissolver tank. (See Figure 1.) According to a report submitted by the licensee, an operator had started to feed a batch of the powder into the dissolver tank when the feed-screw of the Model 608 Accu-Rate feeder stopped. The operator reversed the screw and tapped on the tube-shaped nylon screw-housing, to free the screw. At this time, he observed smoke and sparks coming out of the equipment below the hood. A small crack in the vinyl side of the feeder hopper, apparently the result of contact with the hot powder inside the hopper, was also noticed. The operator and other employees then donned full-face respirators and removed approximately 18 kg of the powder, leaving about 2 kg of powder that could not be removed, in the screw-housing. Meanwhile, the small crack on the side of the hopper had developed into a baseball-sized hole, spilling some powder onto a platform below. The employees cleaned up the spilled powder. Assuming that the incipient fire had been extinguished, the employees then left the area.

All components of the hood and the Accu-Rate feeder that were made of combustible material (e.g., the nylon feed tube, vinyl hopper, rubber parts of a valve, and "Lexan" faces of the hood) were consumed by the fire. The primary stage of the high-efficiency particulate air (HEPA) filter for the room was loaded with soot, and the pre-filter was burnt. The fire alarm bells stopped ringing after about 3 minutes, as the alarm circuitry in the room was damaged by the fire. This confused some employees, who could not tell whether the emergency was over.

The cause of the fire is believed to be the oxidation of the calciner drop powder consisting principally of uranium dioxide (UO_2), but also including other unstable oxides of uranium, which could further oxidize at elevated temperatures. The friction of the feed-screw sliding on the powder or on the nylon tube, which could have been warped, could conceivably have contributed to heating the powder.

1. Limit the type of feed to stable powder whenever possible.
2. Store unstable powder in closed metal containers.
3. Replace the combustible components of powder-transfer lines and of equipment, such as the Accu-Rate feeder, with components made of noncombustible materials, as far as practicable.
4. Require an operator to be present when a process is under way, and improve visibility around vulnerable equipment.
5. Incorporate fire safety of vulnerable equipment in the operator training program, including use of portable fire extinguishers.
6. Implement a preventive maintenance program for vulnerable equipment. Periodic inspection may alert the operator to telltale signs of overheating.
