UNITED STATES
NUCLEAR REGULATORY COMMISSION
OFFICE OF NUCLEAR REACTOR REGULATION
WASHINGTON, D.C. 20555

January 6, 1992

NRC INFORMATION NOTICE 92-04: POTTER & BRUMFIELD MODEL MDR ROTARY RELAY
FAILURES

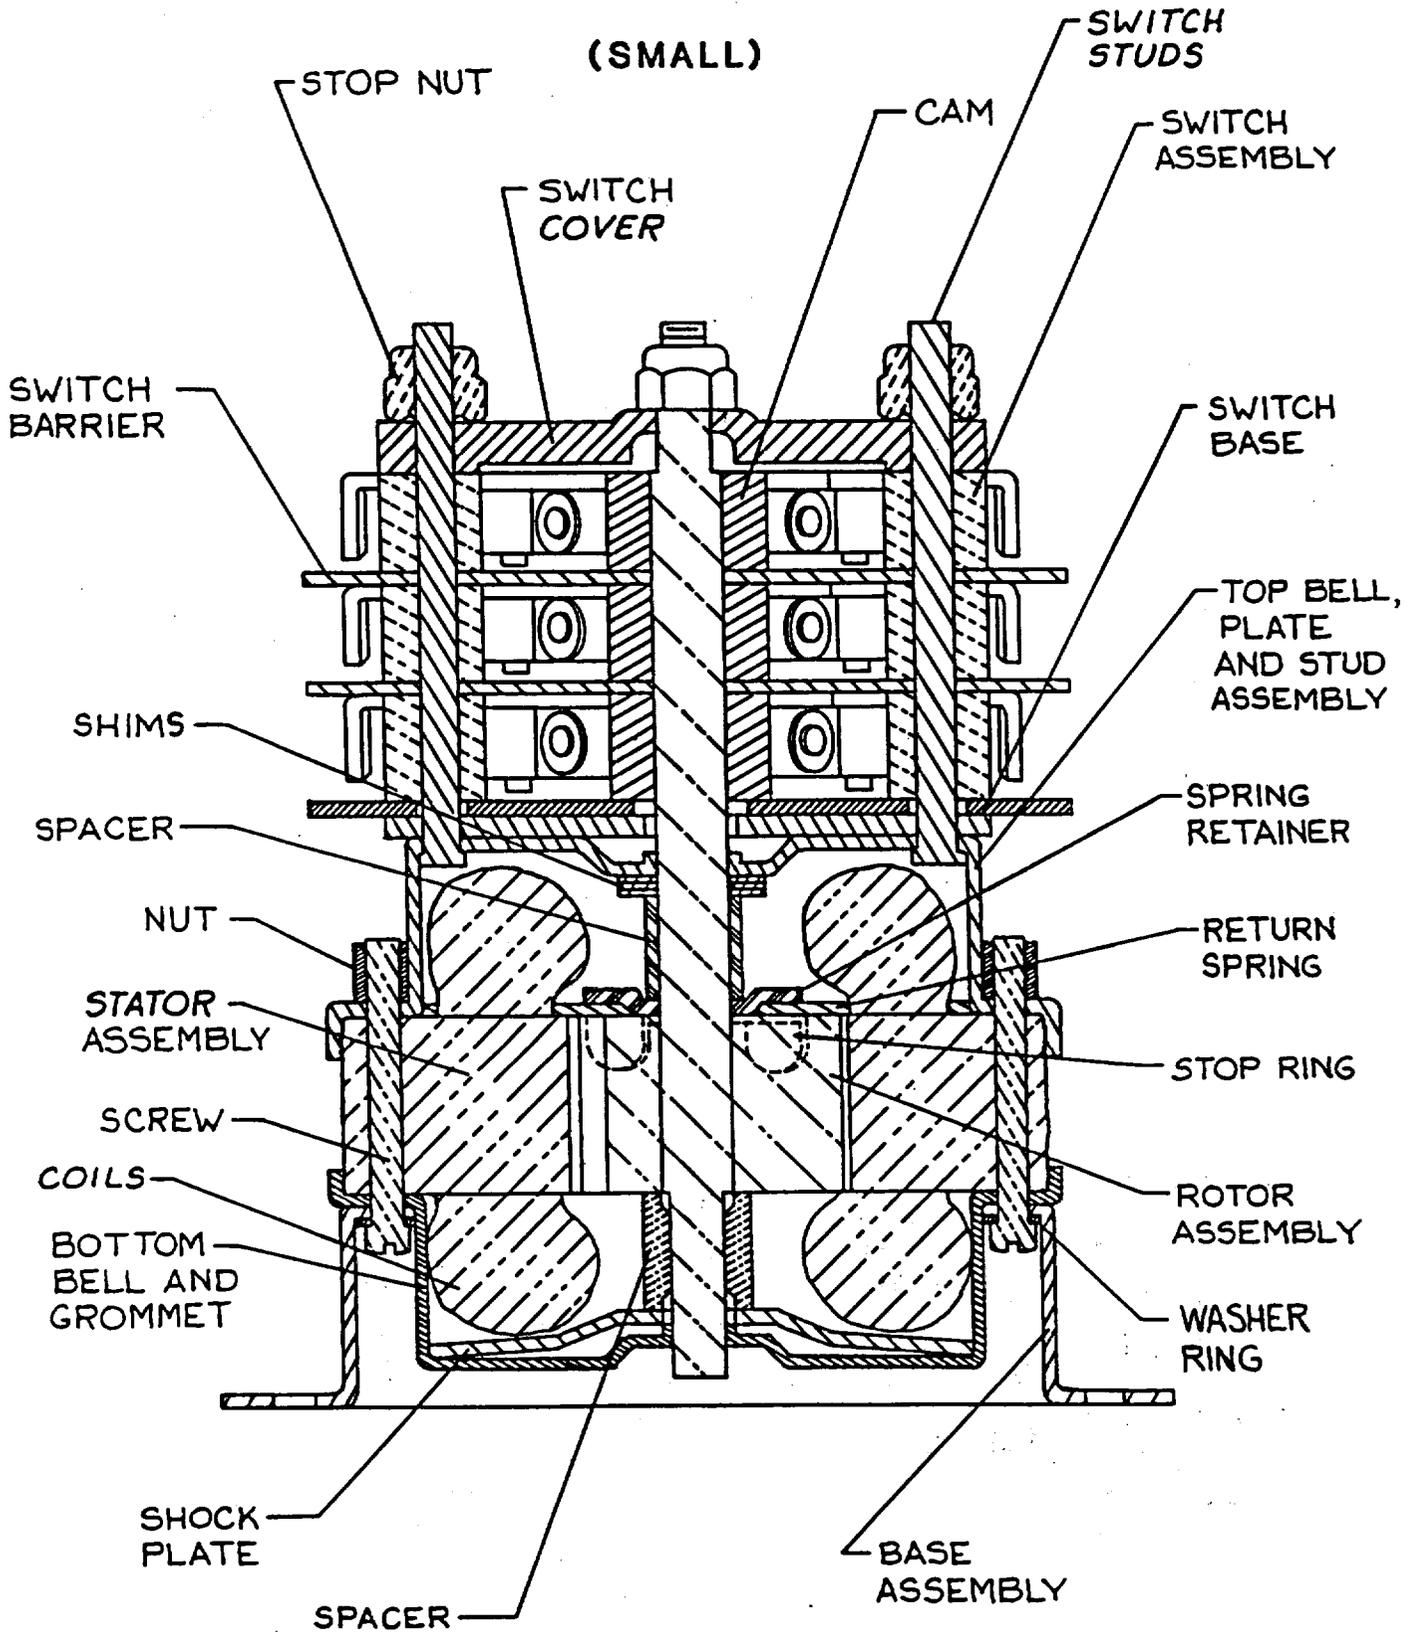
Figure 2

MDR NON-LATCHING RELAY (SMALL)
