SUBJECT: ENGINEERING EVALUATION OF THE H. B. ROBINSON REACTOR COOLANT SYSTEM LEAK ON JANUARY 29, 1981 (GENERIC LETTER NO. 81-22)

REACTOR COOLANT SYSTEM LEAK ON JANUARY 29, 1981

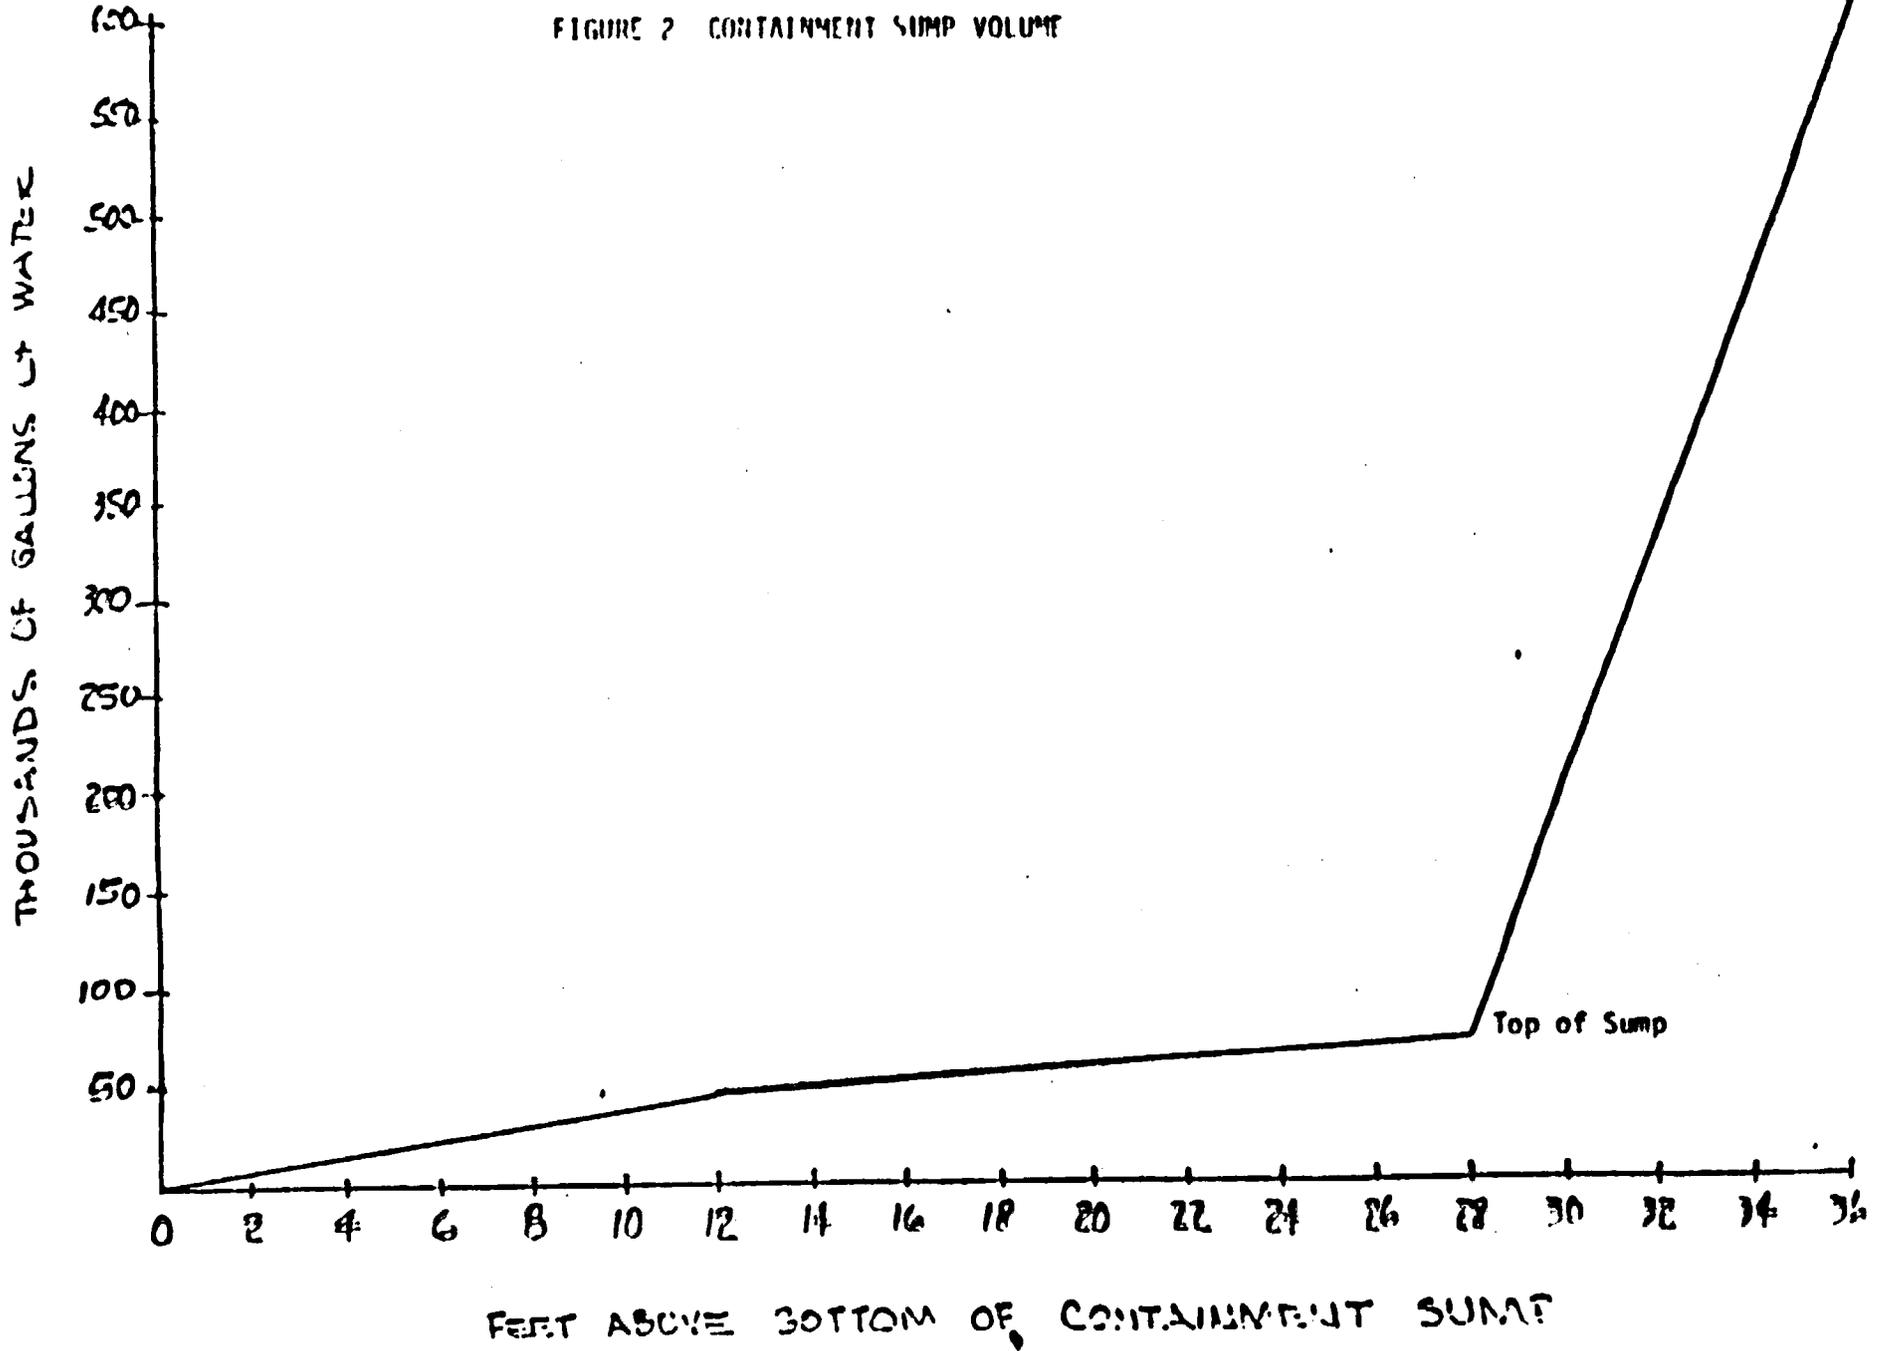
FIGURE 2 CONTAINMENT SUMP VOLUME

The licensee has acknowledged that the quantity of water that leaked into containment can only be approximated. The estimated 6,000 gallons (corresponding to approximately 15" in the sump) is a small fraction of the range of indication in a 65,000-gallon capacity sump (See Figure 2). A mass balance was not possible since neither charging flow nor volume control tank level are recorded. The major leak was after letdown flow had been reestablished between 0635 and 0650. This could account for approximately one half of the 3,000 gallons indicated at 0650. The drain valve could have also been leaking at an unknown reduced rate from the initial 5: until letdown was restored (approximately ten minutes). The ruptured bellows on the relief valve also contributed some amount to the inventory in the sump. These sources in combination with the inaccuracy of the sump measurements can lead to the conclusion that all the leak sources had been identified.
