UNITED STATES
NUCLEAR REGULATORY COMMISSION
WASHINGTON, D. C. 20555

SUBJECT: ENGINEERING EVALUATION OF THE H. B. ROBINSON REACTOR COOLANT SYSTEM LEAK ON JANUARY 29, 1981 (GENERIC LETTER NO. 81-22)

REACTOR COOLANT SYSTEM LEAK ON JANUARY 29, 1981

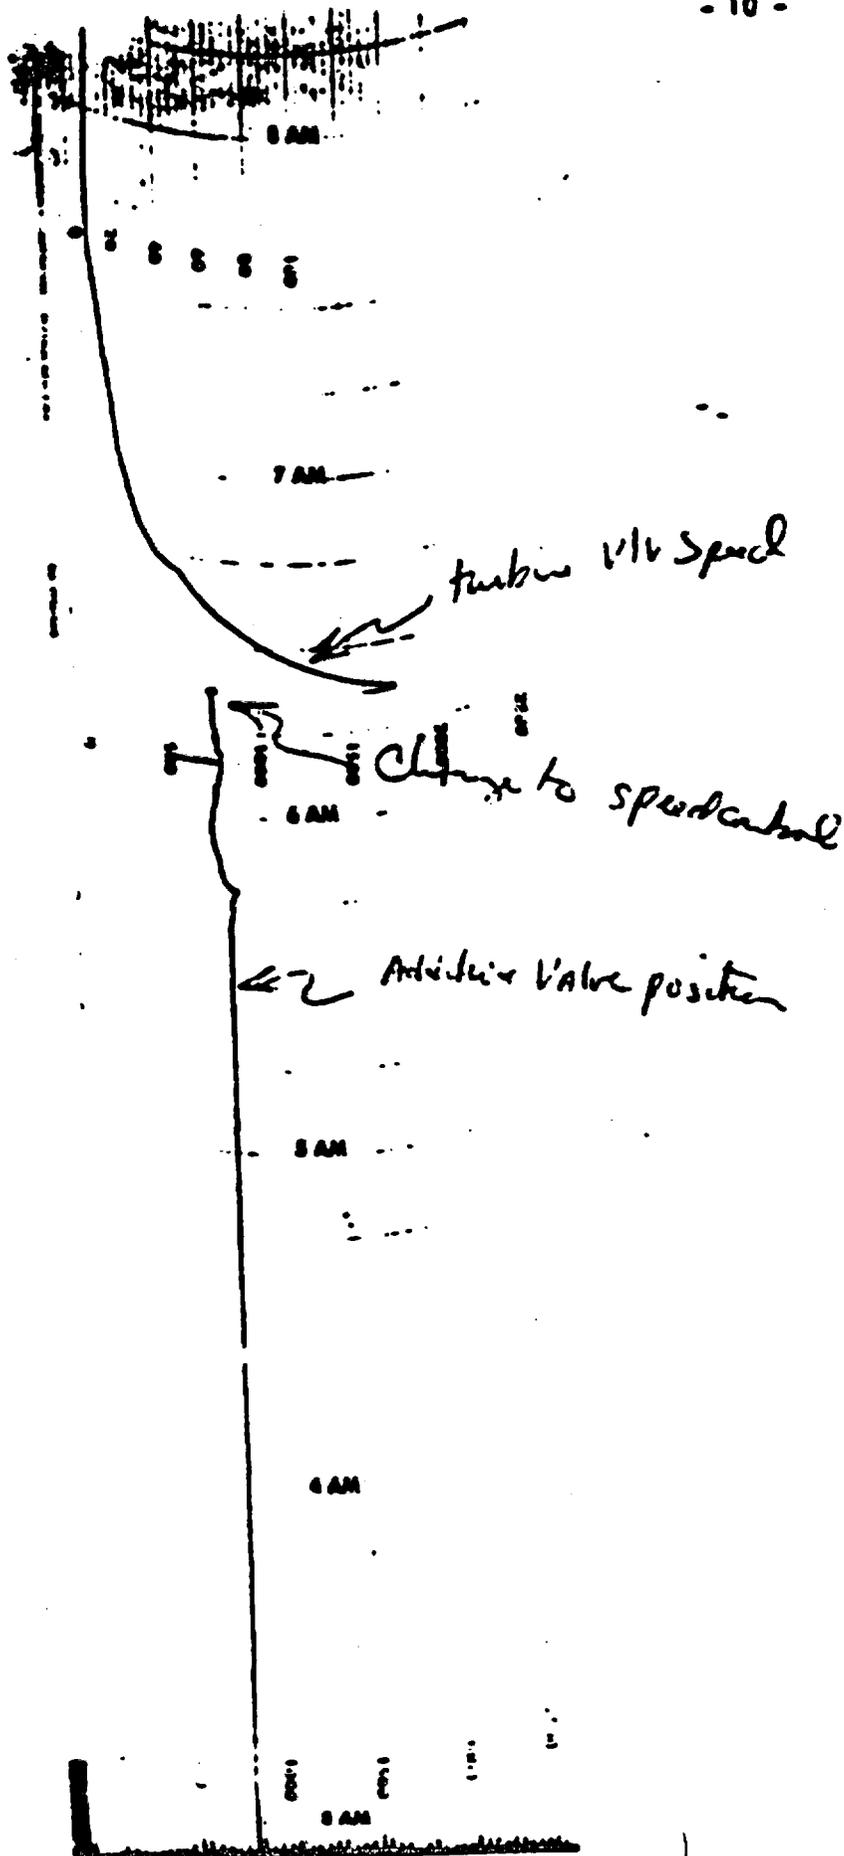
Turbine Governor Valve Position

The first safety injection actuation occurred on a "high steam line flow/low T_{avg} " signal. The licensee's review of the event indicated that the momentary spike-opening of the turbine governor valves caused the steam flow, in at least two steam lines, to exceed the steam flow set point for a period of about 25 msec. The combination of high steam flow in 2/3 steam lines and the existing low average temperature of the reactor coolant generated a main steam isolation valve (MSIV) closure signal and a SI actuation signal.
