UNITED STATES  
NUCLEAR REGULATORY COMMISSION  
OFFICE OF NUCLEAR MATERIAL SAFETY AND SAFEGUARDS  
WASHINGTON, D.C. 20555

September 4, 1990

NRC INFORMATION NOTICE NO. 90-56: INADVERTENT SHIPMENT OF A RADIOACTIVE SOURCE  
IN A CONTAINER THOUGHT TO BE EMPTY

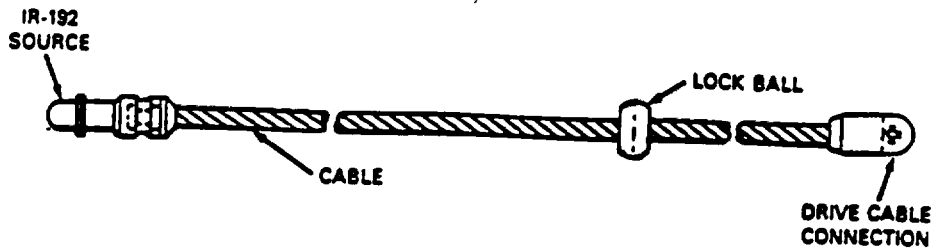
Typical Source Holder Assembly

Most radiographic operations involve projecting a radioactive source out of its shielded position within a radiography device into a pre-positioned tube. In order to facilitate handling, the source capsules are attached to one end of a short piece of cable with a connector attached to the other end. This piece of equipment is described as a "source assembly." An example of a typical source assembly is shown in Attachment 2. A drawing of Amersham's Model 500-SU source changer is also shown.

Apparently, Korean users were using source changers as storage devices for decaying depleted sources, before disposal. To store a source in a Model 500-SU source changer, the source capsule would be cut from the assembly, dropped into the source tube, and would fall to the shielded position. After the source decayed sufficiently, the source changer would be used to move the source to a disposal area. The IIT was able to verify that KIT used the source changer involved in this incident in such a manner, and that KIT failed to remove the source before returning the source changer. Amersham reported that it had received source changers containing severed source capsules (the source remained in the shielded area) on two previous occasions, and that from 1985 to 1989, at least nine source changers were returned from Korea with contaminated source tubes.

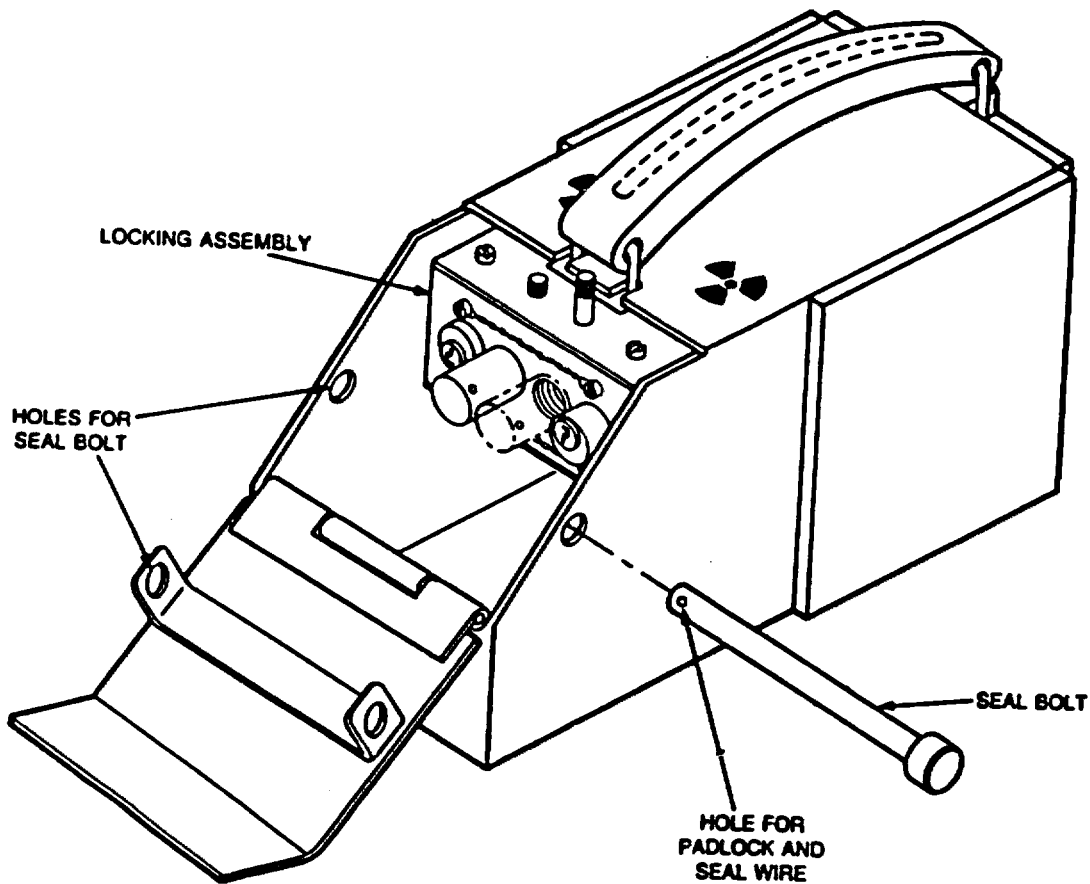
External View of Model 500-SU Source Changer

The Model 500-SU operations manual also informed the user to "... assure that there is no source in the container." However, the manual did not list specific procedures to make this determination. Ordinarily, a visual examination would verify the presence (or absence) of a source assembly, as the connector end of the assembly would be evident. However, a visual examination would not have revealed the source in this incident because the source was cut from the source assembly. A surface radiation survey could also be used to detect a source in a changer. However, NRC determined that even for a changer containing a 3-curie source, the surface readings would be indistinguishable from readings obtained from the DU shield of an empty source changer. Amersham estimated that the minimum source activity detectable through the DU shielding of the Model 500-SU is 4 curies.

3. Licensees returning shielded packages that do not contain radioactive material, especially those packages that incorporate DU shields, are cautioned that complete and accurate radiation surveys must be performed, and that a physical probe of the package may be necessary to verify that the package does not contain radioactive materials.

4. Manufacturers who receive returned packages should ensure that they provide complete instructions to customers for properly verifying that packages are empty as well as for meeting restrictions on surface radiation levels. Licensees that return such packages should ensure that these procedures are strictly followed.
