UNITED STATES
NUCLEAR REGULATORY COMMISSION
OFFICE OF INSPECTION AND ENFORCEMENT
WASHINGTON, D.C. 20555

July 31, 1980

IE Bulletin No. 80-20

FAILURES OF WESTINGHOUSE TYPE W-2 SPRING RETURN TO NEUTRAL CONTROL SWITCHES

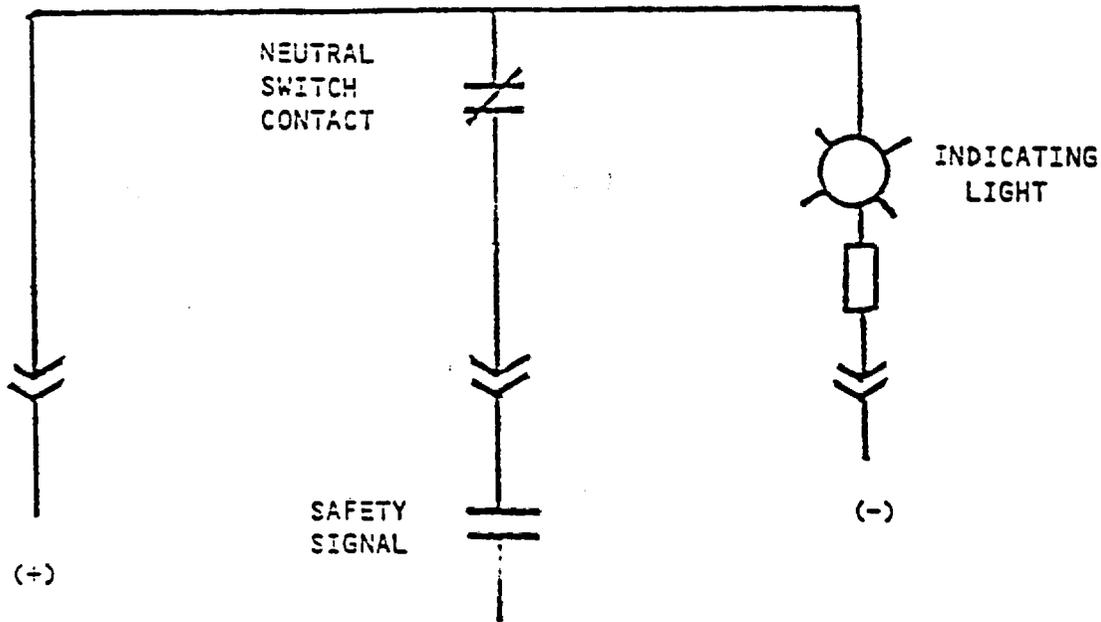
EXISTING INDICATING LIGHT CIRCUIT (TYPICAL)

Depending on how the indicating light circuit is wired, loss of continuity thru the neutral position contact of a W-2 switch could remain undetected until the equipment associated with the switch were called upon to operate. Since such a failure would be equivalent to by-passing the system associated with the switch, consideration should be given to rewiring the switches used in safety-related applications as shown in Figure 1. Such rewiring would provide an acceptable means for detecting contact failure, provided the indicating light is in the control room and readily visible by the operator. If the indicating light is not so located, consideration should be given to annunciating the neutral position contact failures at the control room to alert the operator of the inoperable status of a safety-related system. In addition, consideration should be given to adding redundant contacts to the W-2 switches or to replacing the W-2 switches with others having a more positive contact wiping action.

A review of this matter by Westinghouse led to the issuance of NSD Technical Bulletin No. NSD-TB-80-9 to the utility owners of all Westinghouse operating plants. The recommendations contained in the Westinghouse technical bulletin include: (i) testing the neutral position contacts of the subject W-2 switches for continuity, and (ii) rewiring of the indicating light circuit to permit the early detection of a neutral contact failure as shown in Figure 1.

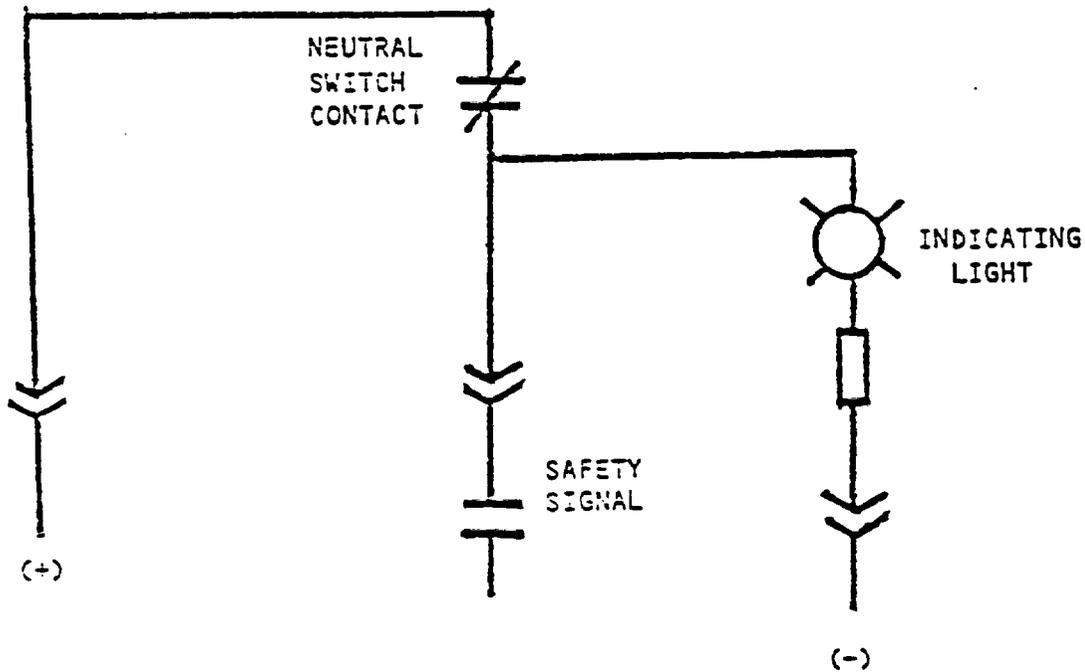
PROPOSED REWIRING OF INDICATING LIGHT CIRCUIT (TYPICAL)

REWIRING OF INDICATING LIGHT CIRCUIT OF W-2 SWITCHES
AS RECOMMENDED BY WESTINGHOUSE TECHNICAL BULLETIN NSD-TB-80-9

3. Licensees of operating plants and holders of construction permits shall describe the longer term corrective measures planned and the date by which such measures will be implemented by actual installation or by design change, as appropriate. As a minimum, the longer term corrective measures should include rewiring the indicating light as shown in Figure 1 provided the light is readily visible to the control room operator. If not, failures of the neutral position contacts should be annunciated in the control room.
