SSINS No: 6820
Accession No.:
8006190050
IEB 80-22

September 11, 1980

IE Bulletin No. 80-22: AUTOMATION INDUSTRIES, MODEL 200-520-008 SEALED-SOURCE CONNECTORS

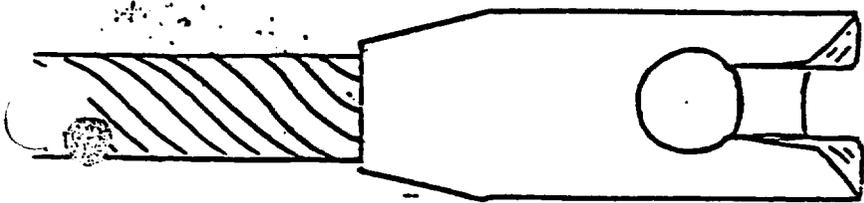
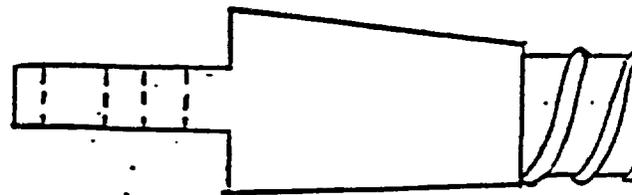
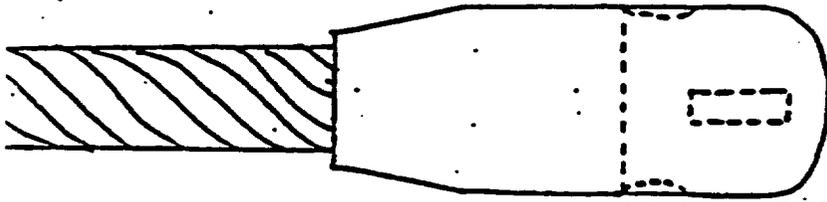
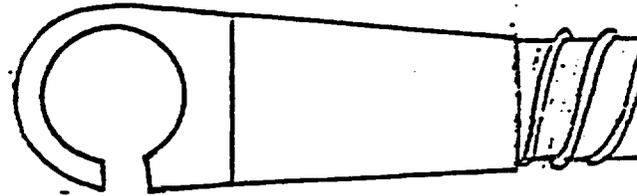
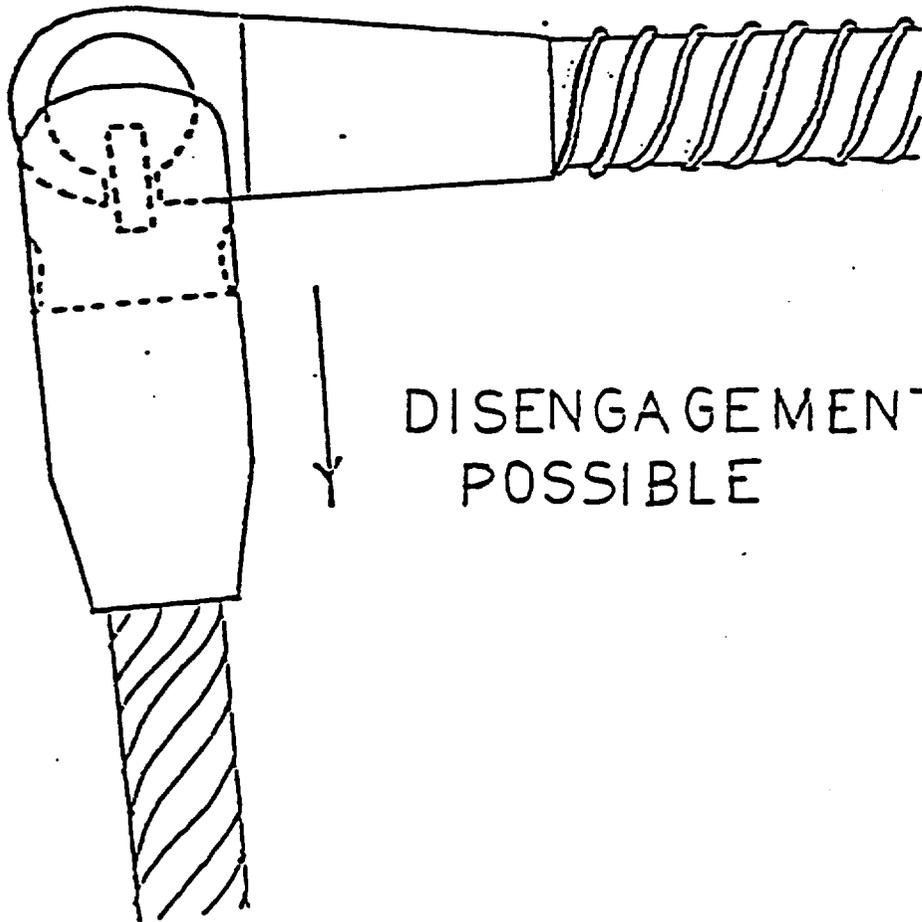
FIGURE 1

An accident recently occurred in the State of California (an Agreement State) that resulted in several serious overexposures (see enclosed Circular 79-16). The accident involved the use of an Automation Industries (AI) Model 200-520-008 source pigtail to drive cable connection. The connector is identified by the manufacturer as its "quick disconnect" type of connector and is used with several models of cobalt-60 and iridium-192 source assemblies distributed by the manufacturer. The connection is a simple hook and eye connection (see Fig. 1) that will permit separation of the eye from the hook when they are oriented at right angles to each other without any further positive action. As a result of the design, a disconnection may occur any time the source assembly is cranked out of the exposure device without the guide tube being attached. Since the Automation Industries Model 200-520-008 sealed-source assembly is authorized to contain up to 120 curies of iridium-192, a source disconnection creates a potential for a serious exposure.

The removal from service of the "quick disconnect" type of connector will require that those drive cables having the matching open hook connector be modified.

DISENGAGEMENT
POSSIBLE

- (1) Determine the number of AI Model 200-520-008 and other assemblies in your inventory that have the "quick disconnect" connector and establish a disposal schedule. Your schedule for iridium-192 sources should be no longer than your usual exchange schedule for diminished activity sources. Your exchange schedule for connector modification for cobalt-60 sources should be accomplished as soon as is conveniently possible. However, you should complete your disposal or modification by September 1, 1981.

- (2) In the interim, a warning mark or tag should be placed on each radiographic device in which AI "quick disconnect" type assemblies are being used.

- (4) Review and modify operating, maintenance, inspection and handling procedures as appropriate to preclude this type of accidental disconnect.
