UNITED STATES
NUCLEAR REGULATORY COMMISSION
OFFICE OF NUCLEAR REACTOR REGULATION
WASHINGTON, D.C. 20555

NRC INFORMATION NOTICE 92-68: POTENTIALLY SUBSTANDARD SLIP-ON, WELDING NECK,
AND BLIND FLANGES

FAILURE ANALYSIS OF A SLIP-ON FLANGE

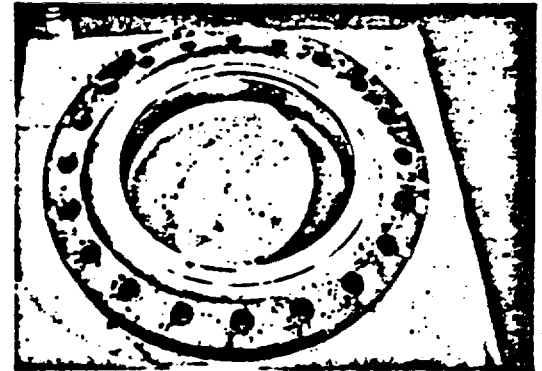
The installation of a 14" slip-on flange in a pipeline was recently witnessed by Al Justin, chief inspector for the State of Minnesota. The flange originally had a 14-3/4" inside diameter, which was reduced by welding a 3/4" ring and machine welding. The ring, however, separated from the flange, giving the appearance of a crack. The flange is reported to have been manufactured in the People's Republic of China.

Figure 1: Gasket side of flange.

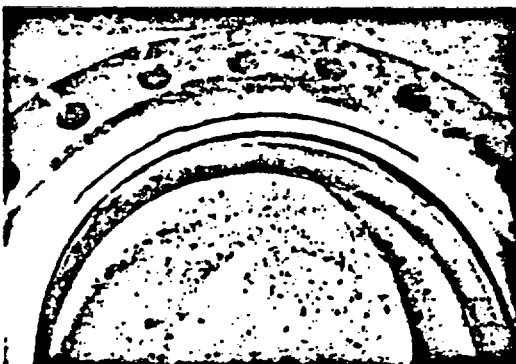
The subject slip-on flange is not an integral forging or a casting. It has been fabricated by welding and machining a ring insert within a large diameter flange. The flange "cracked" because the welds between the flange and the insert were inadequate to withstand the bolting pressures.

Figure 2: A close-up of the gasket side showing the "crack" indication.
