UNITED STATES  
NUCLEAR REGULATORY COMMISSION  
OFFICE OF NUCLEAR REACTOR REGULATION  
WASHINGTON, D.C. 20555

NRC INFORMATION NOTICE 92-68: POTENTIALLY SUBSTANDARD SLIP-ON, WELDING NECK,  
AND BLIND FLANGES

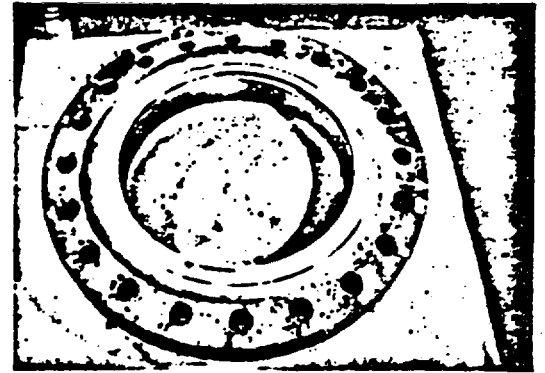
*The installation of a 14" slip-on flange in a pipeline was recently witnessed by Al Justin, chief inspector for the State of Minnesota. The flange originally had a 14-3/4" inside diameter, which was reduced by welding a 3/4" ring and machine welding. The ring, however, separated from the flange, giving the appearance of a crack. The flange is reported to have been manufactured in the People's Republic of China.*

Figure 1: Gasket side of flange.

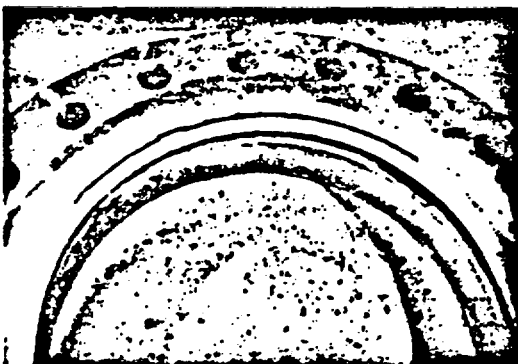
The subject slip-on flange is not an integral forging or a casting. It has been fabricated by welding and machining a ring insert within a large diameter flange. The flange "cracked" because the welds between the flange and the insert were inadequate to withstand the bolting pressures.

Figure 2: A close-up of the gasket side showing the "crack" indication.

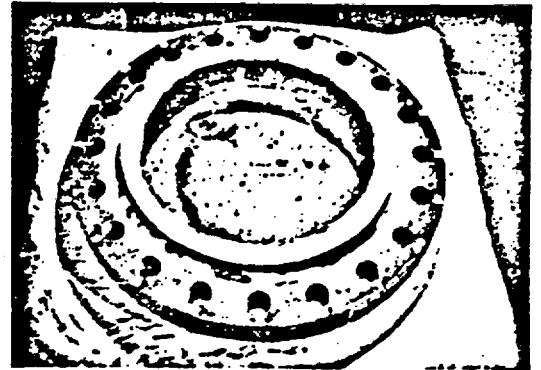
Figure 3: Pipe side of flange.

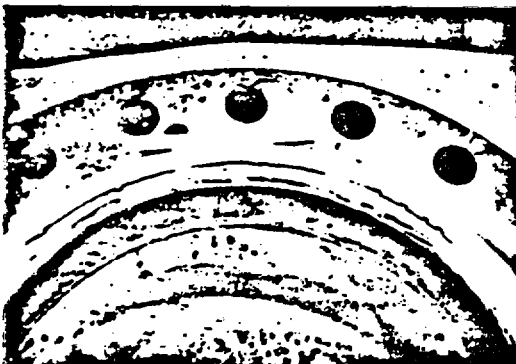
First, the flange was UT tested from the OD. The indications were rather puzzling because the reflections were consistently from a cylindrical surface about 3.75" from the OD. A dry magnetic particle examination confirmed that the cracks extended more or less continuously in a circular path. The NDT examination was concluded with dye penetrant tests as shown in the photographs in Figures 1 through 4. It was quite evident that the flange was not a single piece component. A large inside diameter (ID) flange was reduced to a 14" ID unit by welding a 0.75" thick ring. The welding faces had been machined.

Figure 4: A close-up of the pipe side showing the "crack".

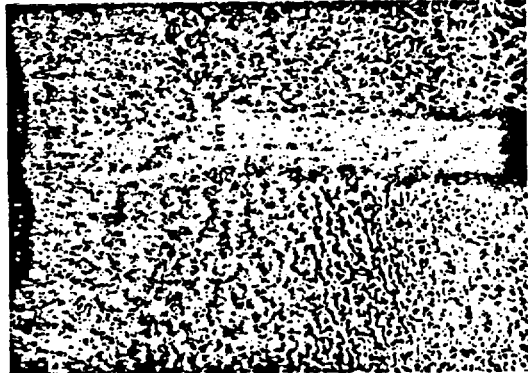
Main Flange:	72,69,70 HRB	Ave =
	70 HRB	
Insert:	76,78,80 HRB	Ave =
	78 HRB

Figure 6: Photo showing general microstructure in the main flange (lower half), insert (upper half) and weld metal (left edge). 25X, Nital etch.
