UNITED STATES
NUCLEAR REGULATORY COMMISSION
OFFICE OF NUCLEAR REACTOR REGULATION
WASHINGTON, D.C. 20555

July 2, 1992

NRC INFORMATION NOTICE 92-50: CRACKING OF VALVES IN THE CONDENSATE RETURN
LINES OF A BWR EMERGENCY CONDENSER SYSTEM

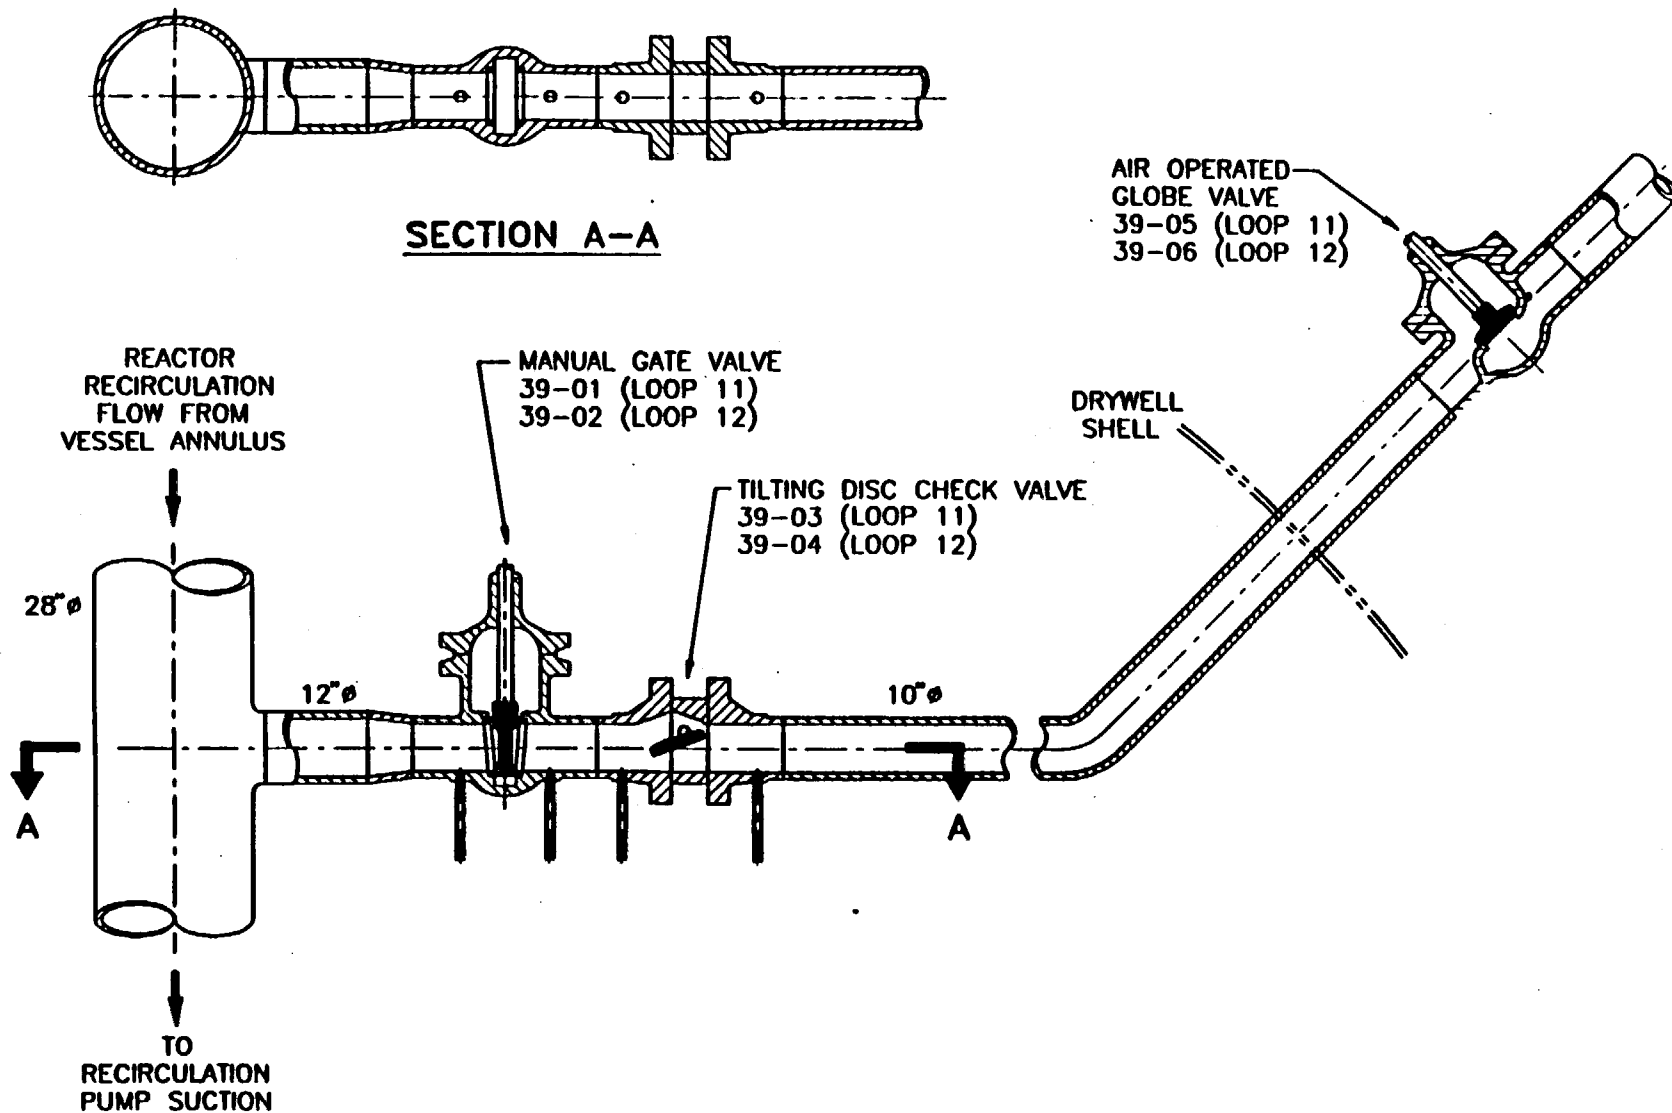
FIGURE 1
NMP-1 EMERGENCY CONDENSER SYSTEM
CONDENSATE RETURN LINE
CONFIGURATION INSIDE DRYWELL

The emergency condenser system has two independent loops (loops 11 and 12). Figure 1 shows the configuration of the condensate return line in loops 11 and 12. In the condensate return line, a manual gate valve is connected downstream of a tilting disc check valve. At each of those two valves, two 1-inch drain lines are connected to the bottom part of the valve body with one drain line at the upstream side and the other one at the downstream side of the valve. The valve bodies are made of CF8M cast stainless steel.

While investigating the leakage at the manual gate valve 39-02, the licensee removed the internal components of the adjacent check valve to perform a visual test (VT), a radiographic test (RT), and an ultrasonic test (UT). The licensee visually observed cracks on the inside surfaces at both valves in loop 12. At gate valve 39-02, the licensee found cracks near each of the two drain holes. At check valve 39-04, the licensee found cracks near a downstream drain hole and found evidence of cracking in the threads of the

upstream drain. These cracks were further examined radiographically and ultrasonically. The licensee found four cracks including a throughwall crack near the drain hole upstream of gate valve 39-02. The licensee reported the throughwall crack to be about 3.5 inches long and oriented radially outward from the hole. The other three cracks were all reported to be within 0.15 to 0.35 inch of passing through the wall (1.25 inch wall thickness). The licensee found two cracks in the drain hole area downstream of the gate valve (39-02), which is the unisolable side of the valve body. The licensee reported the deepest crack to be about 1 inch long and within 0.15 inch of passing through the wall. The licensee found four cracks near the drain hole downstream of check valve 39-04 with the deepest reported to be within 0.1 inch of passing through the wall. The licensee visually observed one small indication on the seat ring in manual gate valve 39-02. The licensee also examined valves 39-01 and 39-03 in the condensate return line for loop 11 of the emergency condenser system and found two cracks near the drain hole upstream of manual gate valve 39-01. The largest crack was reported to be about 1.25 inch long and 1 inch deep. The licensee reported the cracking of the valve body in loop 11 to be less severe than that in loop 12. The licensee observed cracking indications on the inside surface of a butt weld that joins the gate valve to the check valve but did not confirm these indications by the radiographic examination. The licensee ultrasonically examined selected piping welds inboard of the condensate return isolation valves and found no indications.

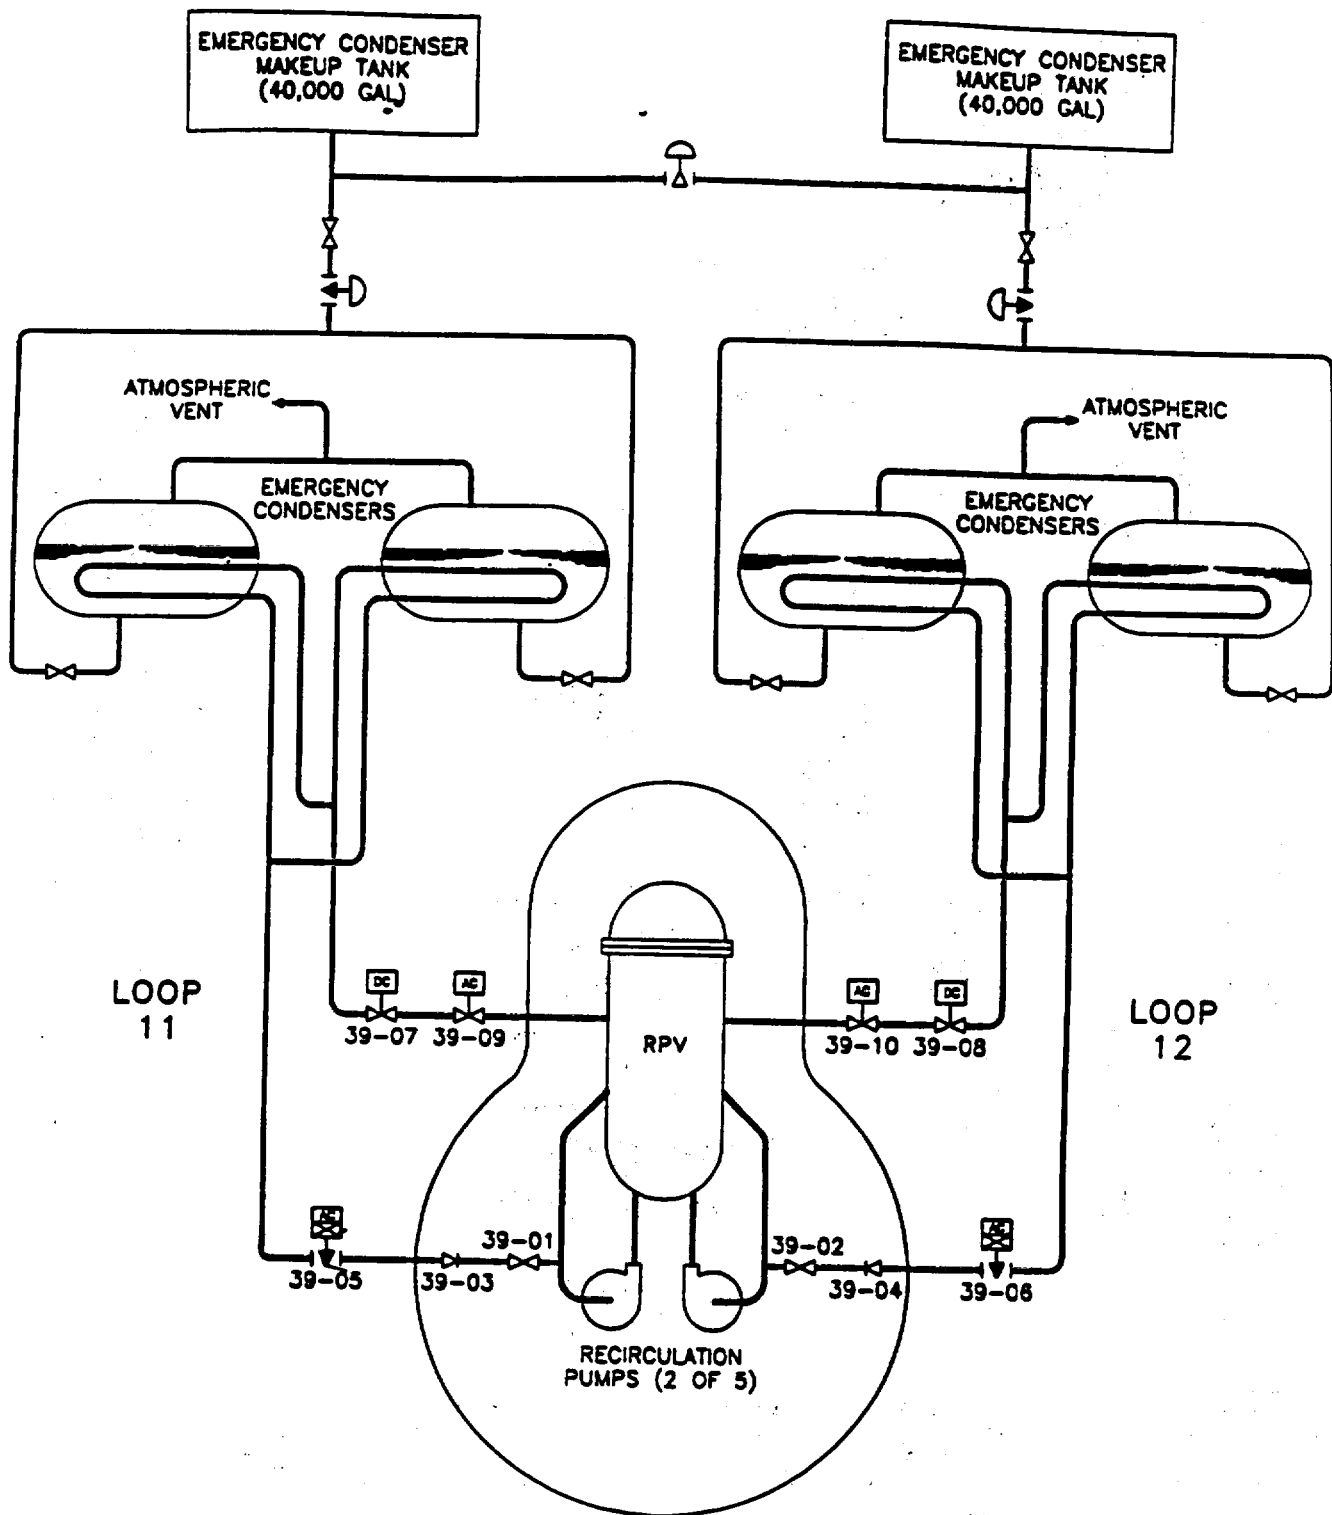
**FIGURE 2 NINE MILE POINT UNIT ONE
EMERGENCY CONDENSER SYSTEM
SIMPLIFIED DIAGRAM**

The emergency condensate system at Nine Mile Point, Unit 1, which is connected directly to the reactor coolant system, operates by natural circulation and acts as a backup for the main condenser to remove the reactor decay heat following a reactor isolation. The emergency condenser system at Nine Mile Point, Unit 1, as shown in Figure 2, has two loops (loop 11 and loop 12) with two condensers in each loop. During normal plant operation, the condensate return isolation valves (39-05 and 39-06) are closed, and the steam isolation valves (39-07, 08, 09, and 10) are open in each loop. As shown in Figure 1, two valves, a manual gate valve and a tilting disc check valve, are located in horizontal sections of the condensate return line. The horizontal sections are connected to the suction side of the recirculation piping system. The manual gate valves are maintenance valves and are open during normal operation.
