UNITED STATES
NUCLEAR REGULATORY COMMISSION
OFFICE OF INSPECTION AND ENFORCEMENT
WASHINGTON, D.C. 20555

IE Bulletin No. 79-09

FAILURES OF GE TYPE AK-2 CIRCUIT BREAKER IN SAFETY RELATED SYSTEMS

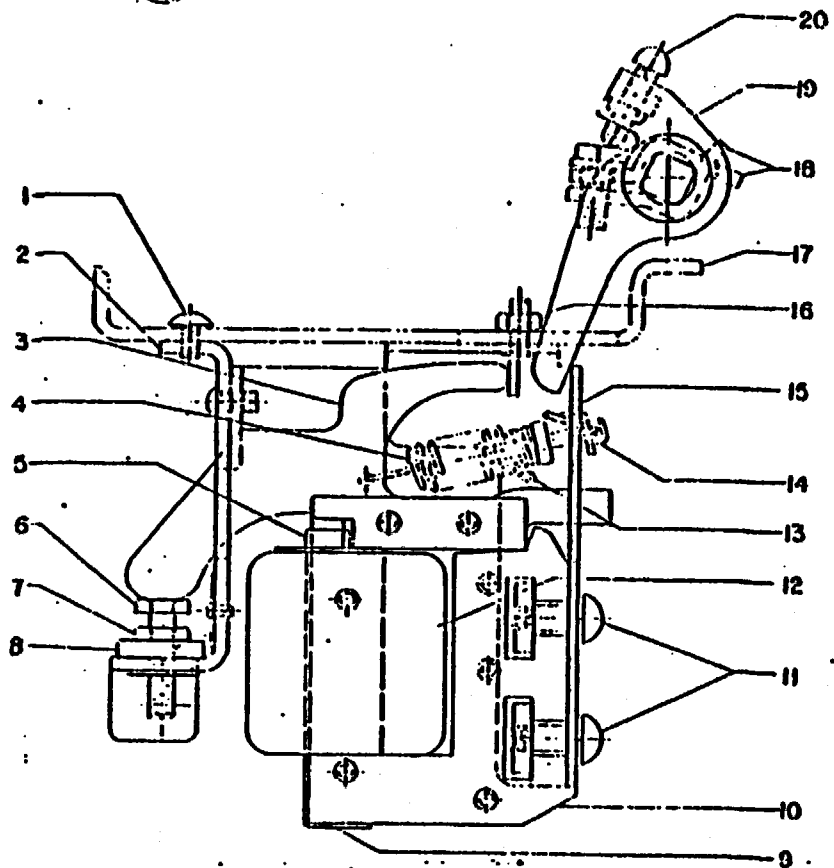
AK-2-15 and AK-2/3-25 Undervoltage Tripping Device

The causes for failure were attributed to either binding within the linkage mechanism of the undervoltage (UV) trip device and trip shaft assembly or out-of-adjustment conditions in the same linkage mechanism. Babcock and Wilcox (B&W) and GE determined that the binding and out-of-adjustment resulted from inadequate preventive maintenance programs

1. Check the undervoltage trip device to assure there is not excessive clearance between the armature and the rivet and that there are no binds as the armature moves through its travel when manually operated. If excessive clearance or binding exists, it should be adjusted by loosening screws (11) and moving the magnet (10) up or down as necessary to obtain the proper freedom of the armature (3) with respect to its pivot on magnet (10) and the guide provided by pivot (13).

To adjust the pick-up of the instantaneous undervoltage trip device, remove the Locking Wire (15) and turn the adjusting screw (14) clockwise to raise the pick-up to the desired setting. A suitable voltmeter and adjustable voltage source should be connected to the undervoltage device coil leads at the terminal board for stationary breakers or the secondary disconnects for drawout type breakers. On AC devices, the pick-up voltage should be read immediately before the armature closes its air gap. After the pick-up is adjusted, locking wire (15) should be installed.

4. The torque required on the trip shaft to trip a closed breaker should not exceed 1.5 pounds-inches. This may be checked with the equivalent of an open-end wrench fabricated from a piece of sheet metal to which a spring scale can be fastened approximately 1 inch from the trip shaft centerline. Where the torque required to trip the breaker exceeds 1.5 pound-inches, hardened grease in the trip shaft bearings and/or latch bearing may be suspected or dirt may have accumulated on the trip latch surface. Hardened grease must be replaced or revitalized with a suitable solvent such as WD-40 or CRC 5-56 or the bearings must be replaced. Excessive grease and dirt should be removed from the trip latch surface.

5. The adjustment between the undervoltage trip device and the trip paddle on the trip shaft should be checked to assure the required positive trip is maintained (positive trip exists when approximately 1/32 inch additional travel of the armature occurs after the undervoltage device trips the breaker.) This adjustment is made with adjusting screw (20).
