UNITED STATES
NUCLEAR REGULATORY COMMISSION
OFFICE OF INSPECTION AND ENFORCEMENT
WASHINGTON, D.C. 20555

IE Bulletin No. 79-09

FAILURES OF GE TYPE AK-2 CIRCUIT BREAKER IN SAFETY RELATED SYSTEMS

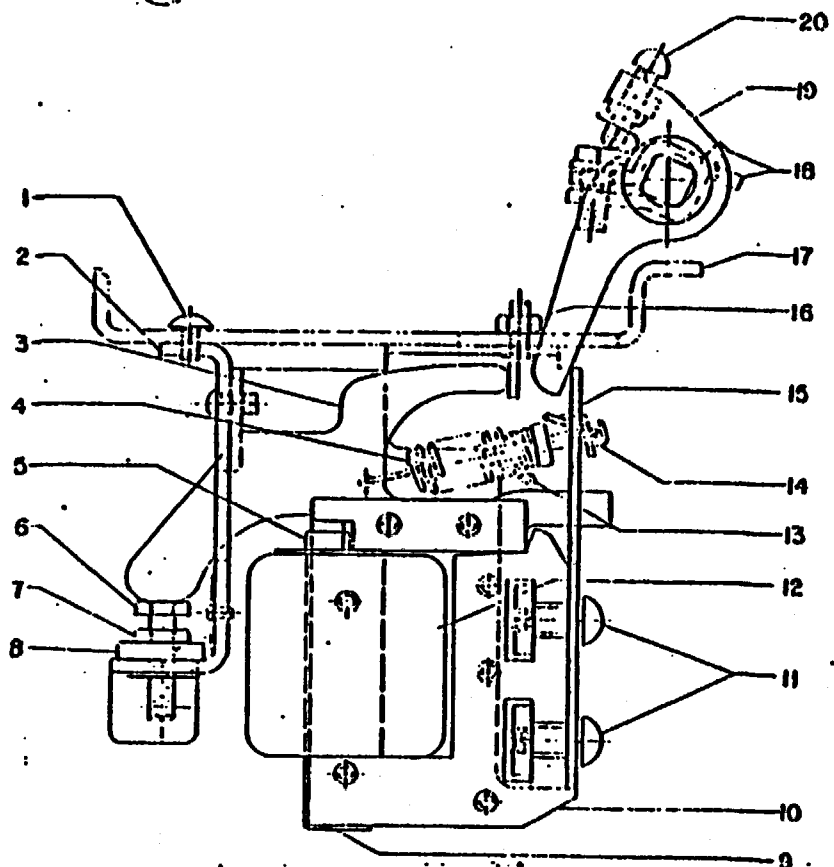
AK-2-15 and AK-2/3-25 Undervoltage Tripping Device

The causes for failure were attributed to either binding within the linkage mechanism of the undervoltage (UV) trip device and trip shaft assembly or out-of-adjustment conditions in the same linkage mechanism. Babcock and Wilcox (B&W) and GE determined that the binding and out-of-adjustment resulted from inadequate preventive maintenance programs

1. Check the undervoltage trip device to assure there is not excessive clearance between the armature and the rivet and that there are no binds as the armature moves through its travel when manually operated. If excessive clearance or binding exists, it should be adjusted by loosening screws (11) and moving the magnet (10) up or down as necessary to obtain the proper freedom of the armature (3) with respect to its pivot on magnet (10) and the guide provided by pivot (13).

To adjust the pick-up of the instantaneous undervoltage trip device, remove the Locking Wire (15) and turn the adjusting screw (14) clockwise to raise the pick-up to the desired setting. A suitable voltmeter and adjustable voltage source should be connected to the undervoltage device coil leads at the terminal board for stationary breakers or the secondary disconnects for drawout type breakers. On AC devices, the pick-up voltage should be read immediately before the armature closes its air gap. After the pick-up is adjusted, locking wire (15) should be installed.

- 4.. The torque required on the trip shaft to trip a closed breaker should not exceed 1.5 pounds-inches. This may be checked with the equivalent of an open-end wrench fabricated from a piece of sheet metal to which a spring scale can be fastened approximately 1 inch from the trip shaft centerline. Where the torque required to trip the breaker exceeds 1.5 pound-inches, hardened grease in the trip shaft bearings and/or latch bearing may be suspected or dirt may have accumulated on the trip latch surface. Hardened grease must be replaced or revitalized with a suitable solvent such as WD-40 or CRC 5-56 or the bearings must be replaced. Excessive grease and dirt should be removed from the trip latch surface.

5. The adjustment between the undervoltage trip device and the trip paddle on the trip shaft should be checked to assure the required positive trip is maintained (positive trip exists when approximately 1/32 inch additional travel of the armature occurs after the undervoltage device trips the breaker.) This adjustment is made with adjusting screw (20).
