Subject: Type HFA relay with latching mechanisms.

RELAY AND ACCESSORY SERVICE ADVICE LETTER

Subject: HFA RELAYS WITH LATCHING MECHANISMS Number 190.1
Issued by: R. R. Hammer November 16, 1987
Prepared by: S. S. Duerwachter

<u>NON-CENTURY SERIES</u>	<u>CENTURY SERIES</u>
TYPES: HFA54 HFA74 HFA51B HFA71B	TYPES: HFA154 HFA174 HFA151B HFA171B

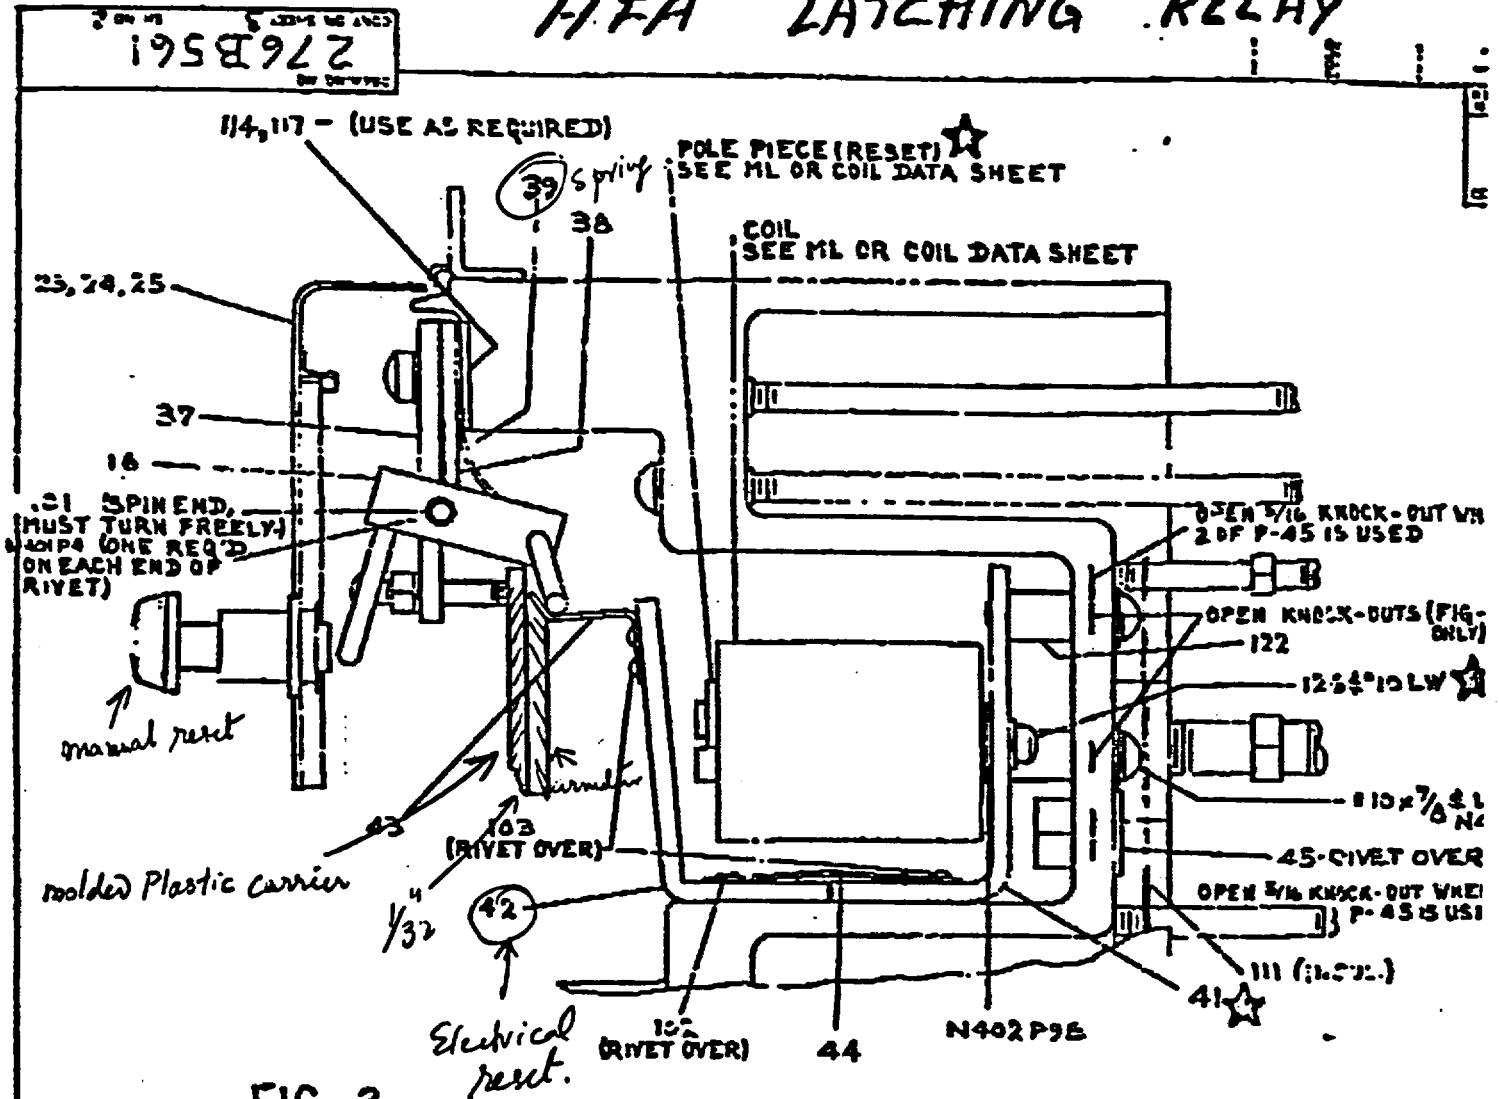
FIG-2

One user of latching-type HFA Relays has reported finding several Relays on which the latch engagement was less than the recommended minimum. With the armature in the latched position, each leg of the U-shaped latch should engage the top of the armature by at least 1/32 inch. There is a possibility that with less than the recommended minimum latch engagement, the relay could unlatch incorrectly.

Our investigation into this report has led us to conclude that latch engagement of less than 1/32 inch may be caused by two circumstances. If there is insufficient clearance between the top of the relay armature and the top of the molded moving contact carrier, it could prevent the mechanical latch from reaching the minimum 1/32 inch engagement. The second reason could be insufficient tension by the formed leaf spring that rotates the latch to its fully engaged position. If this leaf spring does not have proper tension, there is a possibility that the spring will relax before full engagement between the latch and armature is achieved.

- a. If there is insufficient clearance between the top of the molded moving contact support and the top of the armature, a small portion of the molded support can be removed by filing. This can be done as follows:

1. Remove the armature assembly from the relay.
 2. Disassemble armature assembly, maintaining the proper orientation of contact springs and moving contacts.

3. File approximately 1/16 inch from the top of the contact carrier.
 4. Reassemble armature assembly, maintaining original orientation of contact springs and moving contacts, and recheck for at least 1/32 inch clearance, as mention in (A1).

5. Replace armature assembly in Relay.
- b. If full latch rotation is not present:
 1. Remove latch assembly by removing the 10-32 screw at the top of the latch assembly.

2. Re-form leaf latch spring to have less curve (flatter spring).
 3. Reassemble latch assembly and check for full rotation.
 4. If relay is electric reset, check to ensure that relay resets with 60% of rated voltage applied to the reset coil circuit.
