UNITED STATES
NUCLEAR REGULATORY COMMISSION
OFFICE OF INSPECTION AND ENFORCEMENT
WASHINGTON, D.C. 20555

IE Bulletin No. 79-13

CRACKING IN FEEDWATER SYSTEM PIPING

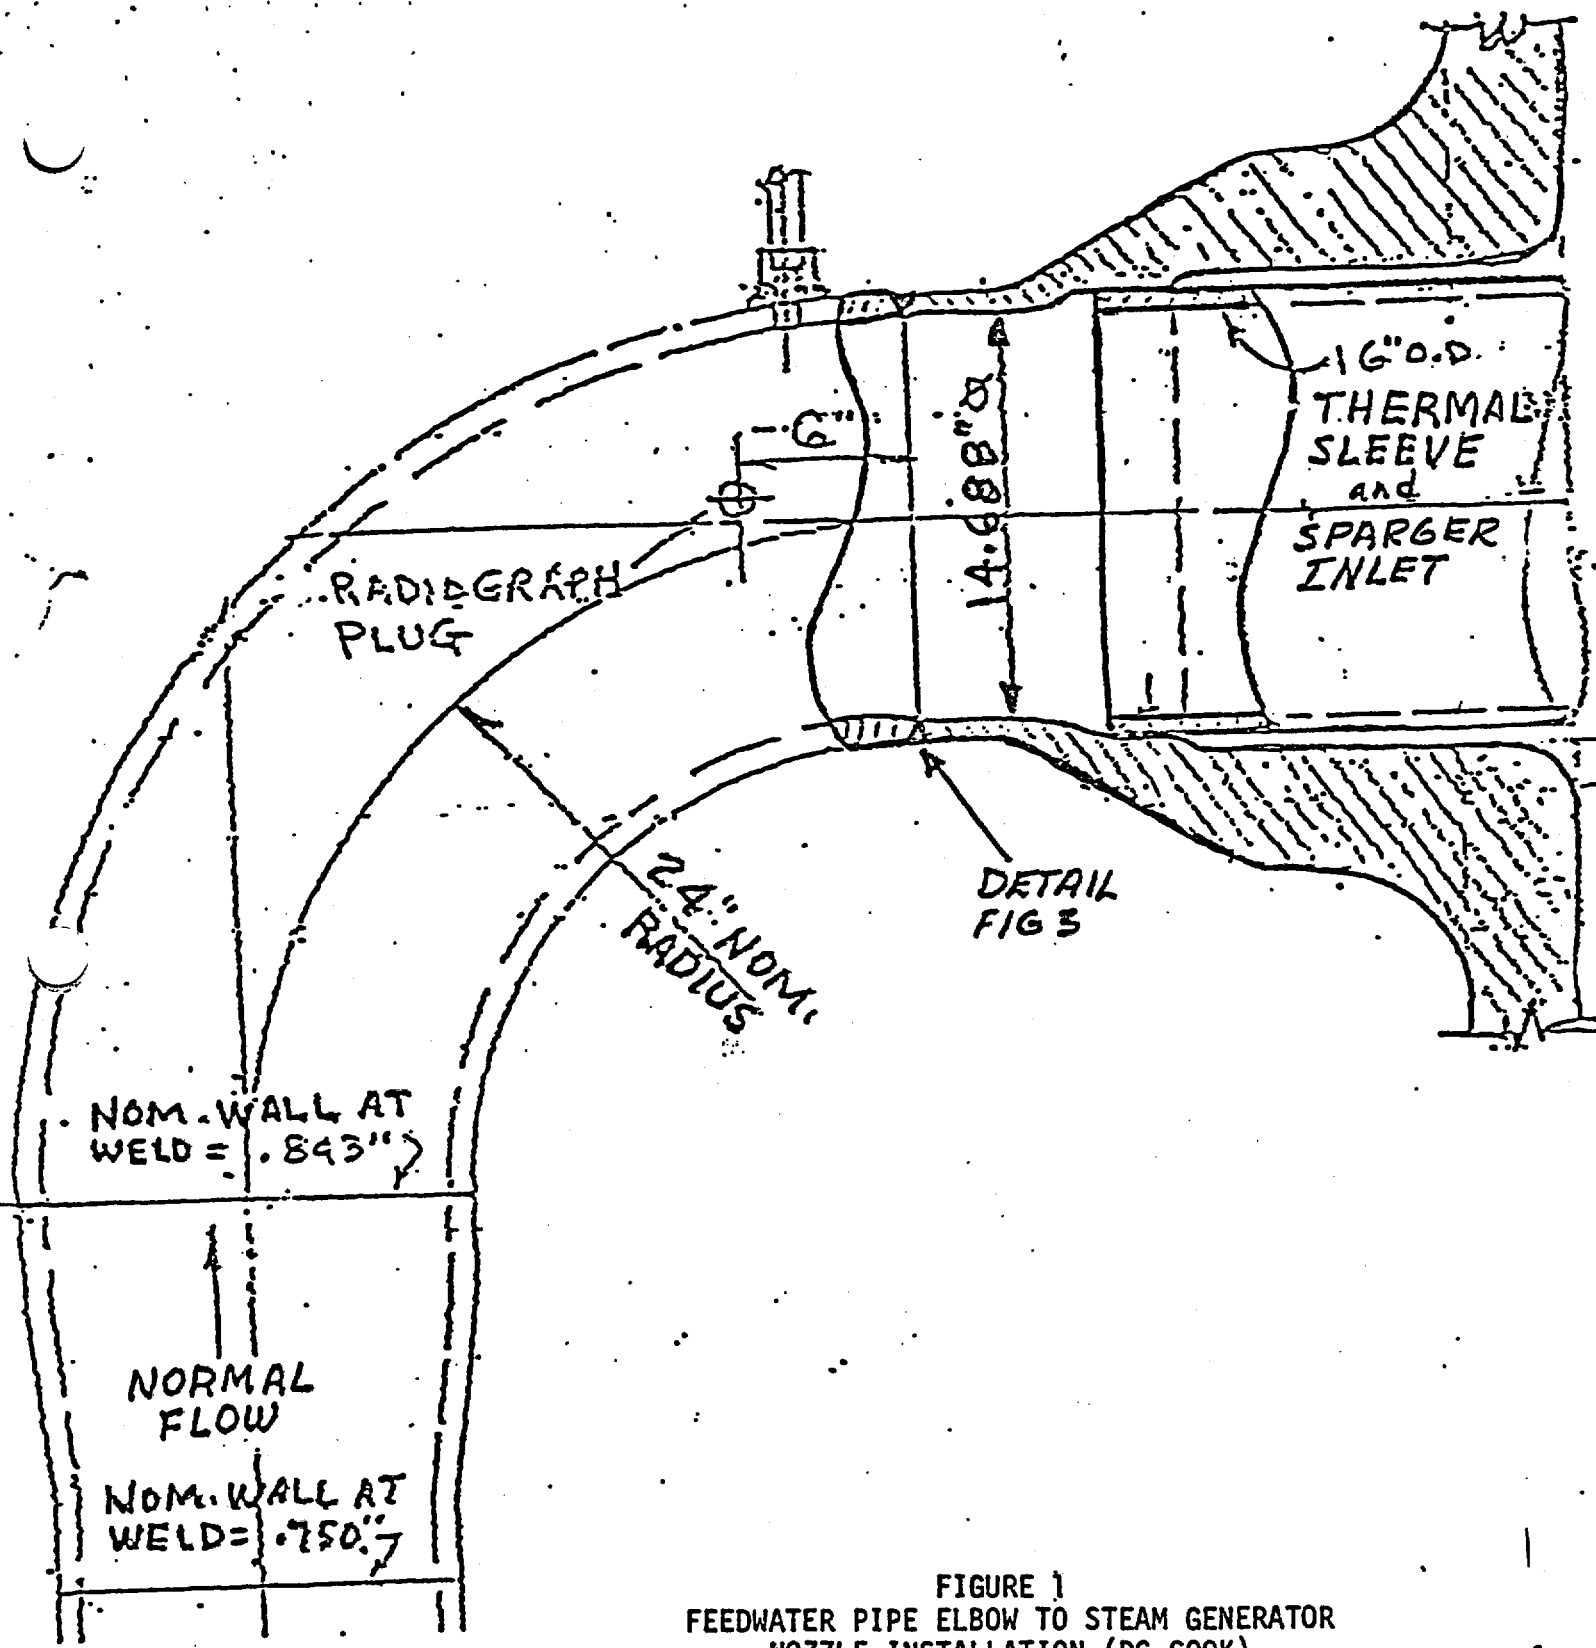
FIGURE 1
 FEEDWATER PIPE ELBOW TO STEAM GENERATOR
 NOZZLE INSTALLATION (DC COOK)

On May 20, 1979, Indiana and Michigan Power Company notified the NRC of cracking in two feedwater lines at their D. C. Cook Unit 2 facility. The cracking was discovered following a shutdown on May 19 to investigate leakage inside containment. Leaking circumferential cracks were identified in the 16-inch feedwater elbows adjacent to two steam generator nozzle elbow welds. Subsequent radiographic examination revealed crack indications in all eight steam generator feedwater lines at this location on both Units 1 and 2.

Cracked weldments have been removed from the D. C. Cook Units 1 and 2 and San Onofre Unit 1 feedwater systems for extensive metallurgical investigation by Westinghouse. Based on preliminary analysis, Westinghouse stated the D. C. Cook failure may be "fatigue assisted by corrosion." The San Onofre cracking was stated to be characteristic of "stress assisted corrosion."

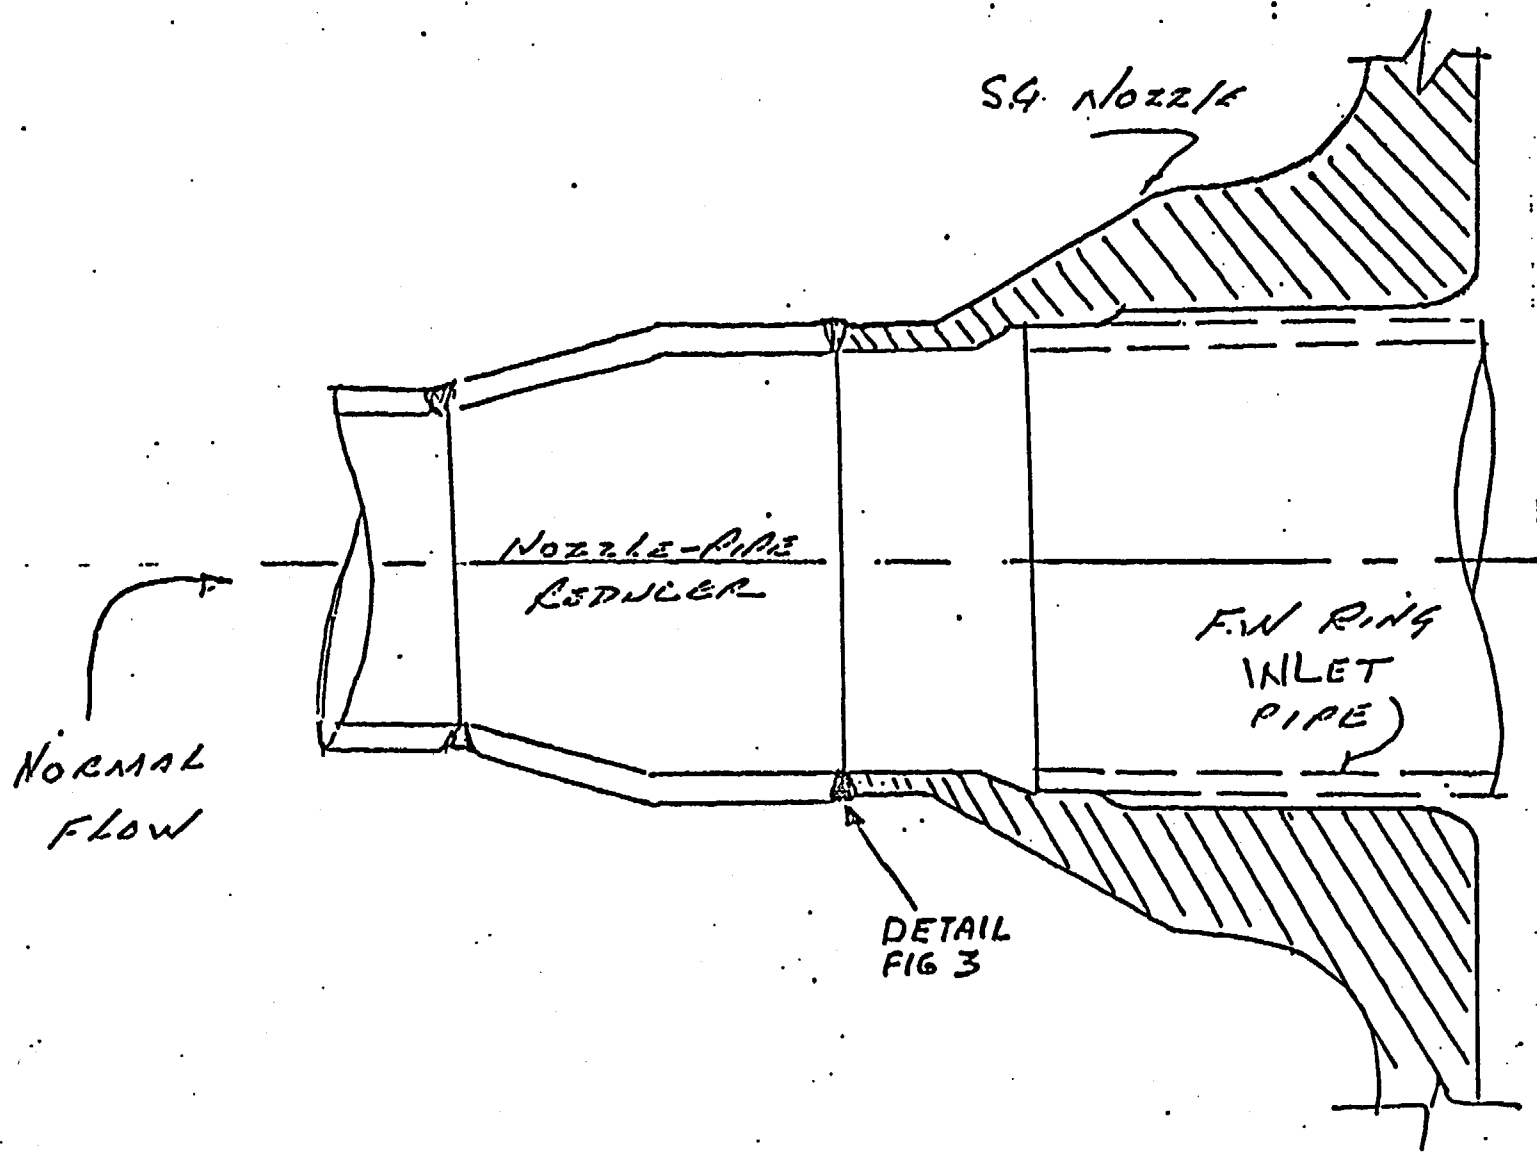
FIGURE 2
FEEDWATER PIPE REDUCER TO STEAM GENERATOR
NOZZLE INSTALLATION (SAN ONOFRE).

As a result of these actions, several other licensees with Westinghouse steam generators reported crack indications. Southern California Edison reported on June 5, 1979, that radiographic examination revealed indications of cracking in feedwater nozzle-to-piping welds on two of three steam generators of San Onofre Unit 1. On June 15, 1979, Carolina Power and Light reported that radiography showed crack indications in similar locations at their H. B. Robinson Unit 2. Duquesne Power and Light confirmed on June 18, 1979, that radiography has shown cracking in their Beaver Valley Unit 1 feedwater piping to vessel nozzle weld. Public Service Electric and Gas Company reported on June 20, 1979 that Salem Unit 1 also has crack indications. Wisconsin Public Service company decided on June 20, 1979 to cut out a feedwater nozzle to pipe weld which contained questionable indication, for metallurgical examination. As of June 22, 1979 and since May 25, 1979 seven other PWR facilities have inspected the feedwater nozzle-to-pipe welds without finding cracking indications.

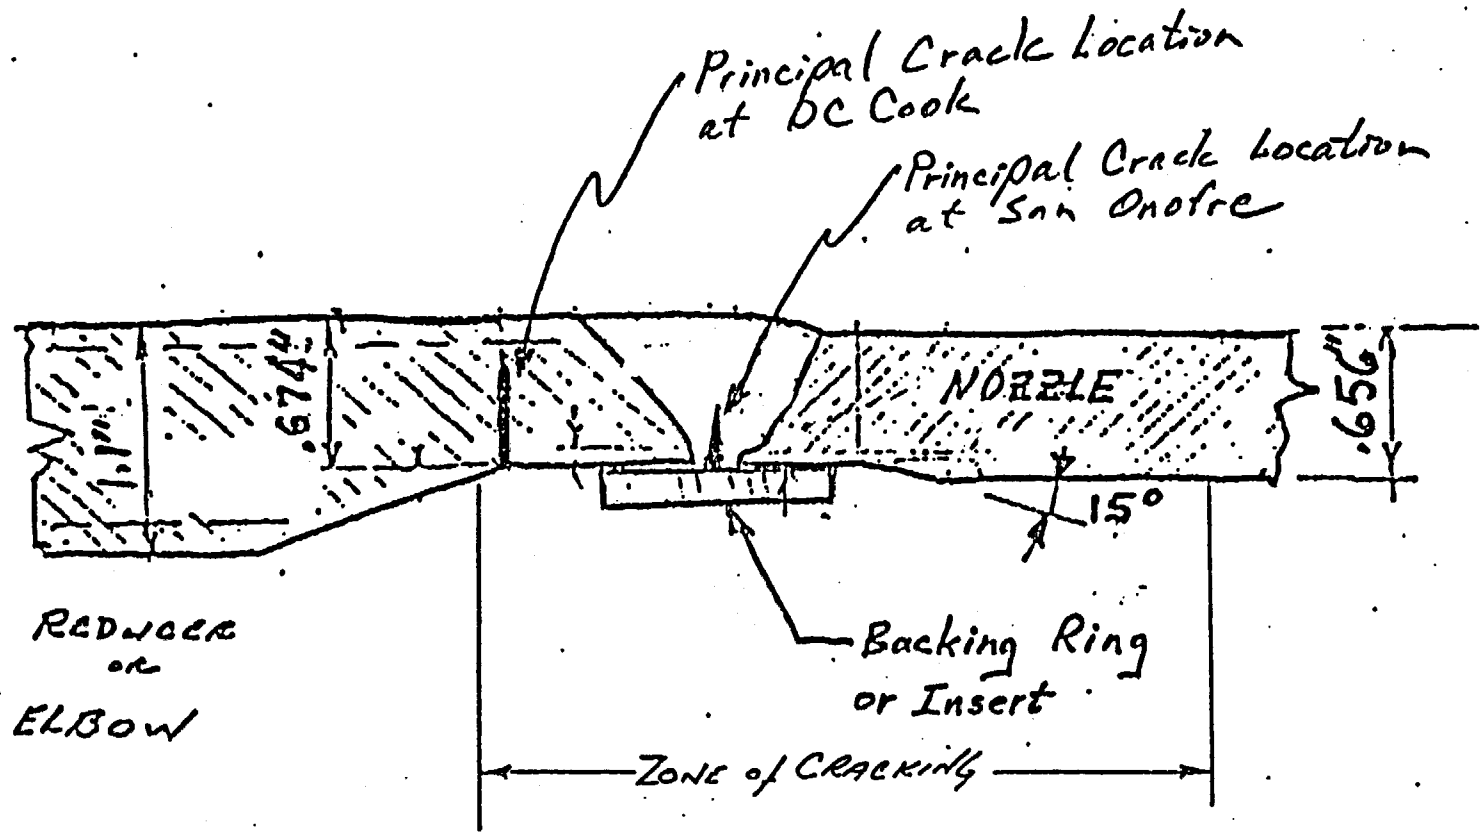
FIGURE 3
 TYPICAL FEEDWATER PIPE TO NOZZLE
 WELD JOINT DETAIL
 (W , CE)

The feedwater nozzle-to-pipe configurations for D.C. Cook and for San Onofre are shown on the attached figures 1 and 2. A typical feedwater pipe-to-nozzle weld joint detail showing the principal crack locations for D.C. Cook and San Onofre are shown on the attached figure 3.

1. Facilities which have steam generators fabricated by Westinghouse or Combustion Engineering that have not conducted volumetric examination of feedwater nozzles since May 1979 shall complete the inspection program described below at the earliest practical time but no later than 90 days after the date of this Bulletin.
 - a. Perform radiographic examination, supplemented by ultrasonic examination as necessary to evaluate indications, of all feedwater nozzle-to-piping welds and of adjacent pipe and nozzle areas (a distance equal to at least two wall thicknesses). Evaluation shall be in accordance with ASME Section III, Subsection NC, Article NC-5000. Radiography shall be performed to the 2T penetrometer sensitivity level, in lieu of Table NC-5111-1, with systems void of water.
